Former International Paper Mill Feasibility Study

**Town of Erving &
Franklin Regional Council of
Governments**

December 2015

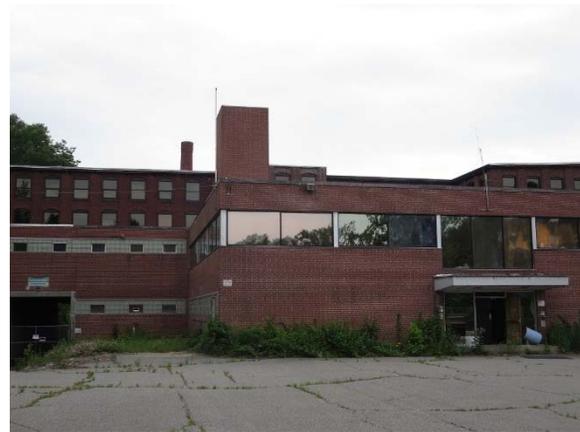
The building has a stone ballast roof supported by interlocking precast elements and long span metal joists. The roof envelope appeared to be in poor condition, as there was significant ponding water noted both days of our inspection and heavy water infiltration into the second floor. Several roof support members showed areas of heavy rust, but did not appear to be in imminent danger of collapse. Heavy moisture and mold growth was apparent throughout the building, indicating likely widespread water infiltration.

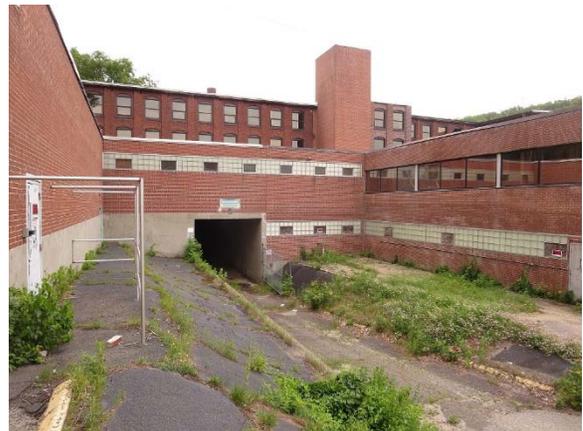
The underpass is cast-in-place concrete and is generally in good to fair condition. It appears to have been previously repaired in several locations, and the repairs are in fair condition. Water appears to be migrating from the inside of the building through the joints between the walls and ceiling of the underpass, carrying efflorescence with it (Photo 6).

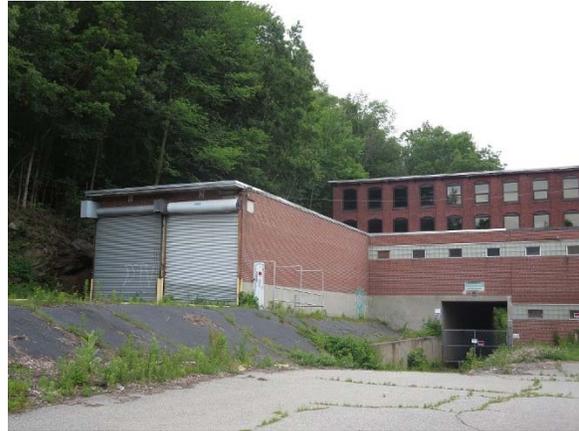
- e) **Building 1e** is a second enclosed loading dock which is connected to the first floor of Building 1b. It is configured in the same way as Building 1d, with two bays sunken relative to the floor of 1b. The roof of this building is a stone ballast system with precast panels and steel support beams, similar to the other adjacent buildings. No significant ponding water was noted, and no water infiltration was apparent from the inside of the building.

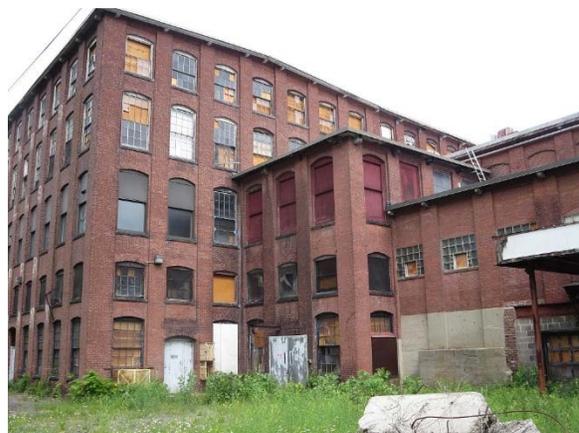
supported by stay-in-place metal deck and steel beams. The metal deck appears to have been recently replaced as there was very little rusting apparent. However, the steel support beams are coated in surface rust. The beams are supported by the Building 2 masonry wall on the south side and a grouted stone masonry wall to the north. There is a definite transition between the Building 2 underpass wall and the Building 1c wall. Both masonry walls appear to be in fair condition.

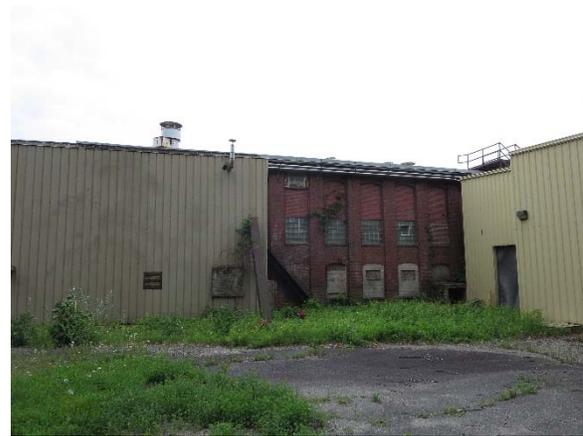
The roof of 4a is constructed of a wood plank deck with metal trusses that clear span the building from north to south. The deck and trusses both appear to be in good overall condition. The roof covering was a single ply membrane that appeared to be in good condition. The roof was pitched to drain to the north and south and no significant ponding water was observed.

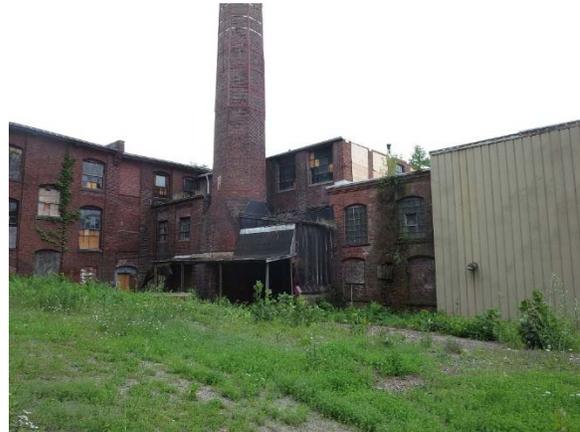
The exterior of the building is not exposed very much as it is surrounded by other buildings on three sides. The north edge of the building is exposed to view and is in poor condition. Water damage is apparent and vegetation growth has started. The mortar is extremely soft and has failed in several locations where brick units have fallen out of the wall.

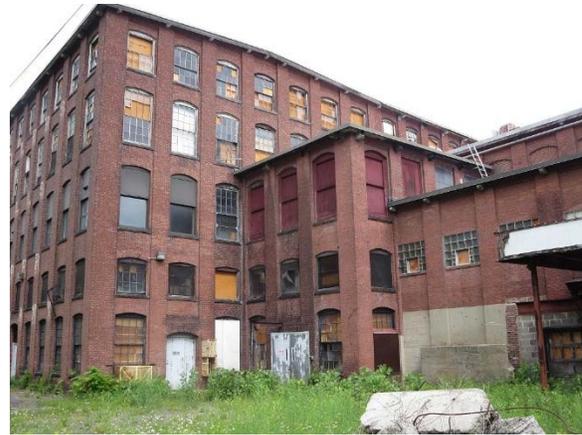
The exterior of the building is only visible from the south side, where a steel canopy covers what appears to have been a small delivery area. The steel canopy is in fair condition, however the exterior foundation wall of the building is in extremely poor condition with significant deterioration.

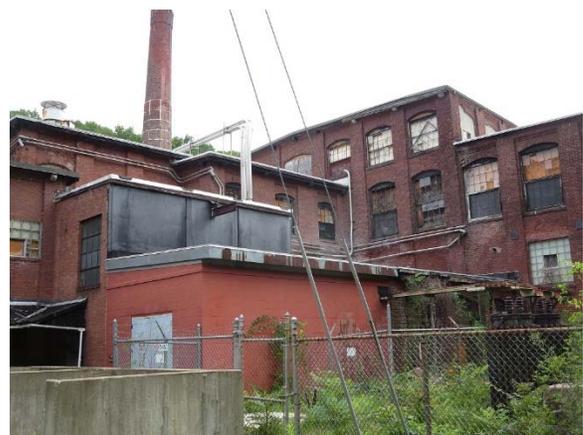
- e) Building 4e is a single story brick masonry structure used as an electrical room. It is accessible only from the exterior and through the basement of Building 5a. The roof is a modified bitumen type and appeared to be in fair condition. The roof framing is a wood deck with heavy timber beams, several of which have been reinforced with steel channels.

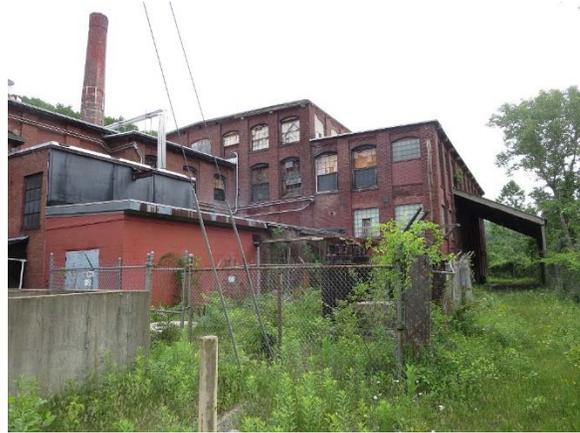
- f) Building 4f is a small three story building which connects at the basement and first floor to Buildings 2, 4a and 4c and connects to Building 2 at the second floor. The building is a brick masonry structure with a modified bitumen roof. The roof is in fair to poor condition. Although no ponding water was noted, moisture migration was apparent as there was widespread paint peeling off the wood roof framing.

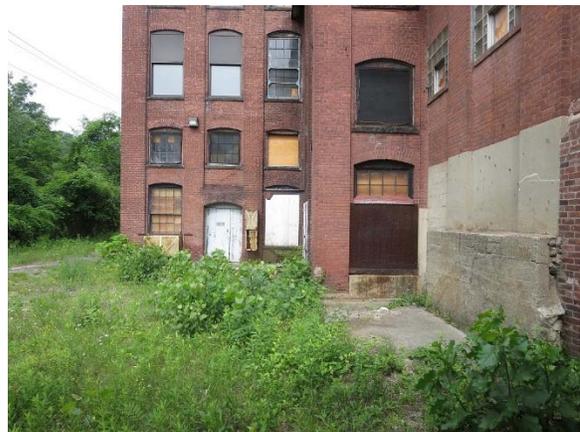
The roof framing appeared in fair condition with no significant deficiencies noted. The floor framing was generally wood beams supported on steel pipe columns or brick masonry pilasters. All structural members appeared to be in fair condition, with some isolated areas of masonry deterioration in poor condition.

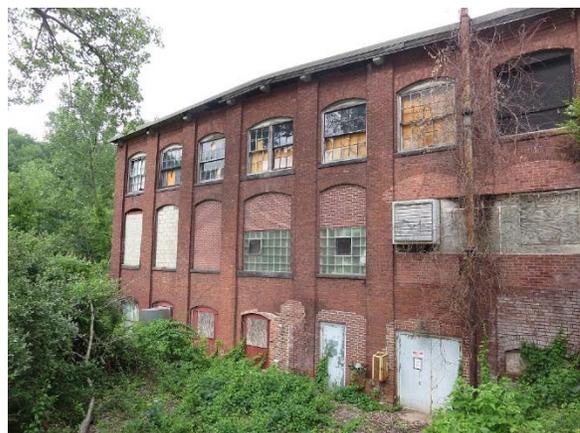
The exterior brick walls are generally in poor condition. There are several locations throughout the building's perimeter where loose or soft mortar was found and numerous areas where brick units are loose or have been lost.

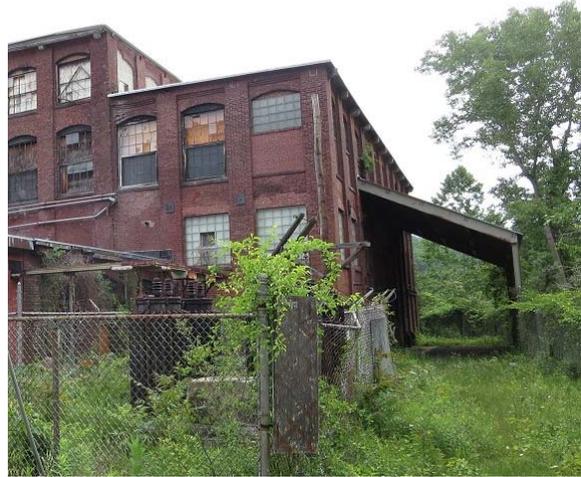
- c) Building 5c is an open ended structure comprised of a metal roof and single wall running parallel to Building 5b. It provides protection from rain or snow to the chemical delivery process to the complex. The concrete slab which runs against the wall of Building 5b is deteriorating and its coarse aggregate is exposed in large patches. There is a containment area adjacent to the delivery ports with a metal grate and steel structural frame. The grating system appears to have a protective coating and is in fair to good condition.

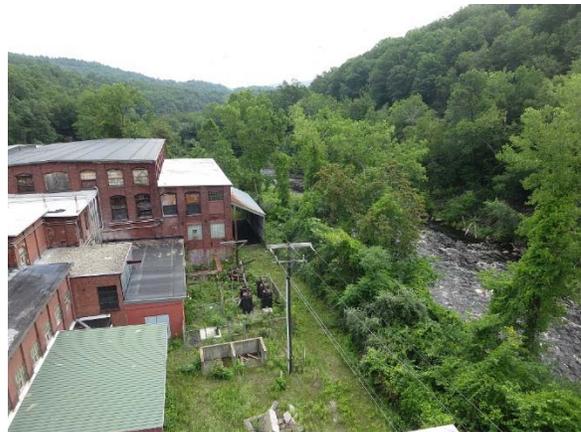
- d) Building 5d is a large boiler room accessible only from the outside or through the ground floor of Building 5a. There is very little of the building exposed to the exterior as the building is surrounded by structures on all sides. The building is approximately 2½ to three stories high, with no apparent basement level. The perimeter brick masonry walls clear span to the roof as there are no intermediate floors, however there are several catwalks within the space.

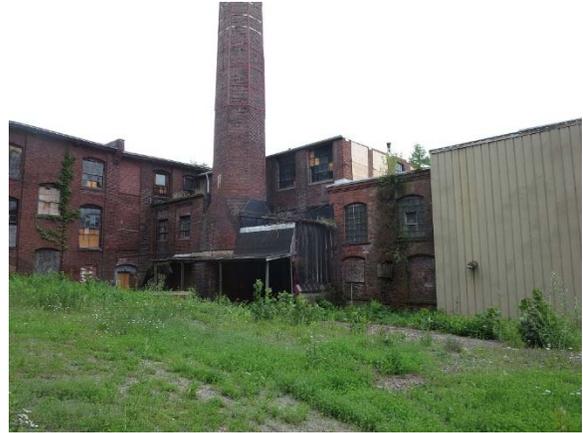
- e) Building 5e is a small connector building used to access the base of the chimney stack. The building is a two story brick masonry structure with a brick masonry chimney stack at the west end. Adjacent to the chimney is a small wood framed shed type roof structure.

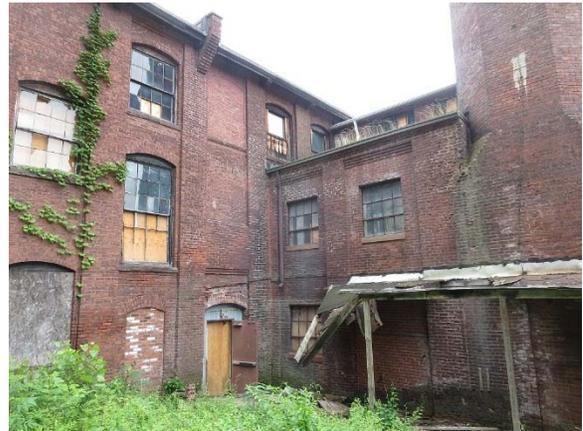
The brick masonry building is currently in fair condition, however with the water ingress into it from the roof collapse, deterioration will likely accelerate. The brick chimney appeared to be in fair to poor condition. Approximately one third to one half of the chimney has been previously reinforced and there are signs of deterioration throughout its height.

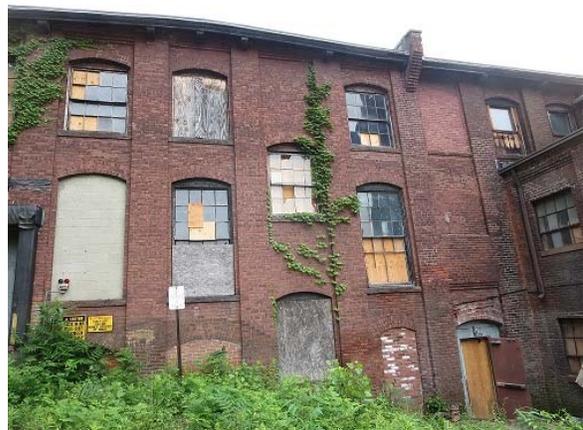
connects only to the basement level of Building 5a. At this doorway, there is a wide flange section which has been cut away. Past this room is another room with two small pools of liquid. The masonry columns are in varying conditions ranging from good to poor. The concrete masonry unit (CMU) walls show some signs of wetness and appear to be in fair condition. The ground floor is a concrete slab supported by integrally-cast steel beams, which appear to be in good condition. From the ground floor, a large crack is visible in the floor above. The second floor contains a reinforced pathway for forklifts in good condition. The steel columns which support the third floor are in good condition. The roof appears to be in good condition from the inside, and is supported by wood columns in fair condition.

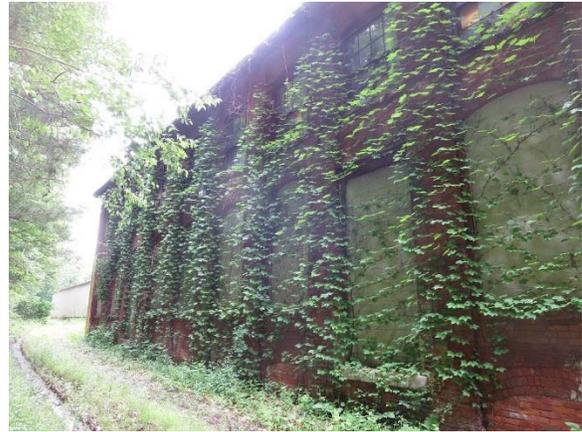
- c) Building 6c is a two story building which is connected to Buildings 6b, 6a, and 7b. Its ground floor is a cast-in-place concrete slab supported by stay-in-place corrugated steel formwork and steel wide flange sections. This slab is fireproofed and looks to be in good condition. There is a circular opening in the floor where a vat presumably passed through which has since been covered with a wood platform. Its second floor is a similar cast-in-place concrete slab, which appears to be in good condition as well. Some bricks are missing from the base of the wall on the third floor. The roof is in good condition.

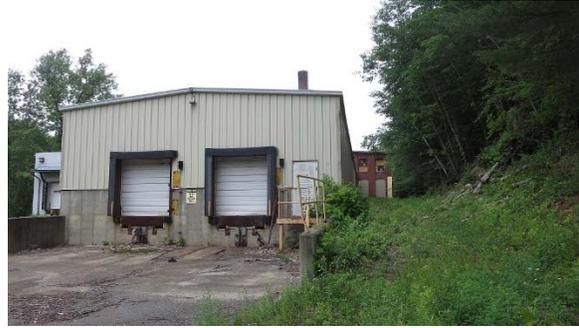
- a) Building 7b is a large storage area with single-wythe CMU walls. The CMUs on the southern wall near the connection with Building 5a area appear to be coving. The roof is sheet metal supported by light trusses. It frames into Building 7a indicating that Building 7b was constructed afterwards.
