ROAD SAFETY AUDIT

Route 2 from MM 60 to MM 62.9

Town of Erving

02/17/2023

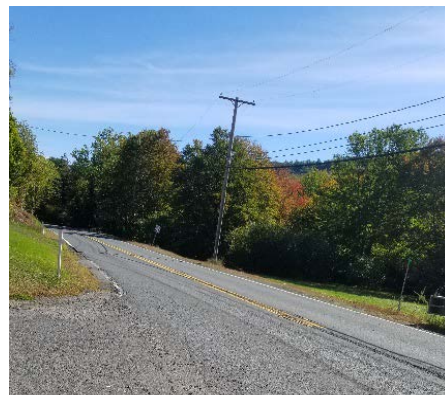
During the site walk, it was noted that roadway lighting is currently present at the intersections of Maple Avenue, Bridge Street and Wheelock Street. But no lighting is present anywhere else in between these intersections or beyond. The lack of lighting elsewhere throughout the cluster can serve as a contributing factor to the nine crashes that took place at nighttime within this segment. It should also be noted that all of the 4 single vehicle crashes involving animal crossings took place at nighttime. With limited lighting, drivers can easily drift away from the travel lane to either collide with a fixed object on the side of the road or veer off beyond the roadway centerline to either sideswipe or collide head-on with a vehicle in the opposite direction. The crash records indicate a total of 5 crashes of these types mentioned, in which one of those crashes took place at nighttime and could potentially affiliate with the lack of lighting on the roadway. There are a few additional utility poles along this roadway section with no roadway lighting.

Image 4: Utility Poles Along Route 2, East of Wheelock Street

1. Evaluate the feasibility to implement any additional lighting to the other remaining utility poles beyond the intersections to make visibility more frequent for drivers.
2. Implement a more effective type of lighting that fosters LED power to provide a more durable way of enhancing the visibility of the roadway for drivers.
3. Improve pavement marking reflectivity, sign reflectivity, and replace guardrail reflectors as needed to provide more visual guidance in addition to the street lighting.

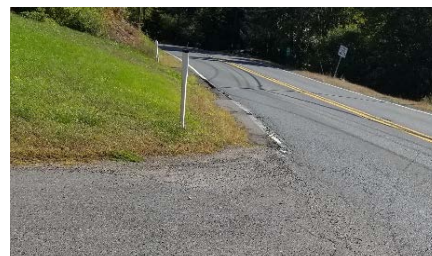
Striping was faded throughout various sections within this cluster. East of Holmes Avenue (East), shoulder markings on the north side of the road were worn down and contained missing sections. The double-yellow centerline also had some faded sections scattered throughout this section of roadway. Stop bars at all of the side street approaches were faded too. As with insufficient lighting, faded or missing markings can lead to driver confusion and cause them to veer off the side of the road or into the opposite travel lane, as reflected by the 11 single vehicle crashes taking place on the side of the road and the 5 head-on or sideswipe crashes taking place near the center of the road.

Image 5: Faded Shoulder Markings East of Wheelock Street

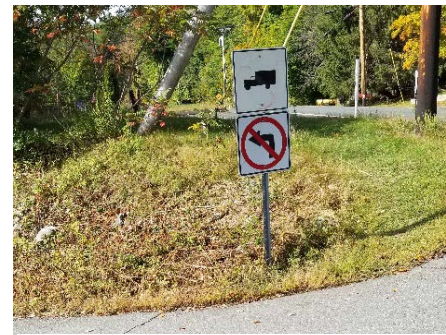
There were a few miscellaneous signs that were faded, which can be less noticeable for drivers. As depicted in Image 6, the R5-2 signs on the two assemblies restricting heavy truck access on Bridge Street are significantly faded to the point where the red “Do Not Enter” symbol over the truck logo is barely visible. The intersection warning sign on Route 2 west of Maple Avenue is also not compliant with the MUTCD and is outdated as well. It should also be noted that all other signs in this corridor are not retroreflective, which can make it difficult for drivers to take notice and respond promptly in a safe manner, especially at night.

Image 6: R5-2 signs on Bridge Street

1. Replace old and faded signage with new signs that are compliant with the MUTCD and are retroreflective to be more noticeable for oncoming drivers.
2. Remove all street name signs and install new signs that are sized at the proper dimensions with respect to the MUTCD to make drivers more aware of any oncoming side streets.
3. Install additional advanced deer crossing warning signs to encourage drivers to operate with increased awareness of animal crossings throughout the corridor.

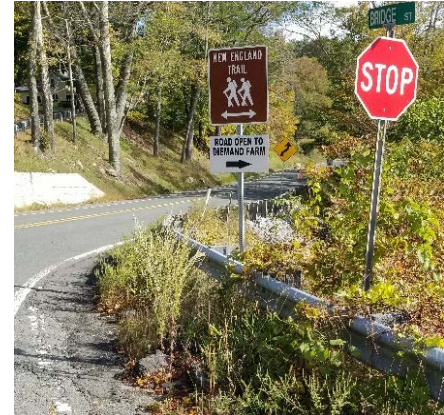
At the eastern corner of the Bridge Street Approach to Route 2, there is a recreational sign assembly for the New England Trail that obstructs the line of sight for drivers looking east on Route 2 to the right. The constraints on sight distance makes it more difficult for drivers to safely turn onto Route 2, with the risk of impeding the travel path of any oncoming vehicle travelling on Route 2. There is also a vertical curve adjacent to the Bridge Street/Holmes Avenue intersection that strictly limits the driver's line of sight to its crest when looking west from either the Bridge Street or Holmes Avenue (West) approach.

Image 7: New England Trail Sign Assembly near the Bridge Street Stop bar

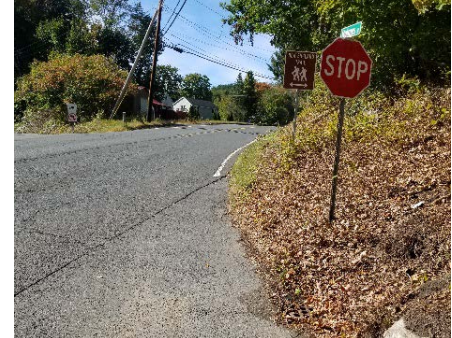
The Bridge Street/Holmes Avenue intersection at Route 2 serves as a pedestrian crossing location for thru hikers making use of the New England Trail, which runs along Bridge Street and crosses over Route 2 onto Holmes Avenue. Although no pedestrian crashes occurred in this cluster, Route 2 is a very difficult roadway for pedestrians to cross due to the high vehicular speeds, along with the lack of crosswalks and warning signage for pedestrian crossings.

Image 8: Pedestrian Crossing Location to the New England Trail

6. Under the condition that the western approach of Holmes Avenue is closed off, install a sidewalk along the closed stretch in addition to a crosswalk between Bridge Street and Holmes Avenue (West) to provide safe pedestrian access.

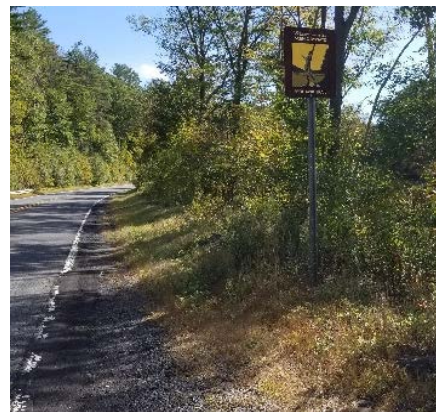
Image 9: Route 2 Section with No Utility Poles

1. Identify and evaluate any feasible areas to propose utility poles for additional roadway lighting.
2. Install roadway lighting at any other existing utility poles residing on this roadway section to enhance the visibility of any roadway sections that are lacking in it.
3. Implement a more effective type of lighting that fosters LED power to provide a more durable way of enhancing the visibility of the roadway for drivers.

4. Improve pavement marking reflectivity, sign reflectivity and replace guardrail reflectors as needed.

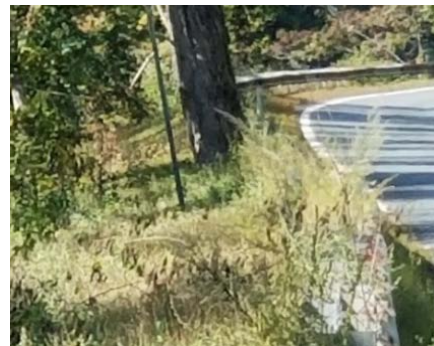
Along various sections of this roadway, the shoulders are narrower to the point where there is nearly no buffer space between the shoulder marking and the edge of roadway. Without a safe buffer space, any vehicle that veers off beyond the shoulder is immediately at risk of striking a fixed object, which can comprise of guardrail, ditches, or trees. In contrast to other sections of Route 2, this cluster has a lot of steeper side slopes located just beyond the north side of the roadway, increasing the chances of impact to occur when veering off beyond the shoulders. There were 9 crashes within this cluster that involved vehicles veering off to the side of the road, in which 8 of those crashes took place on the north side of the roadway. The town also reported a lot of trees that have also fallen down onto various section of this roadway, resulting in traffic backups and one single vehicle collision with a fallen tree.

Image 10: Narrow Shoulders along Route 2

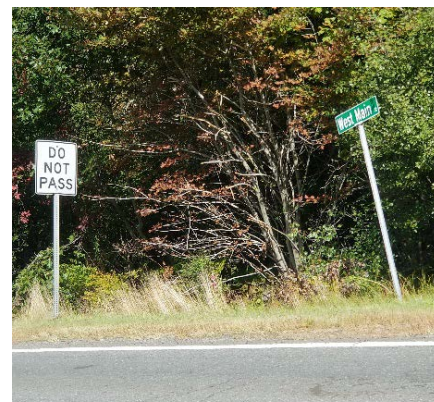
None of the signs in this corridor are retroreflective, which makes it difficult for drivers to take notice and respond accordingly in a safe manner. Without the visibility of essential warning and regulatory signs, drivers will not be aware of any upcoming road conditions to watch out for, especially with the high amount of animal crossings occurring at night.

Image 11: Existing signs Oriented Sideways

1. Replace old and faded signs with new signs that are compliant with the MUTCD and are retroreflective to be more noticeable for oncoming drivers.
2. Replace the current Passing Zone signs with new ones installed at proper locations based on AASHTO guidelines on passing sight distance and from the MUTCD, so that drivers can be properly informed on the correct areas that allow for passing.
3. Install additional Mile Marker Signs to act as reference markers for emergency responders.
4. Inspect all school bus stop signs to confirm that it's been placed at a proper location and at a safe distance from any sharp curves nearby.

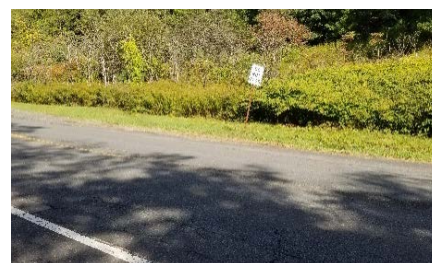
Although the striping is not as faded in this roadway section, the lack of retroreflectivity on the pavement markings strictly limits the visibility of drivers and their ability to operate safely within their respective travel lanes. As discussed earlier on roadway confinement, the shoulder pavement lines are positioned close to the edge of roadway at various locations, increasing the chances for a vehicle to collide into a fixed object when encroaching just beyond the shoulder striping. The deficiencies in the roadway striping can also contribute to the nine single vehicle crashes that resulted from drivers veering off the road.

Image 12: Faded double-yellow centerline along Route 2 near MM 62.

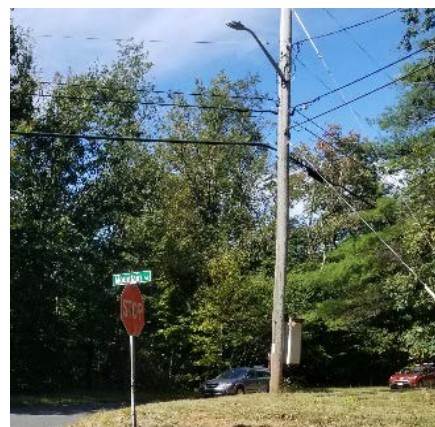
During the site walk, there was only one streetlight mounted on the utility pole adjacent to the Mountain Road approach. There is no street lighting present in all other areas on this roadway stretch despite the high number of utility poles. As discussed, a lack of roadway lighting can increase driver confusion and the potential to stray away from the travel lane, which can affiliate to 45% (5 crashes) of the total crashes involving single vehicle crashes veering off on the north side of the Route 2 west of Mountain Road. As noted in Appendix C, there were six total crashes taking

Image 13: The Lone Roadway Light at Mountain Road

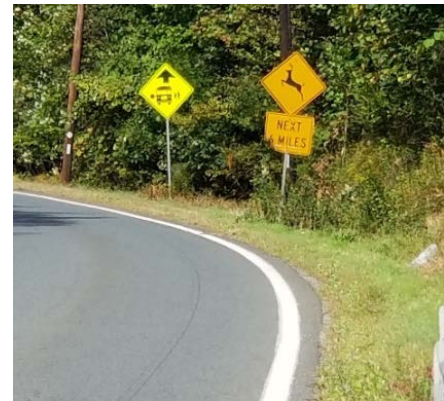
Image 14: Narrow Shoulders along Route 2 West of Mountain Road

1. Identify available space to widen the roadway and accommodate shoulders of a larger width along the Route 2 section parallel to Gary Street.
2. Install additional chevron signs to warn and guide drivers to proceed with caution through sections with swift changes in horizontal curvature.
3. In addition to the roadway widening, construct a retaining wall between Gary Street and Route 2 to prevent any slope runoff and to create a stable barrier between the two streets.
4. Trim down any trees and remove any fixed objects that are in danger of falling into the roadway.

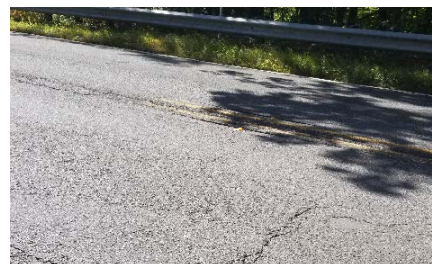
The striping for shoulders and double-yellow centerline is faded along various locations along this corridor. As discussed earlier on roadway confinement, the shoulder pavement lines are positioned close to the edge of roadway at various locations. The deficiencies in the roadway striping can also serve as a contributing factor to those six single vehicle crashes that occurred beyond the edge of the roadway.

Image 15: Faded double-yellow centerline along Route 2 East of Mountain Road

1. Restripe the corridor with new retroreflective pavement markings that's either of the wet-reflective or thermoplastic type to visually guide drivers into their own respective lane.
2. Install rumble strips on the shoulders and double yellow centerline to increase driver awareness on remaining in the correct travel lane.
3. Replace any old guardrail reflectors as needed to enhance the visibility of the roadway.

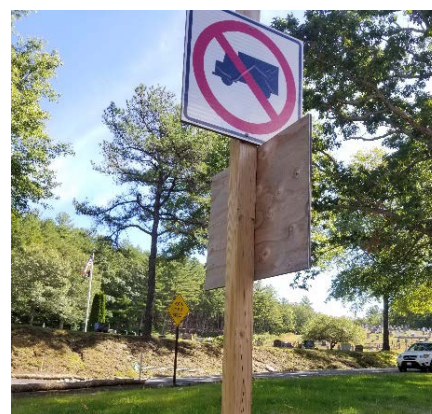
The street name sign for Mountain Road is also designed at a size that is smaller than the D3-1 dimension requirements from the MUTCD. Street name signs designed at that small of a size can make it difficult for drivers to recognize what it reads. The street name sign for Gary Street is also at a substandard size and was seen lying on the ground during the site walk. Street name signs subject to these conditions can result in delayed driver reactions,

Image 16: Temporary Sign Assembly for Truck Restrictions on Mountain Road

1. Replace old and faded signage with new signs that are compliant with the MUTCD and are retroreflective to be more noticeable for oncoming drivers.
2. Remove the existing street name signs and install new D3-1 signs for Mountain Road and Gary Street on separate posts to make drivers more aware of upcoming side streets.
3. Install a permanent R5-2 (No Trucks) sign assembly for restricting trucks and remove the temporary assembly to emphasize the restriction of trucks on Mountain Road.
4. Install additional chevron alignment signs to warn and guide drivers to proceed with caution through segments with swift changes in horizontal alignment.
5. Install W3-5 warning signage to provide drivers an advanced notice of a lower speed limit section and to encourage lower speeds when heading to Erving Center in the eastbound direction.

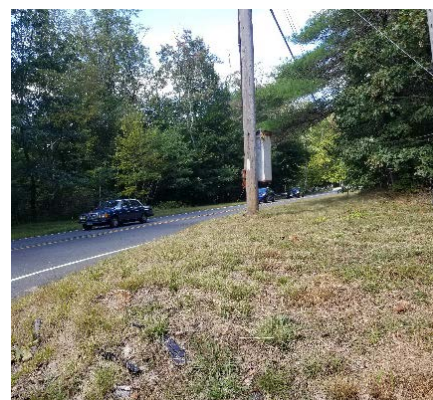
At the Mountain Road intersection approach to Route 2, the team took note of any obstructions and features that served as a limiting factor for the intersection sight distance. The stop bar along Mountain Road is placed far back from the Route 2 edge of travel way, making it very difficult for drivers to see far along Route 2 in either direction. Other obstructions on sight distance included trees and utility poles. Sight distance constraints can lead to unsafe turning movements from minor streets, especially if the driver is unable to notice any oncoming vehicles travelling on Route 2 when taking a turn.

Image 17: Limited Sight Distance when Looking West from the Stop Bar on Mountain Road
