# **Center Cemetery Gravestone Preservation Project**

**Erving, Massachusetts  
2018**

**Report prepared by  
Ta Mara Conde  
Historic Gravestone Services  
New Salem, MA**

## **Conservation report for Center Cemetery 2018**

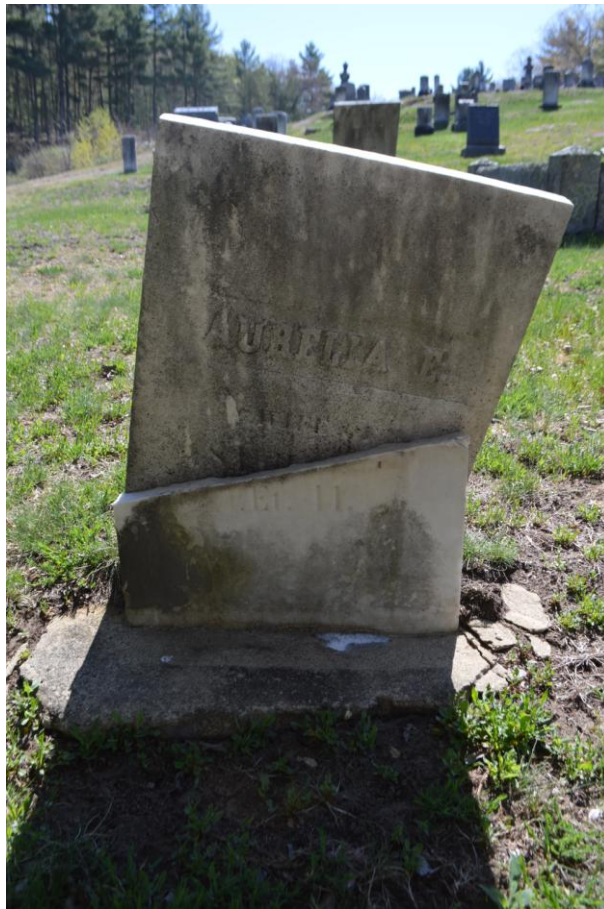
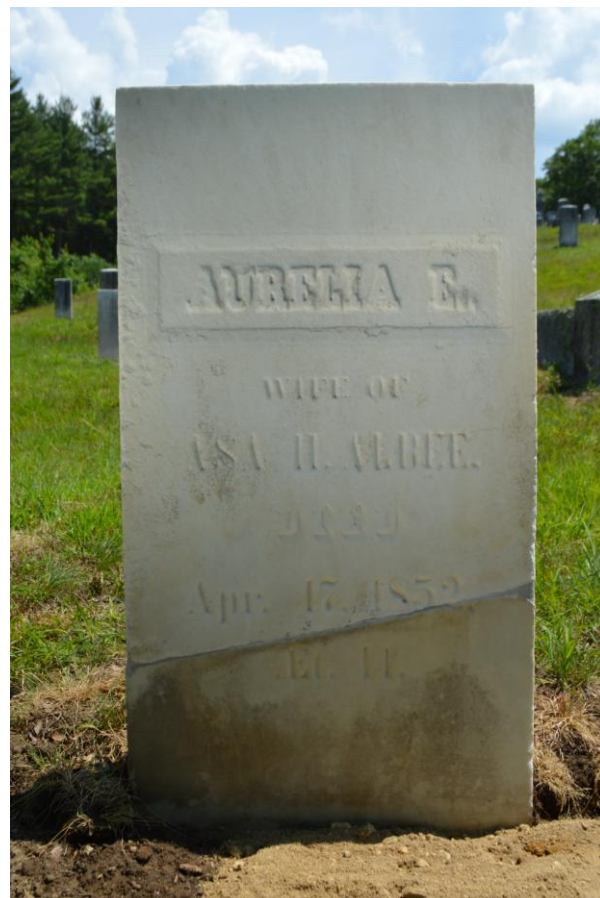
**Cemetery** Center Cemetery  
**Location** Erving, MA  
**Record Date** July 2018  
**Name** Albee, Aurelia E.  
**Date of Death** April 17, 1852

**Stone Condition** Ambient dirt and biological growth  
Broken, 2 fragments  
Concrete around fragment

**Treatments** Cleaned and treated with D2  
Remove concrete  
Reset stone plumb  
Reattach fragment with Jahn M120

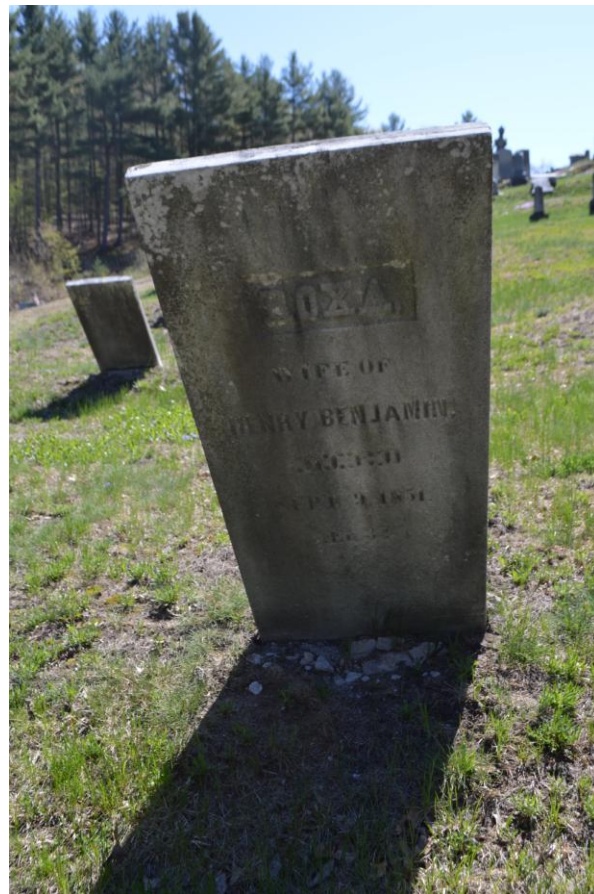
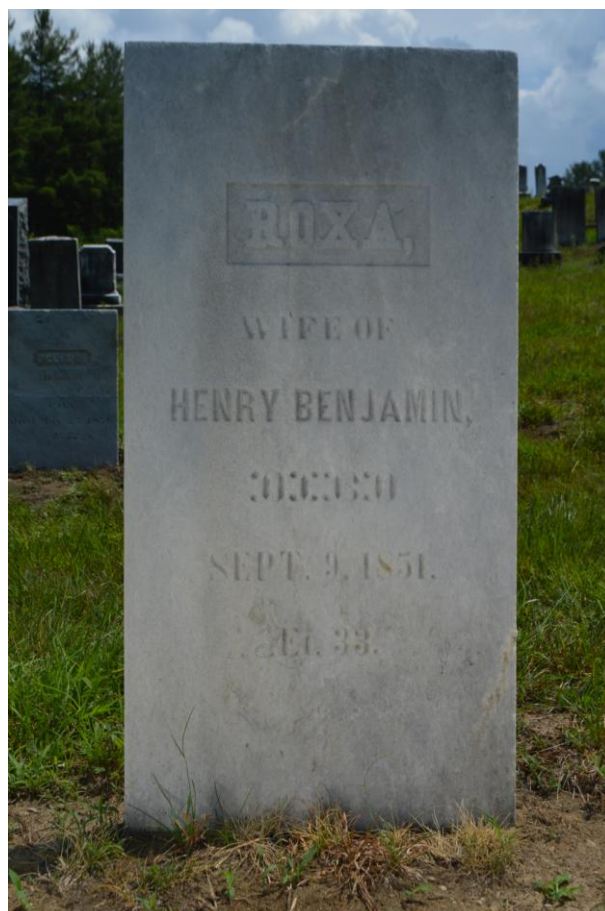
**Cemetery** Center Cemetery  
**Location** Erving, MA  
**Record Date** July 2018  
**Name** Benjamin, Roxa  
**Date of Death** Sept. 9, 1851

**Stone Condition** Ambient dirt and biological growth  
Leaning  
Sunken

**Treatments** Cleaned and treated with D2  
Reset stone plumb at the correct height

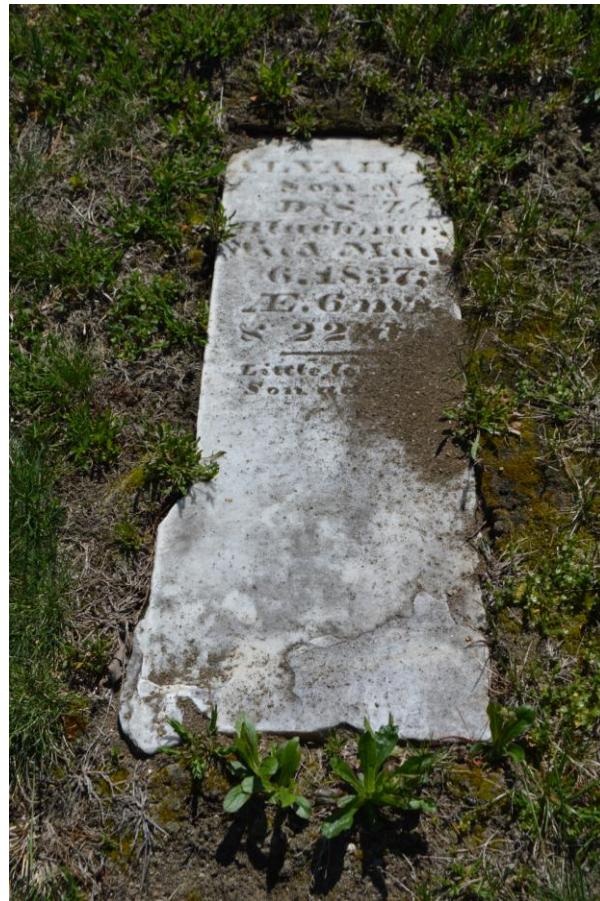
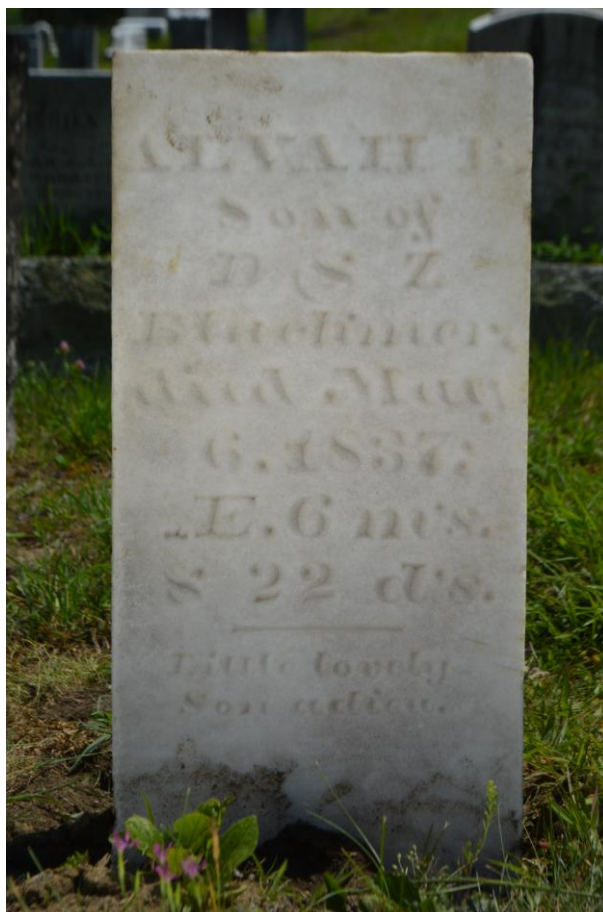
**Cemetery** Center Cemetery  
**Location** Erving, MA  
**Record Date** July 2018  
**Name** Blaclimer, Alvah R.  
**Date of Death** May 6, 1837

**Stone Condition** Ambient dirt and biological growth  
Fallen  
Sunken in ground

**Treatments** Cleaned and treated with D2  
Reset plumb

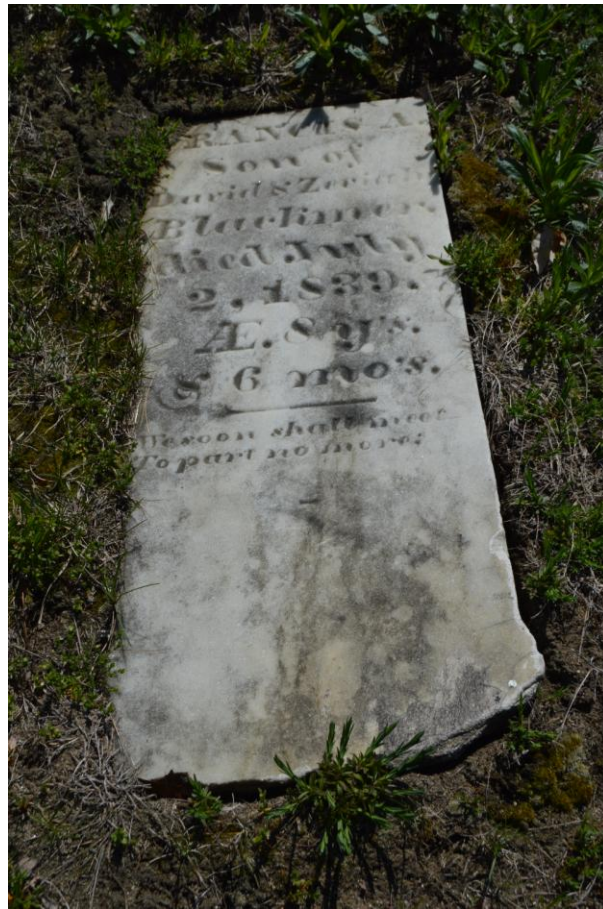
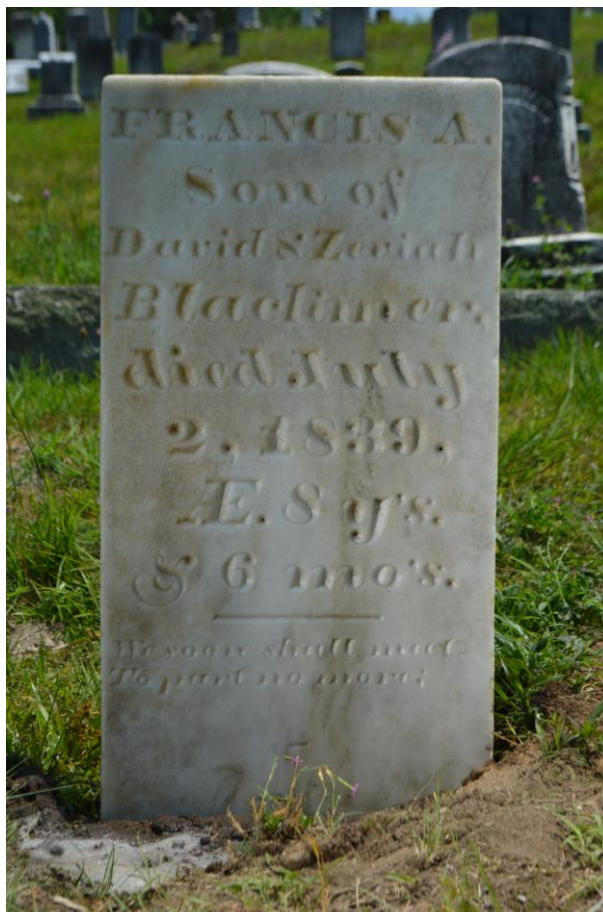
**Cemetery** Center Cemetery  
**Location** Erving, MA  
**Record Date** July 2018  
**Name** Blaclimer, Francis A.  
**Date of Death** July 2, 1839

**Stone Condition** Ambient dirt and biological growth  
Fallen  
Sunken in ground

**Treatments** Cleaned and treated with D2  
Reset plumb

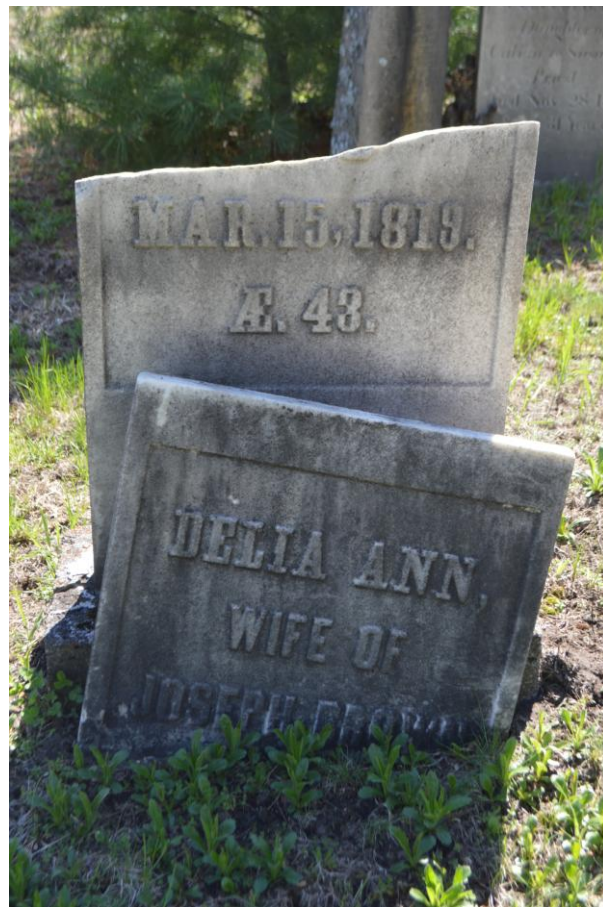
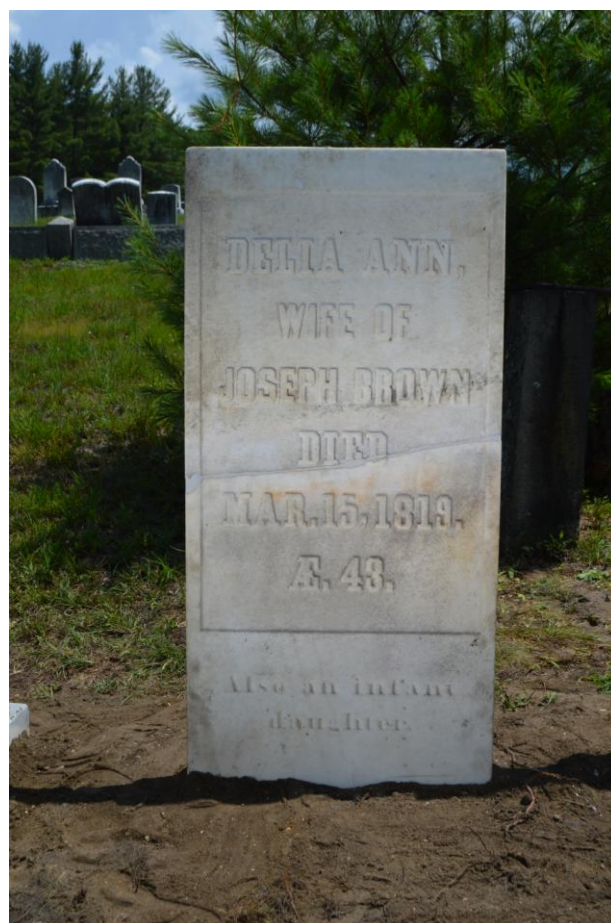
**Cemetery** Center Cemetery  
**Location** Erving, MA  
**Record Date** July 2018  
**Name** Brown, Delia Ann  
**Date of Death** March 15, 1819

**Stone Condition** Ambient dirt and biological growth  
Broken, 3 fragments  
Leaning  
Concrete around fragment

**Treatments** Cleaned and treated with D2  
Remove concrete  
Create and set new concrete base  
Reset stone fragment into base with lime mortar  
Reattach fragments with Jahn M120

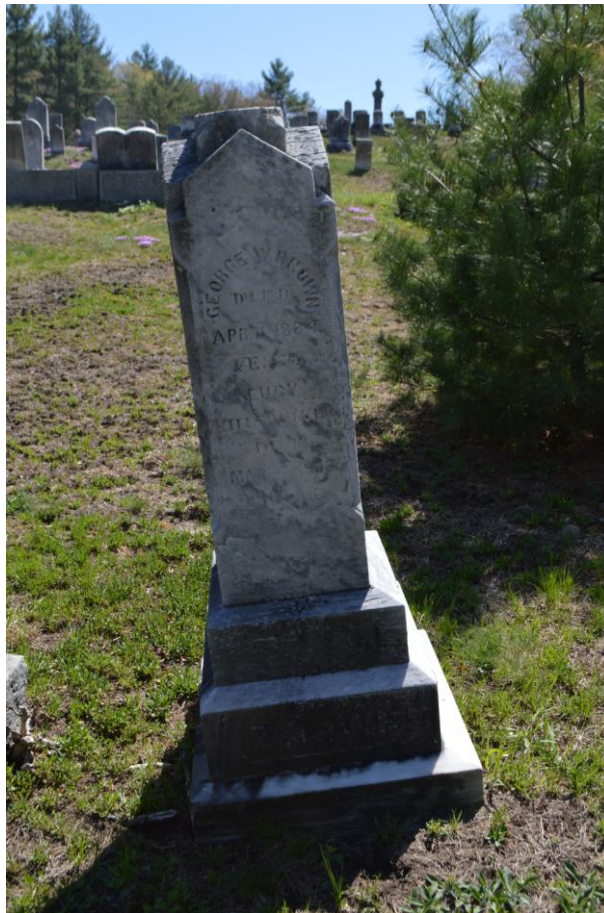
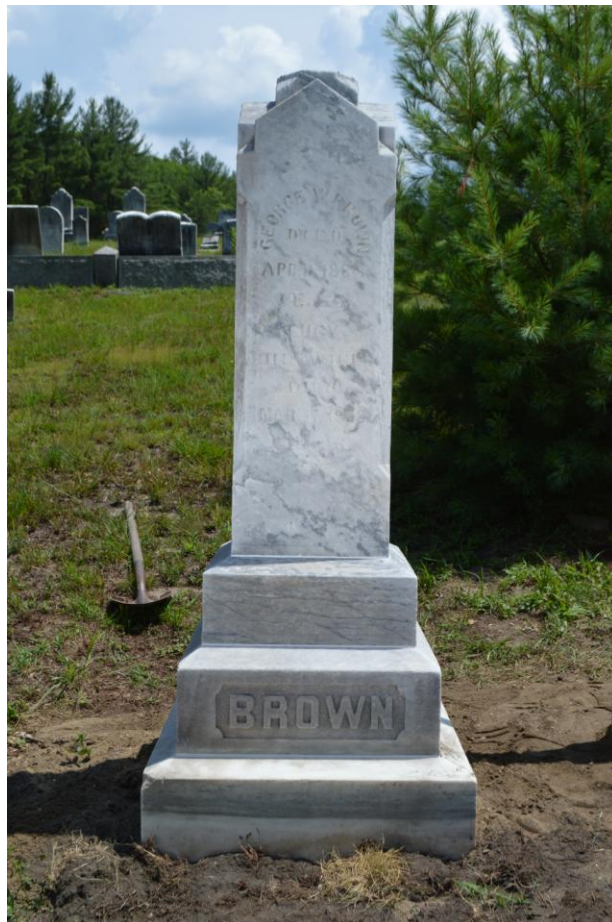
<b>Cemetery</b>	Center Cemetery
<b>Location</b>	Erving, MA
<b>Record Date</b>	July 2018
<b>Name</b>	Brown, George & Lucy
<b>Date of Death</b>	Apr. 11, 1884      Mar. 17, 1908

<b>Stone Condition</b>	Ambient dirt and biological growth Leaning Missing mortar
<b>Treatments</b>	Cleaned and treated with D2 Reset base stone plumb Reassemble elements with lime mortar

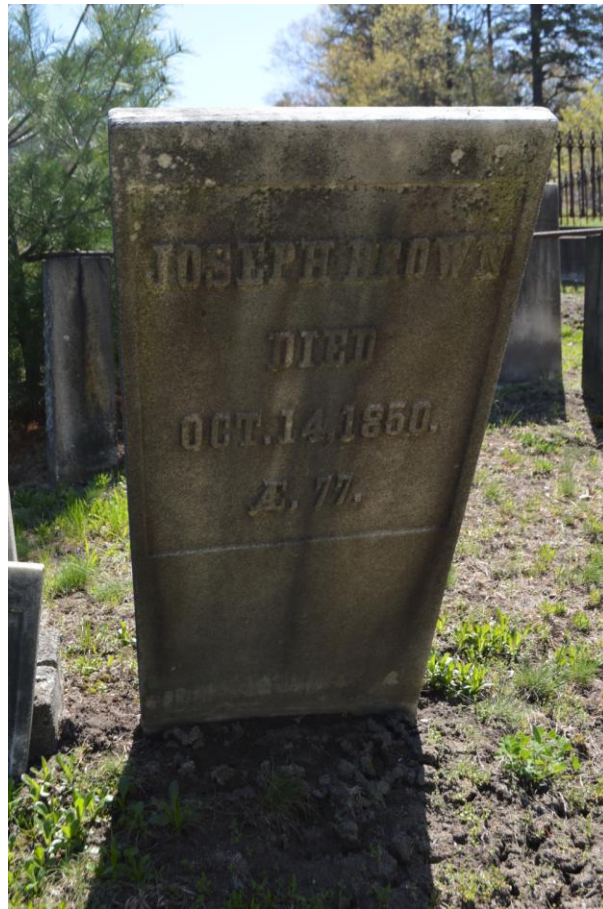
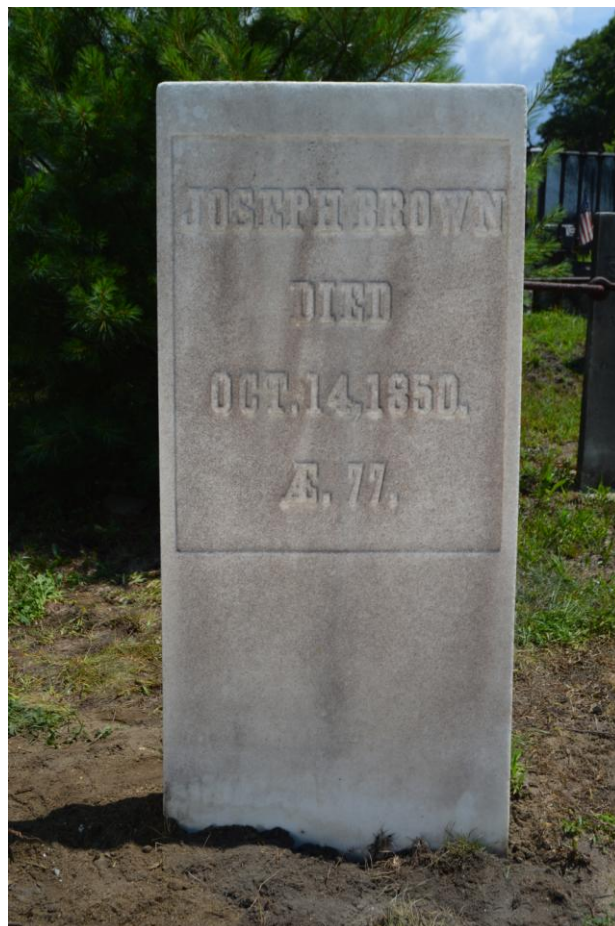
**Cemetery** Center Cemetery  
**Location** Erving, MA  
**Record Date** July 2018  
**Name** Brown, Joseph  
**Date of Death** October 14, 1850

**Stone Condition** Ambient dirt and biological growth  
Leaning  
Concrete around stone

**Treatments** Cleaned and treated with D2  
Remove concrete  
Reset stone plumb

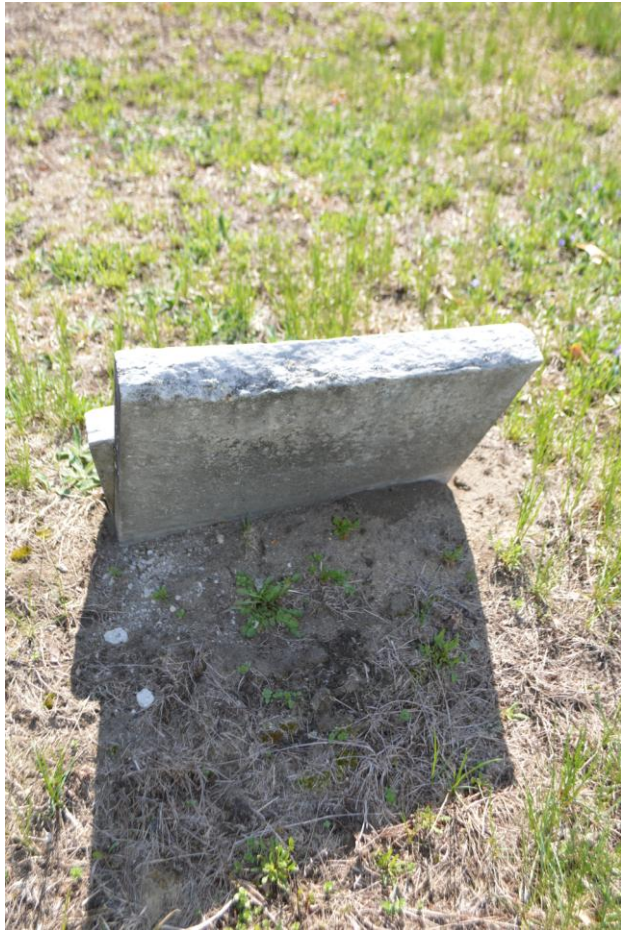
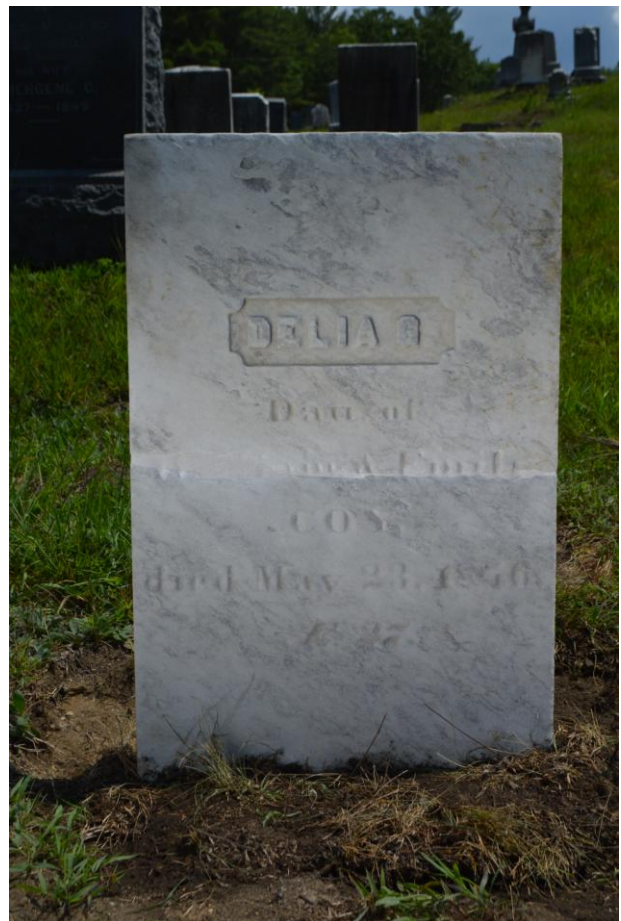
**Cemetery** Center Cemetery  
**Location** Erving, MA  
**Record Date** July 2018  
**Name** Coy, Delia G.  
**Date of Death** May 23, 1856

**Stone Condition** Ambient dirt and biological growth  
Broken, 2 fragments  
Concrete around fragment  
Leaning

**Treatments** Cleaned and treated with D2  
Remove concrete  
Reset stone plumb  
Reattach fragment with Jahn M120

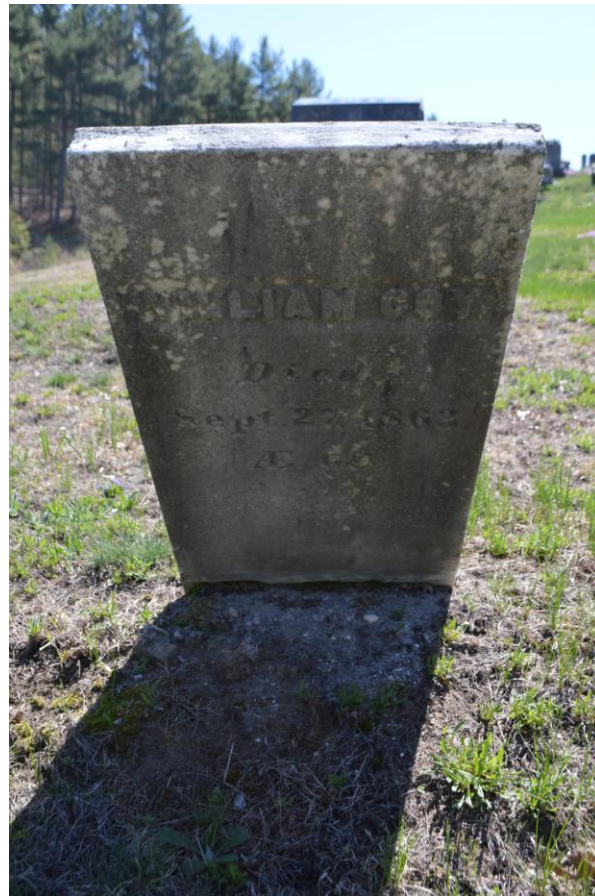
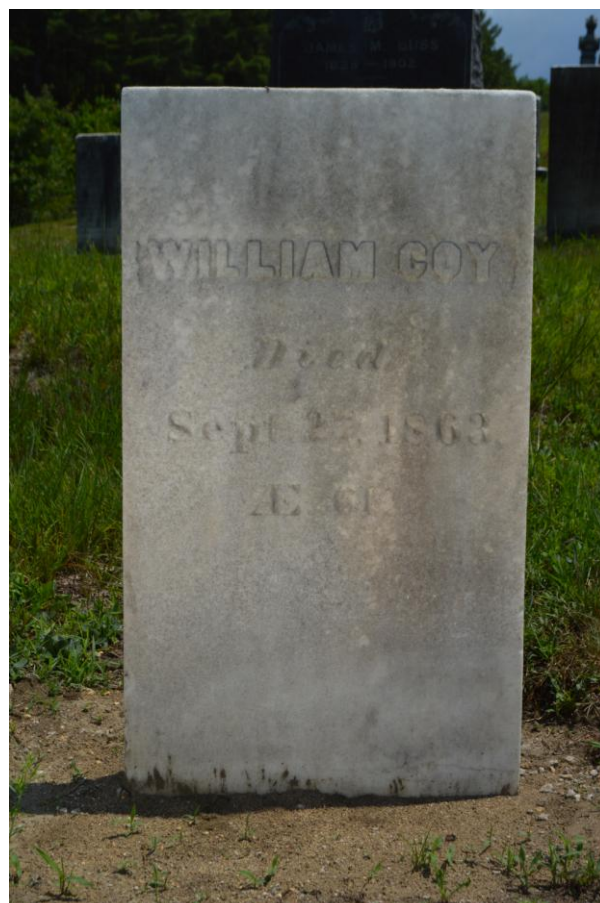
**Cemetery** Center Cemetery  
**Location** Erving, MA  
**Record Date** July 2018  
**Name** Coy, William  
**Date of Death** Sept. 27, 1863

**Stone Condition** Ambient dirt and biological growth  
Leaning  
Sunken

**Treatments** Cleaned and treated with D2  
Reset stone plumb at the correct height

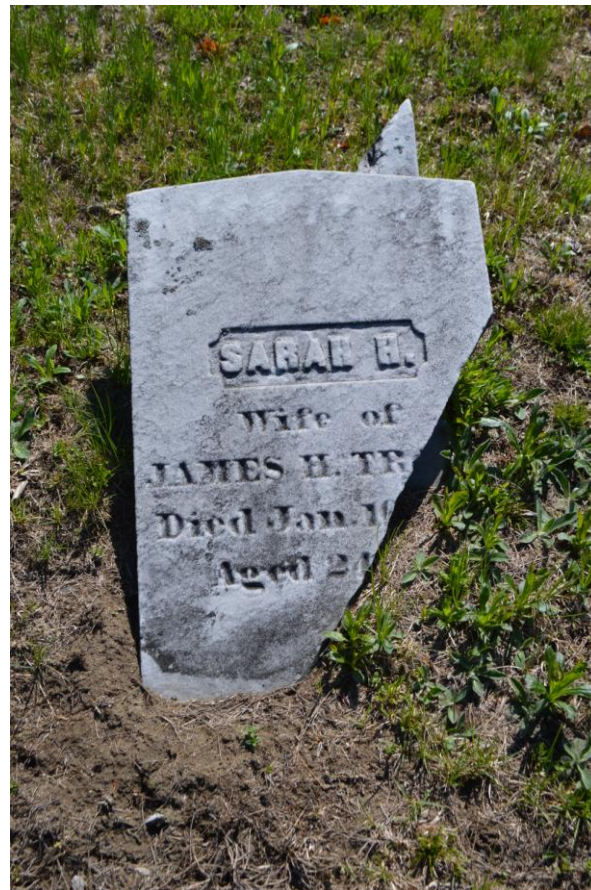
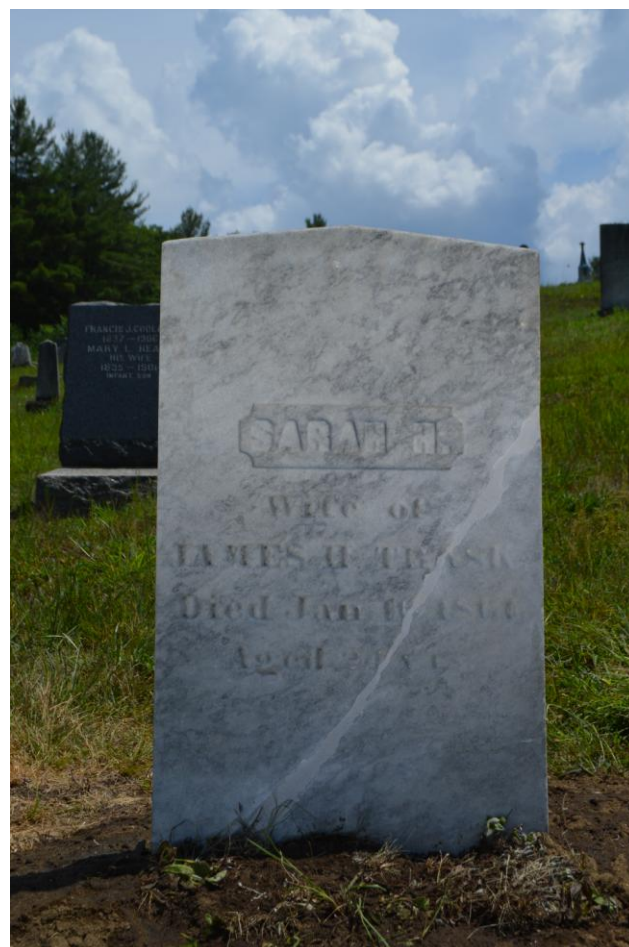
**Cemetery** Center Cemetery  
**Location** Erving, MA  
**Record Date** July 2018  
**Name** Trask, Sarah H.  
**Date of Death** Jan. 11, 1860

**Stone Condition** Ambient dirt and biological growth  
Broken, 2 fragments  
Leaning

**Treatments** Cleaned and treated with D2  
Create and set new concrete base  
Reset stone fragment into base with lime mortar  
Reattach fragment with Jahn M120
