Gravestone Preservation Project

Center Cemetery

Erving, Massachusetts

Conservation report for Center Cemetery 2023

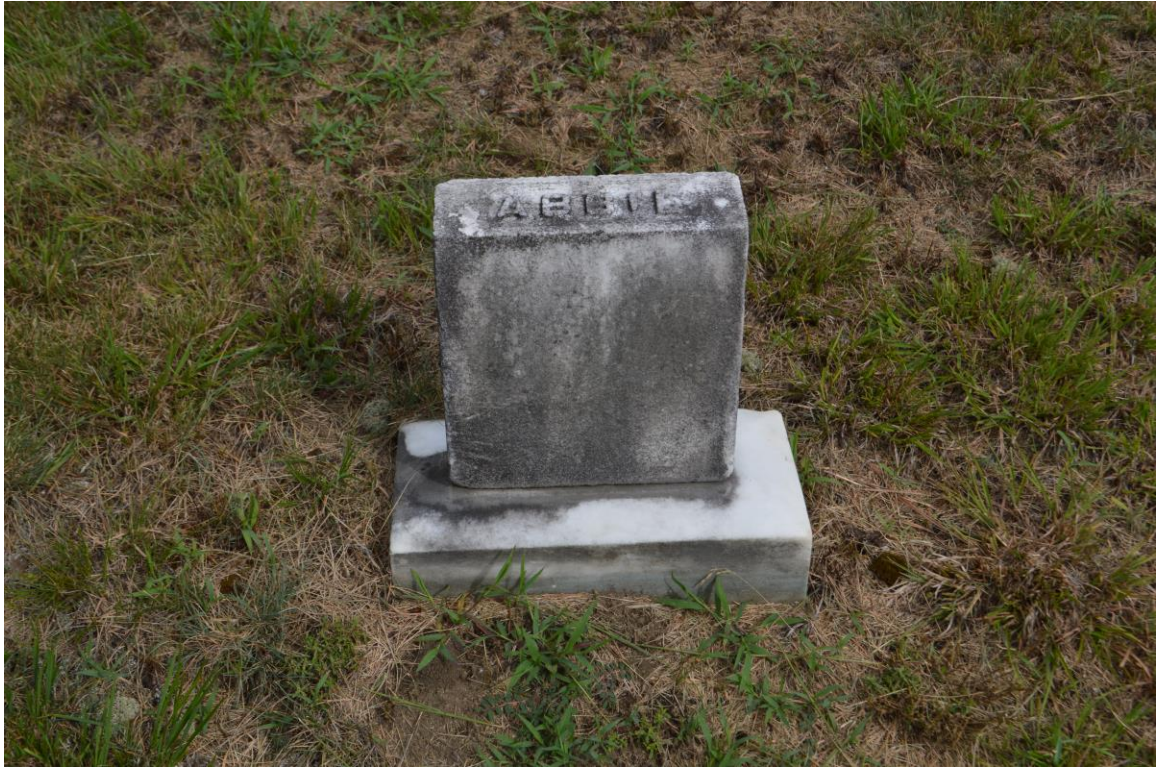
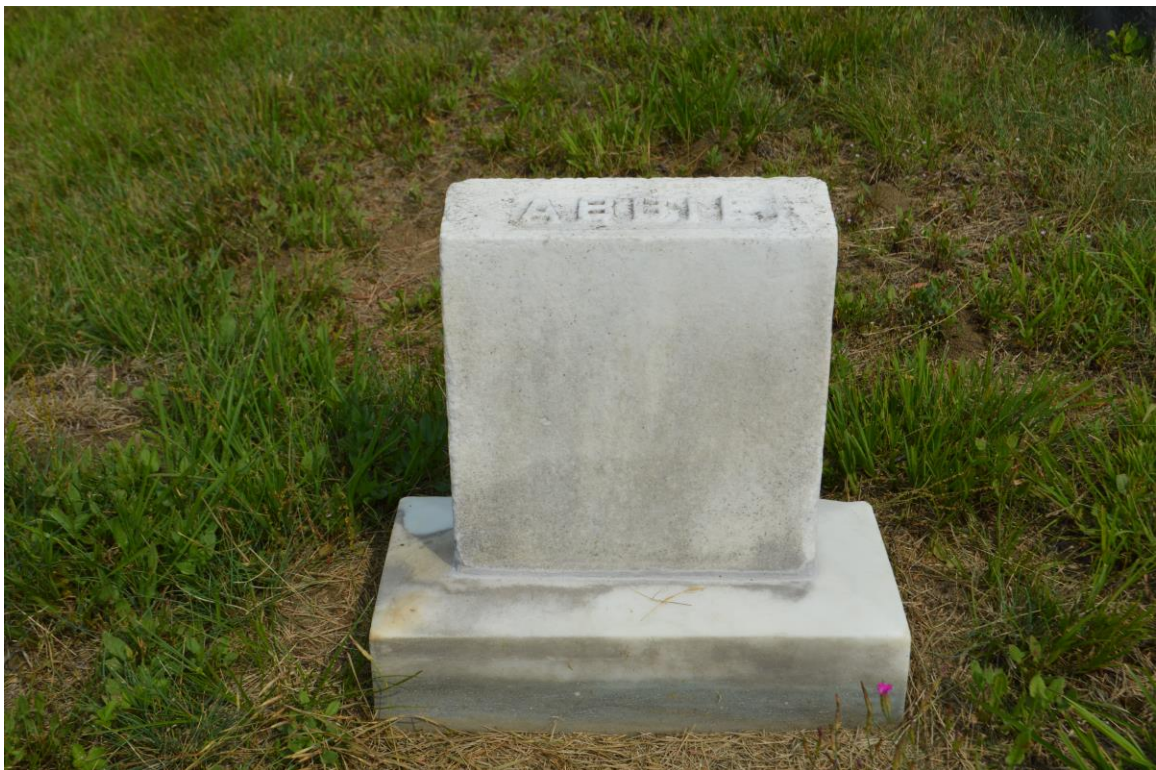
Cemetery Center Cemetery
Location Erving, MA
Record Date May 2023
Name Clark, Abbie
Date of Death 1930
Material Marble
Style Die with base

Stone Condition Ambient dirt and biological growth
Sunken base
Leaning
Pins

Treatments Cleaned and treated with D2
Reset foundation stone plumb
Remove pins
Reset die with lime mortar

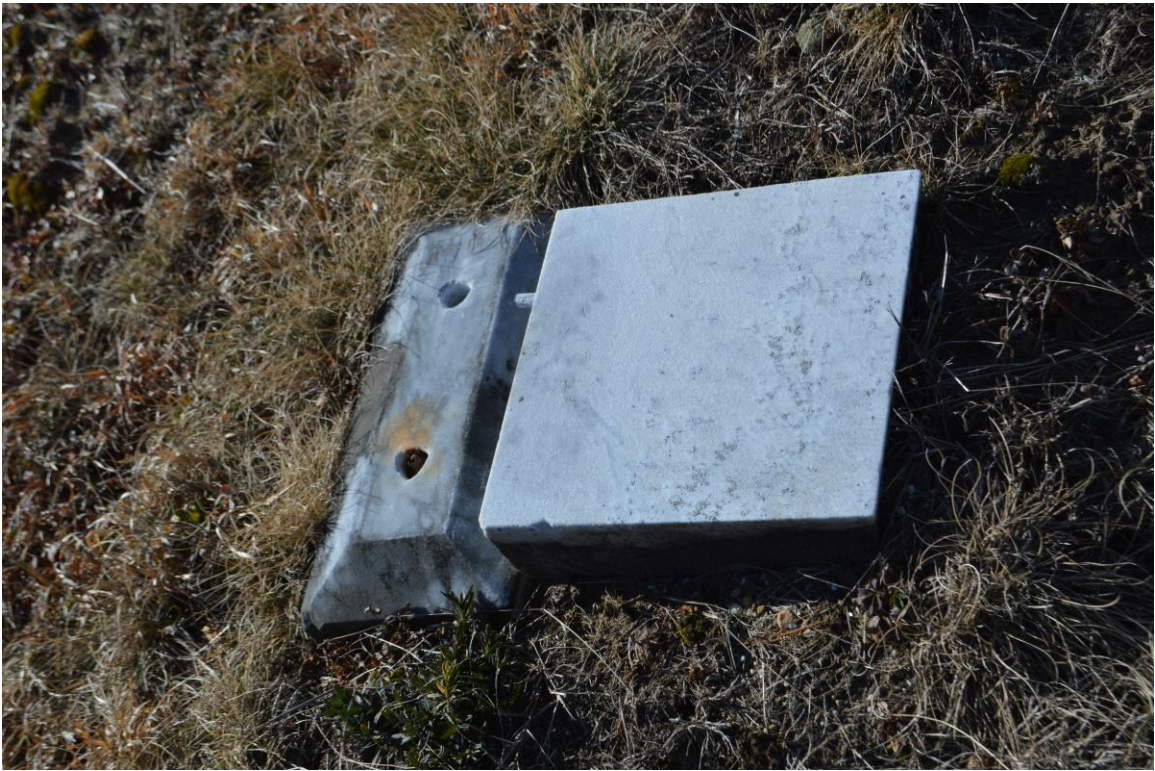
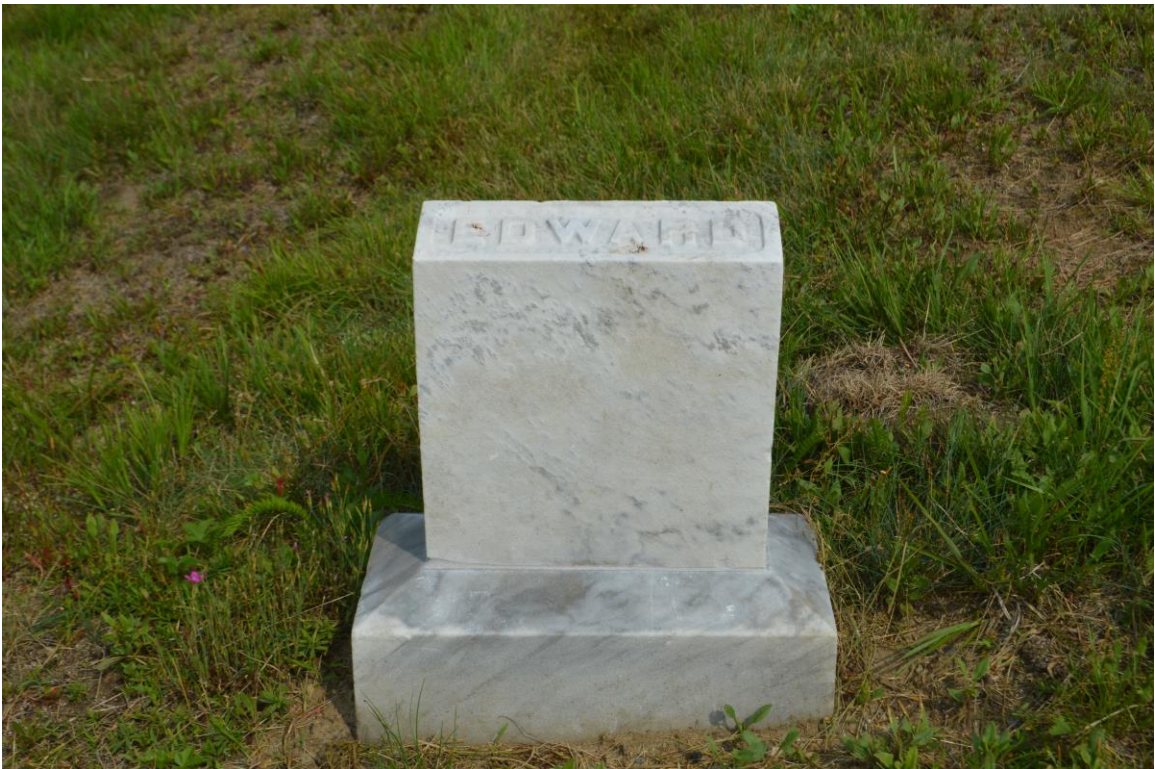
Cemetery Center Cemetery
Location Erving, MA
Record Date May 2023
Name Clark, Edward
Date of Death 1913
Material Marble
Style Die with base

Stone Condition Ambient dirt and biological growth
Sunken base
Fallen, off base
Pins

Treatments Cleaned and treated with D2
Reset foundation stone plumb
Remove pins
Reset die with lime mortar

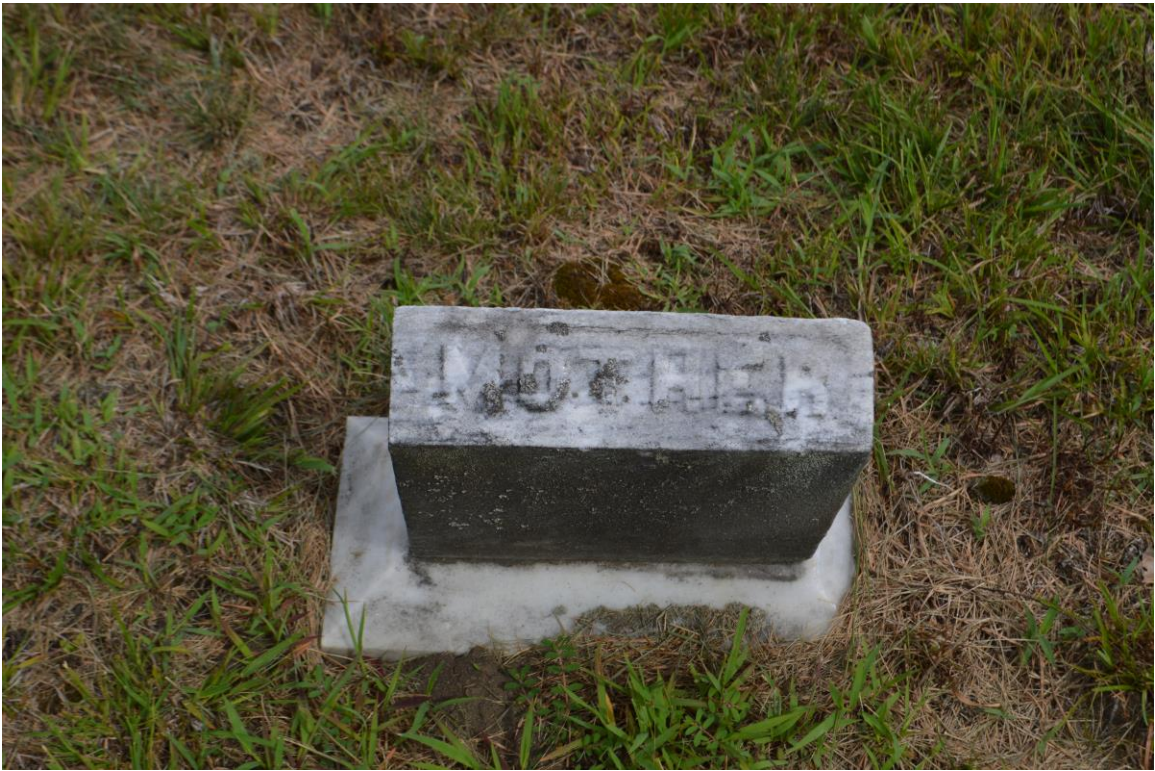
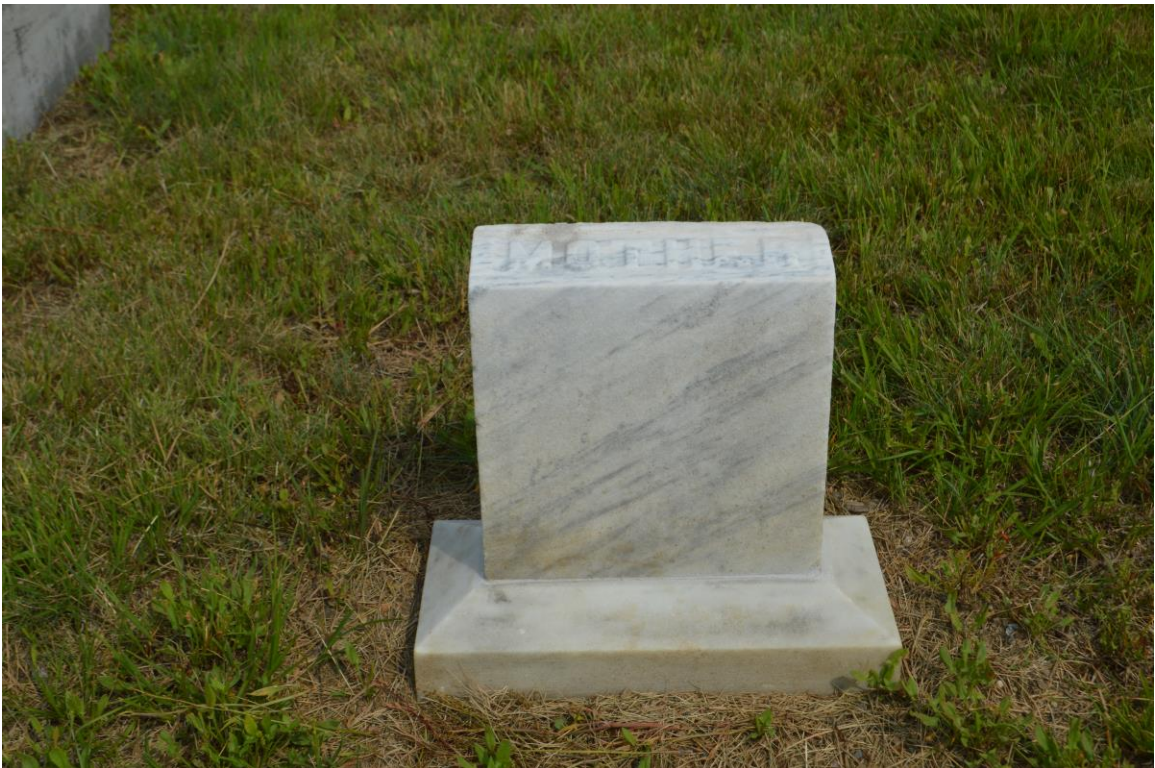
Cemetery Center Cemetery
Location Erving, MA
Record Date May 2023
Name Clark, Mother
Date of Death
Material Marble
Style Die with base

Stone Condition Ambient dirt and biological growth
Sunken base
Loose on base
Pins

Treatments Cleaned and treated with D2
Reset foundation stone plumb
Remove pins
Reset die with lime mortar

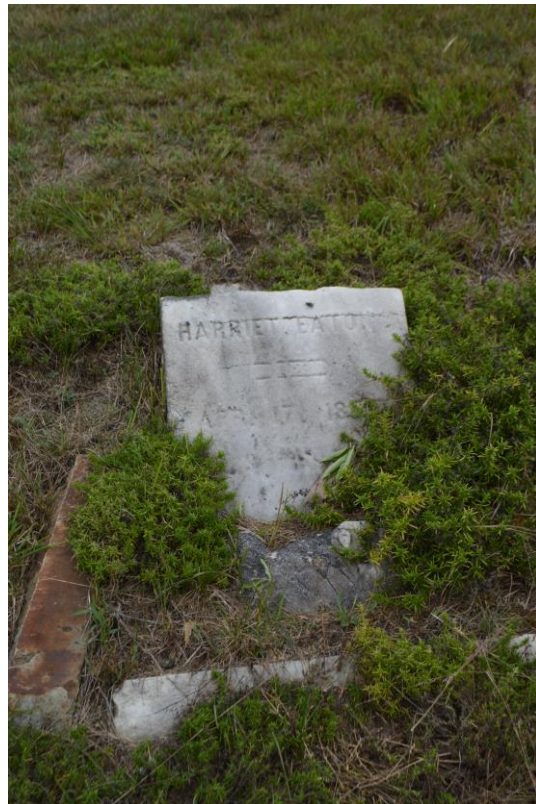
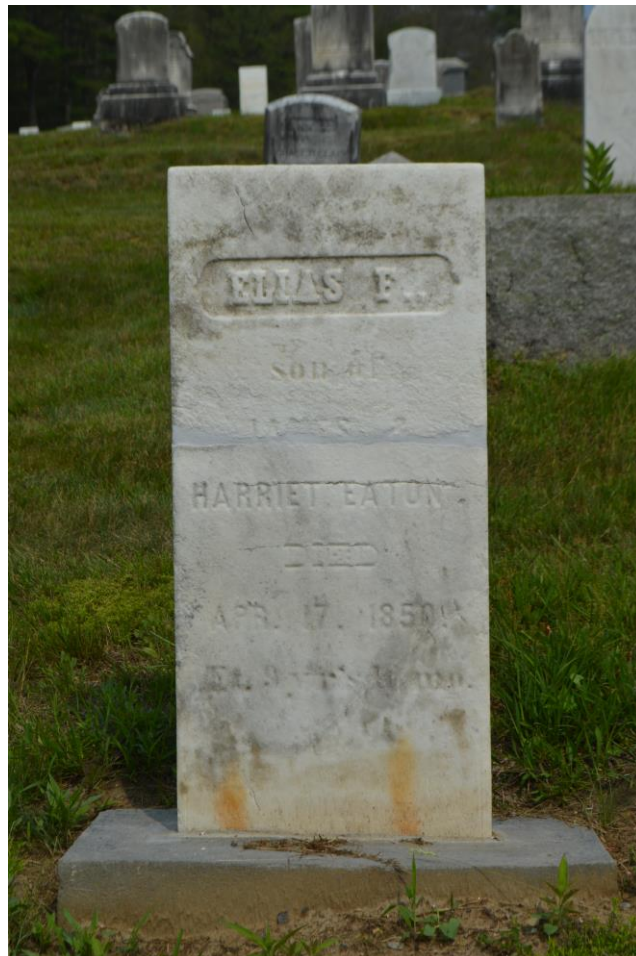
Cemetery Center Cemetery
Location Erving, MA
Record Date May 2023
Name Eaton, Elias
Date of Death April 17, 1850
Material Marble
Style Tablet with base

Stone Condition Ambient dirt and biological growth
Fallen
Broken 3 fragments

Treatments Cleaned and treated with D2
Create new below grade base
Reset fragment in to base with lime mortar
Reattach fragments with Jahn M120

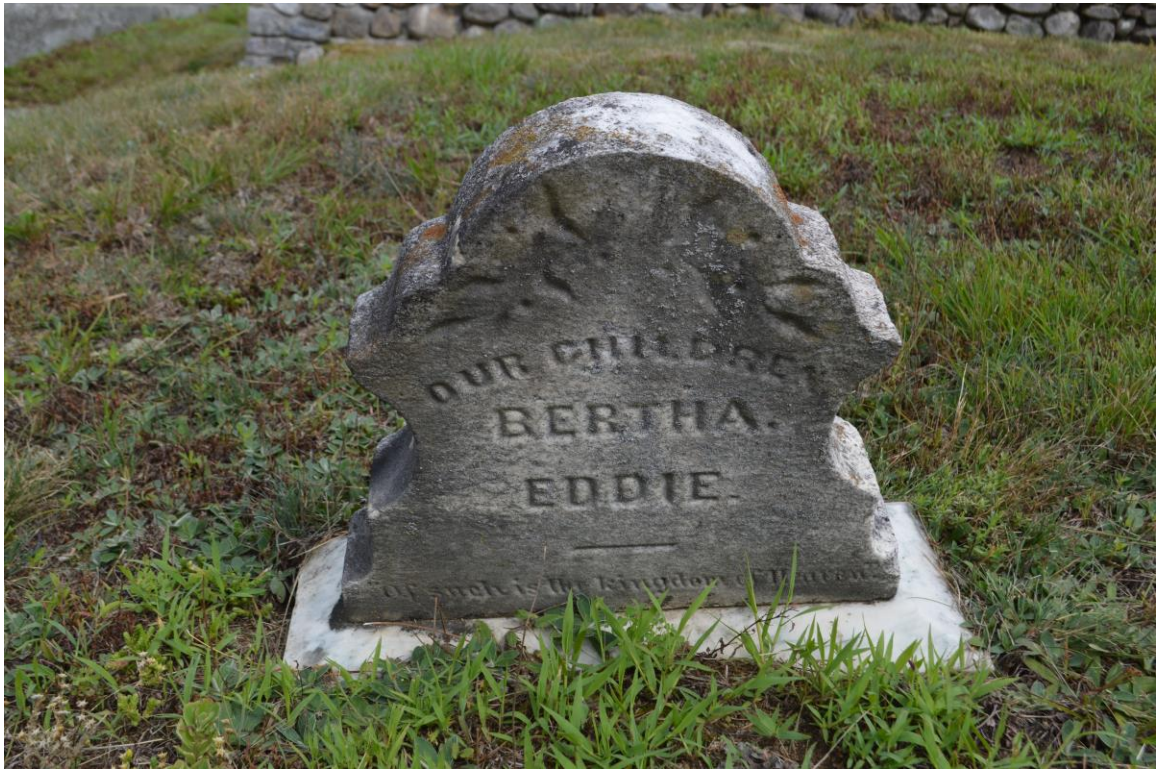
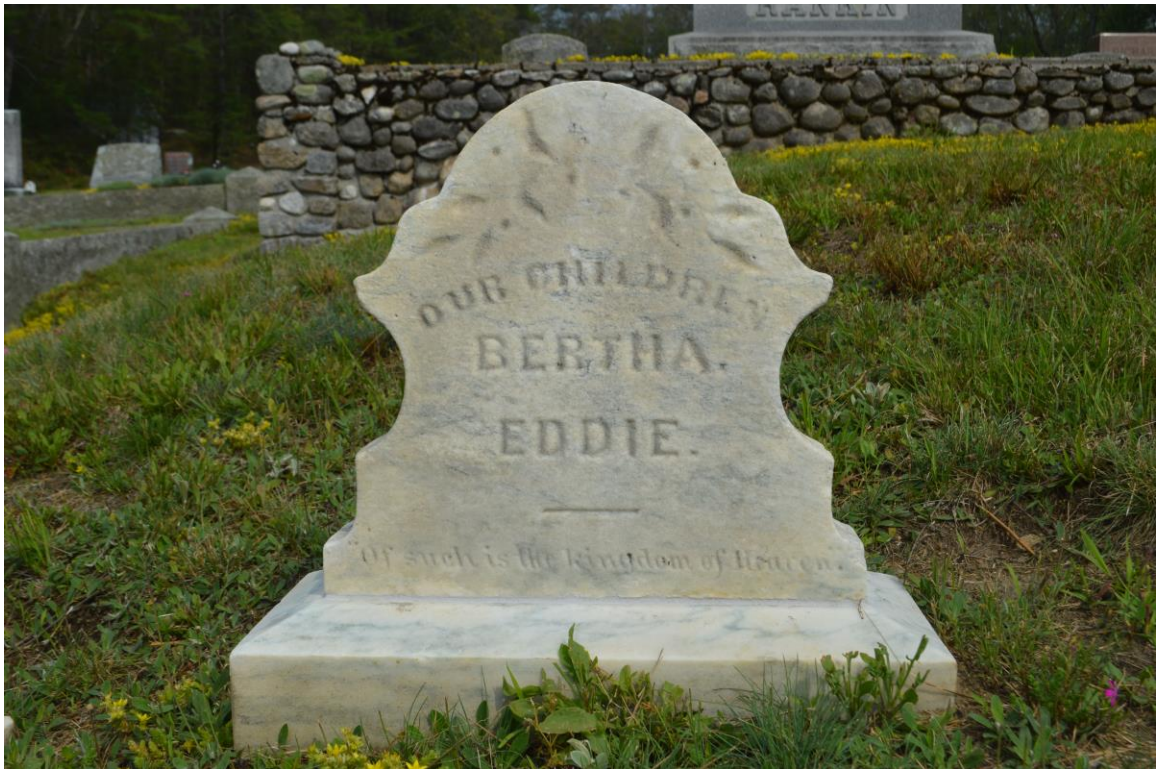
Cemetery Center Cemetery
Location Erving, MA
Record Date May 2023
Name Gary, Bertha & Eddie
Date of Death
Material Marble
Style Die with base

Stone Condition Ambient dirt and biological growth
Leaning
Sunken base
Erosion

Treatments Cleaned and treated with D2
Reset foundation stone plumb
Fill erosion area
Reset die with lime mortar

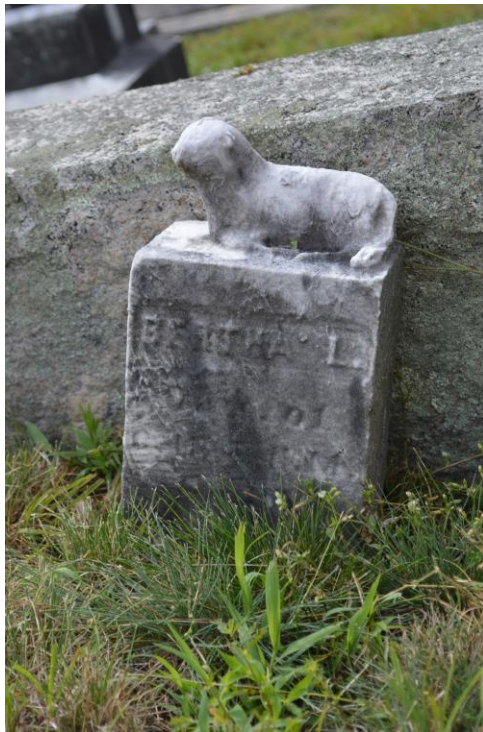
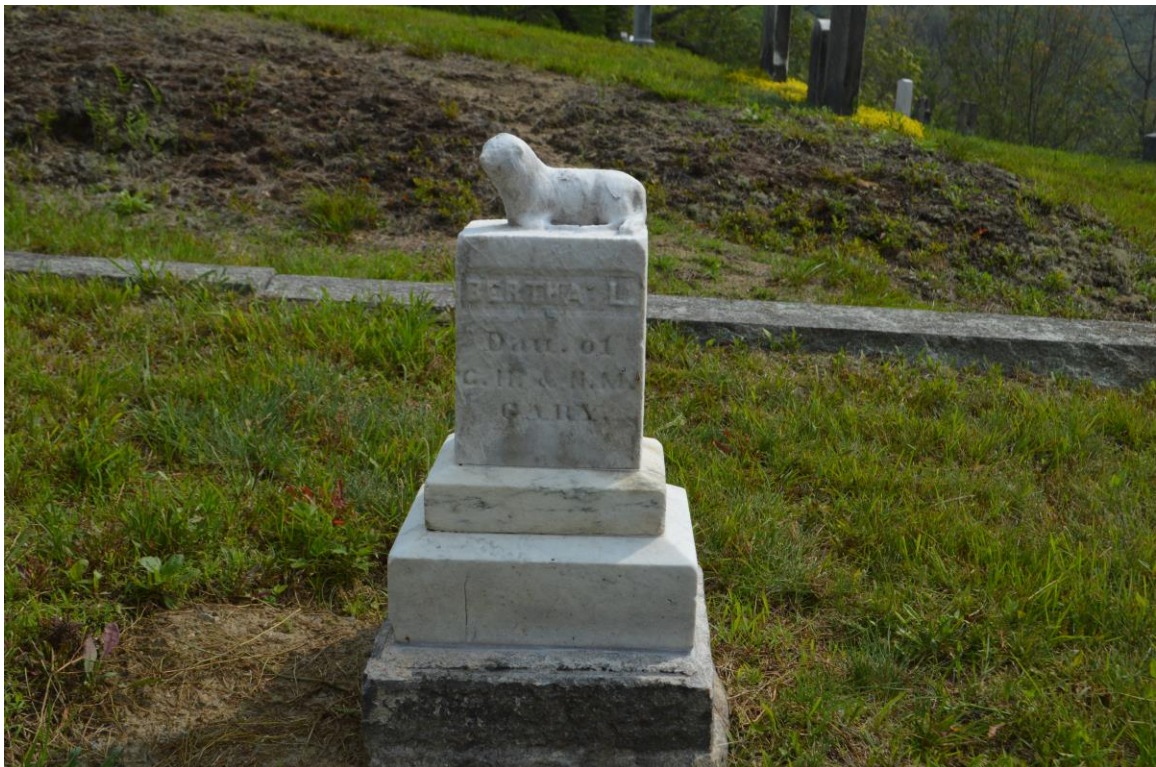
Cemetery Center Cemetery
Location Erving, MA
Record Date May 2023
Name Gary, Bertha L.
Date of Death March 2, 1882
Material Marble
Style Die with base

Stone Condition Ambient dirt and biological growth
Sunken base
Fallen, off base and set in corner of lot

Treatments Cleaned and treated with D2
Reset foundation stone plumb
Fill erosion area
Reset die with lime mortar

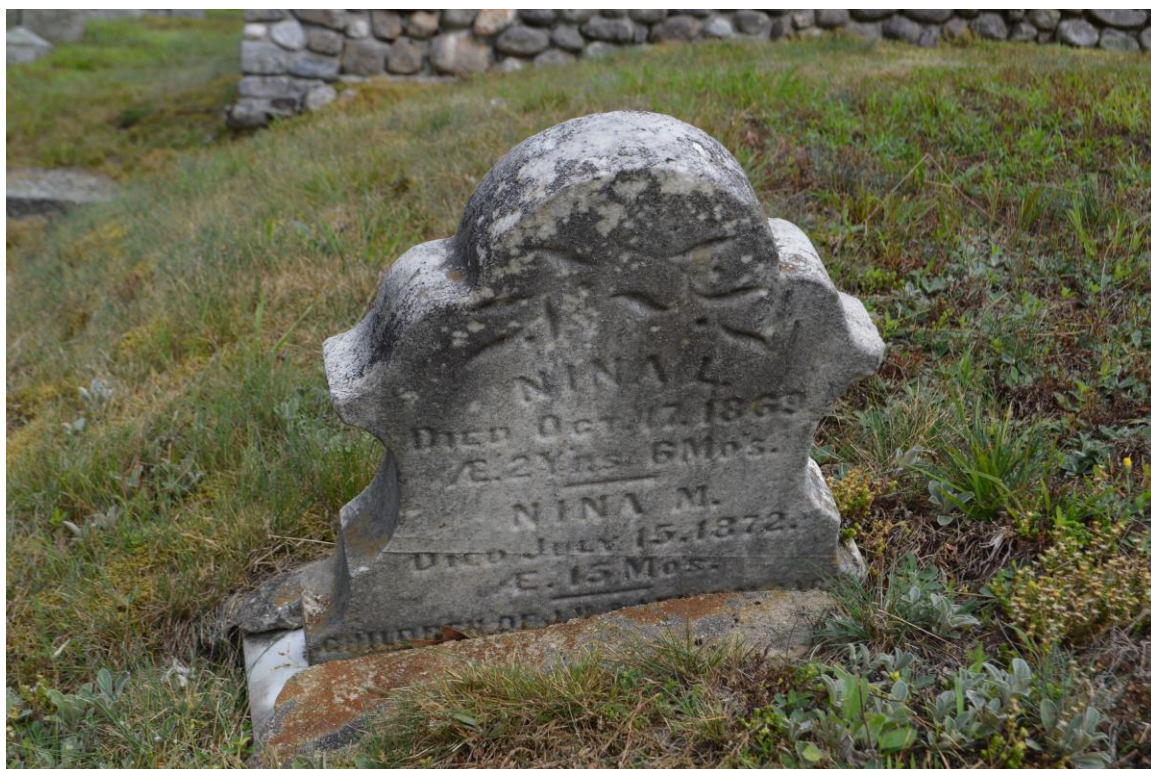
Cemetery Center Cemetery
Location Erving, MA
Record Date May 2023
Name Gary, Nina L. & Nina M.
Date of Death 1869 1872
Material Marble
Style Die with base

Stone Condition Ambient dirt and biological growth
Leaning
Sunken base
Concrete

Treatments Cleaned and treated with D2
Remove concrete
Reset foundation stone plumb

Reset die with lime mortar

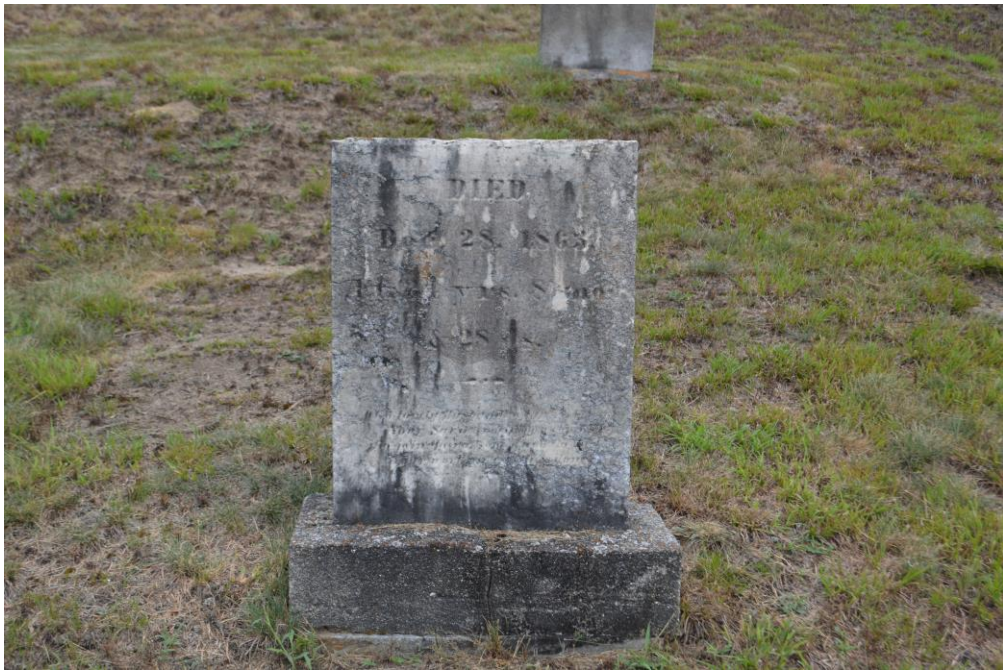
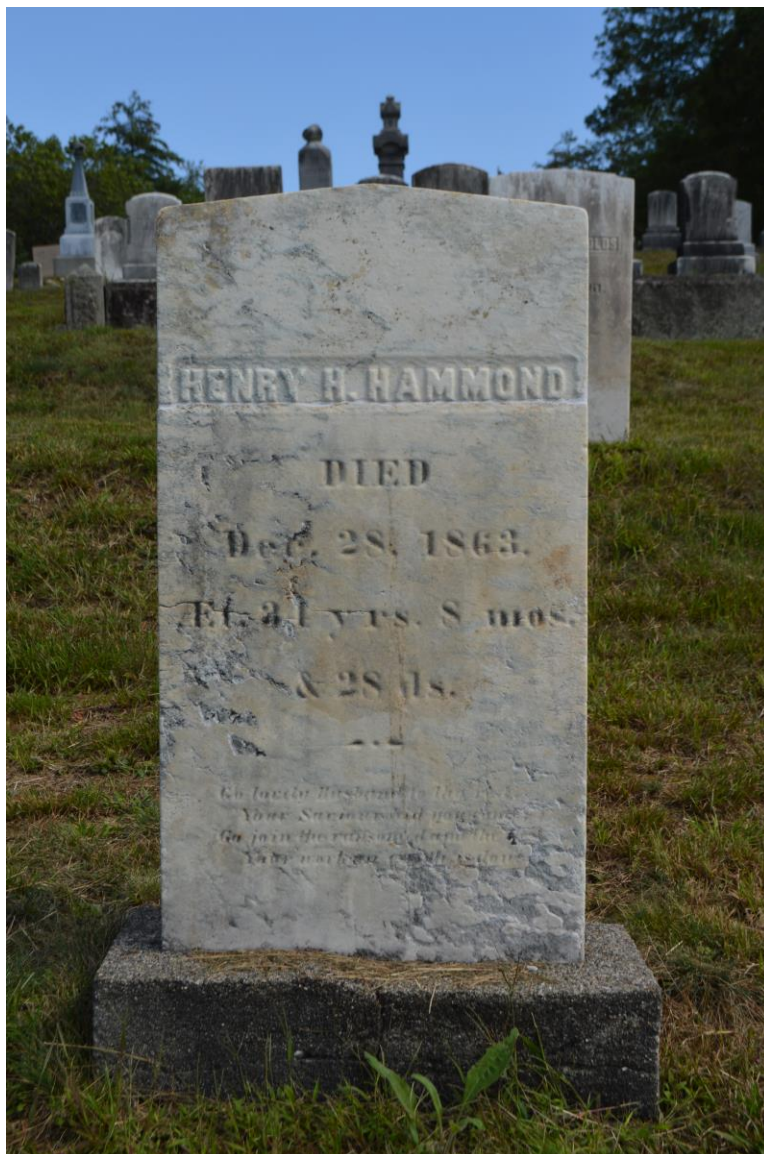
Cemetery Center Cemetery
Location Erving, MA
Record Date May 2023
Name Hammond, Henry
Date of Death Dec. 28, 1863
Material Marble
Style Tablet with base

Stone Condition Ambient dirt and biological growth
Leaning
Broken 2 fragments
Concrete

Treatments Cleaned and treated with D2
Reset base and stone plumb
Reattach fragments with Jahn M120

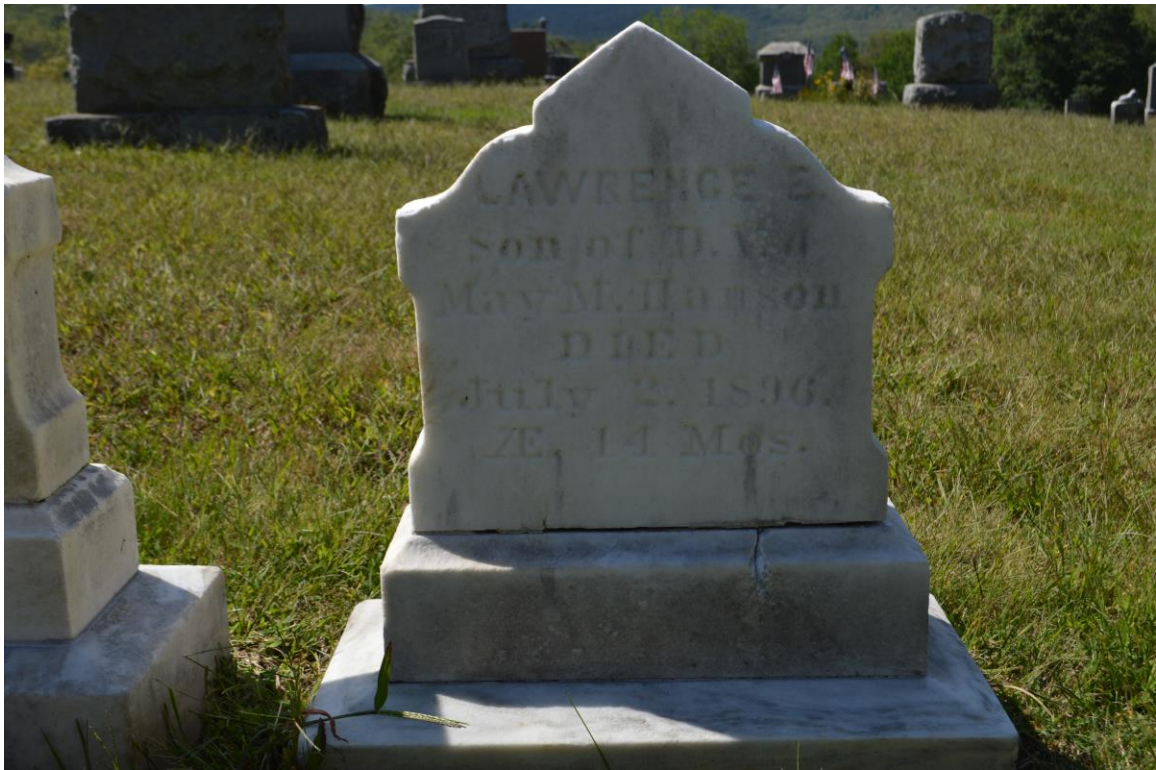
Cemetery Center Cemetery
Location Erving, MA
Record Date May 2023
Name Hanson, Lawrence
Date of Death July 2, 1896
Material Marble
Style Die with base

Stone Condition Ambient dirt and biological growth
Leaning
Sunken base
Missing mortar

Treatments Cleaned and treated with D2
Reset foundation stone plumb
Reset die with lime mortar

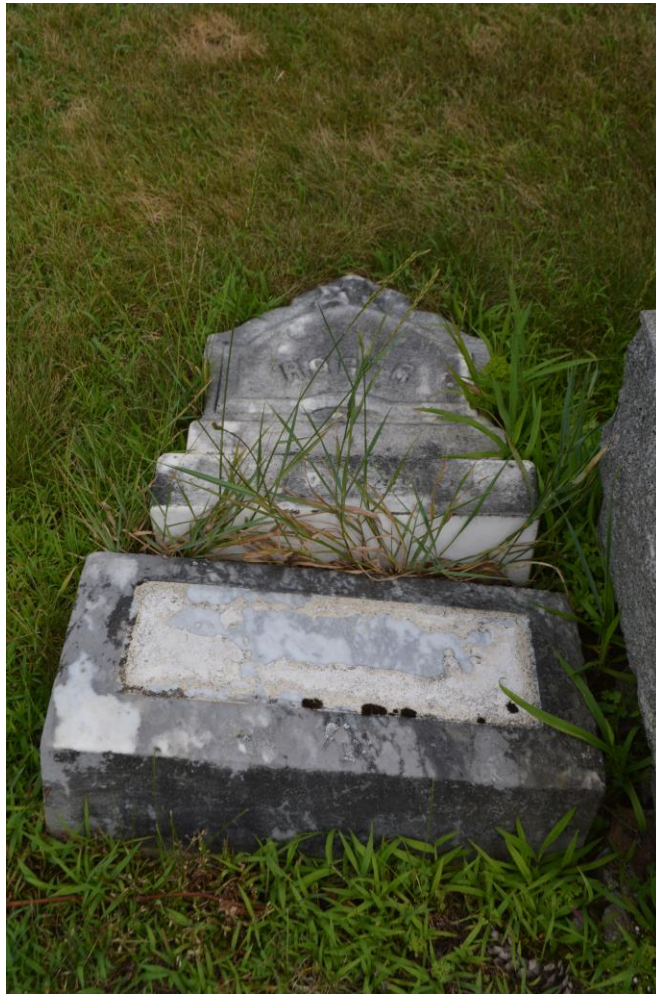
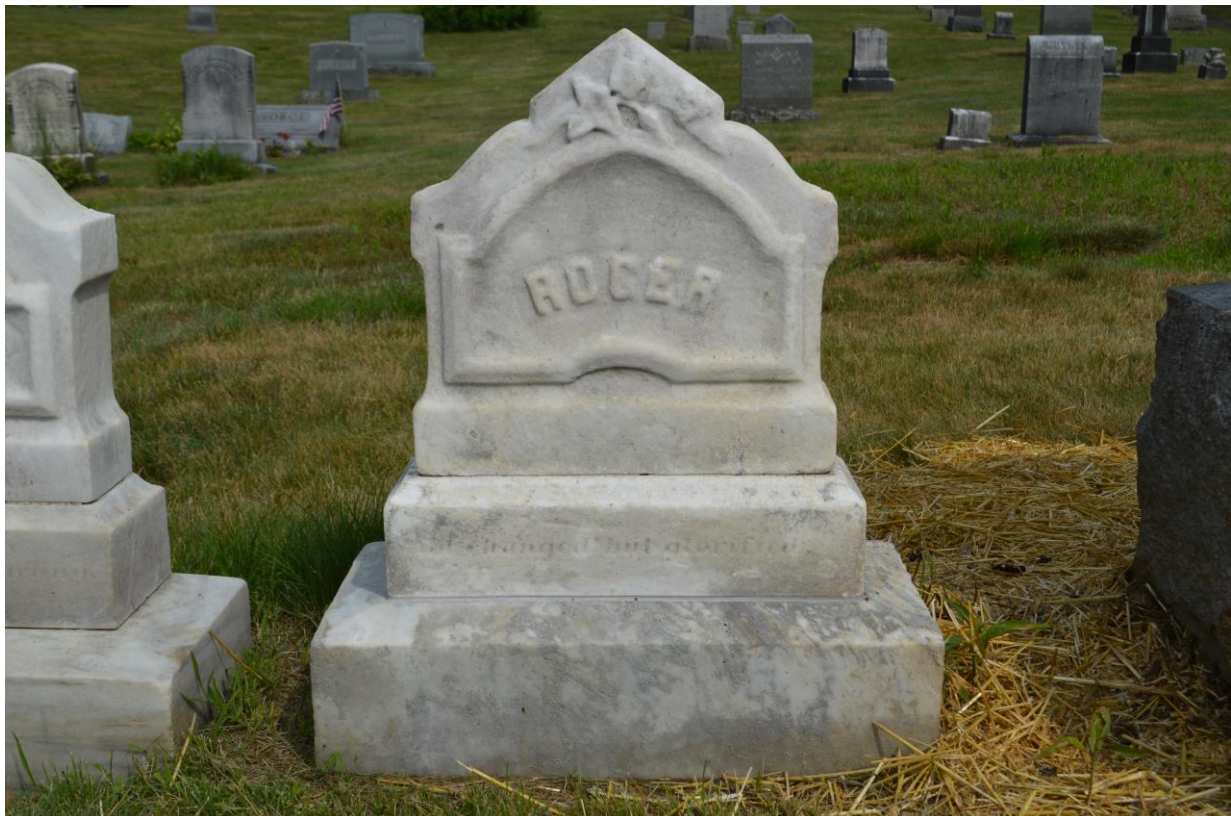
Cemetery Center Cemetery
Location Erving, MA
Record Date May 2023
Name Hanson, Roger
Date of Death Sept. 12, 1900
Material Marble
Style Die with base

Stone Condition Ambient dirt and biological growth
Fallen
Sunken, leaning base
Missing mortar

Treatments Cleaned and treated with D2
Reset foundation stone plumb
Reset die with lime mortar

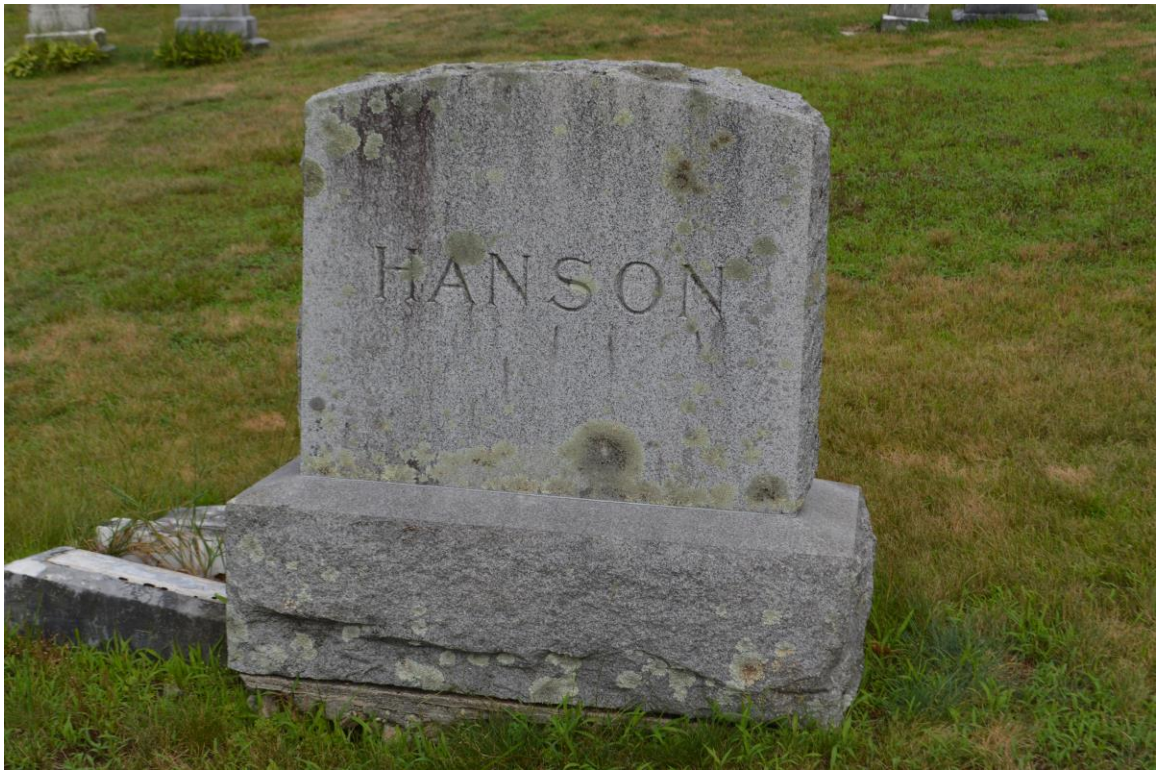
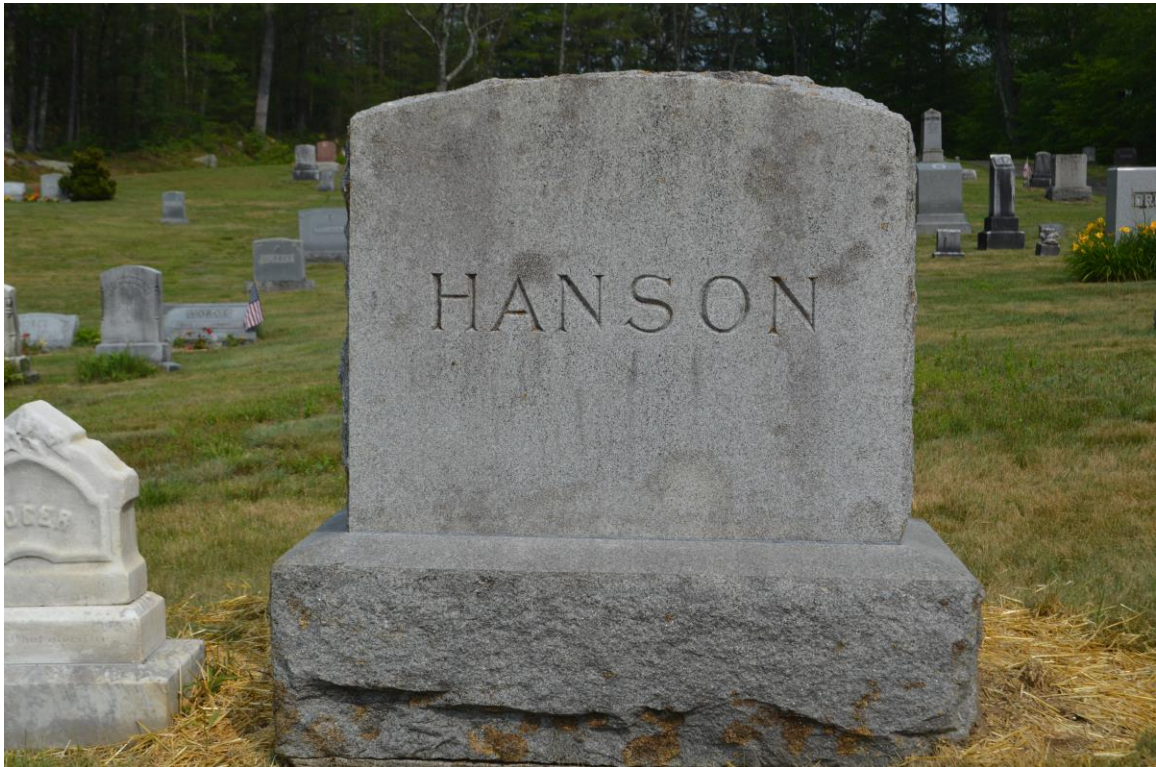
Cemetery Center Cemetery
Location Erving, MA
Record Date May 2023
Name Hanson
Date of Death
Material Granite
Style Die with base

Stone Condition Ambient dirt and biological growth
Leaning
Sunken base

Treatments Cleaned and treated with D2
Reset foundation stone plumb
Reset die with setting compound

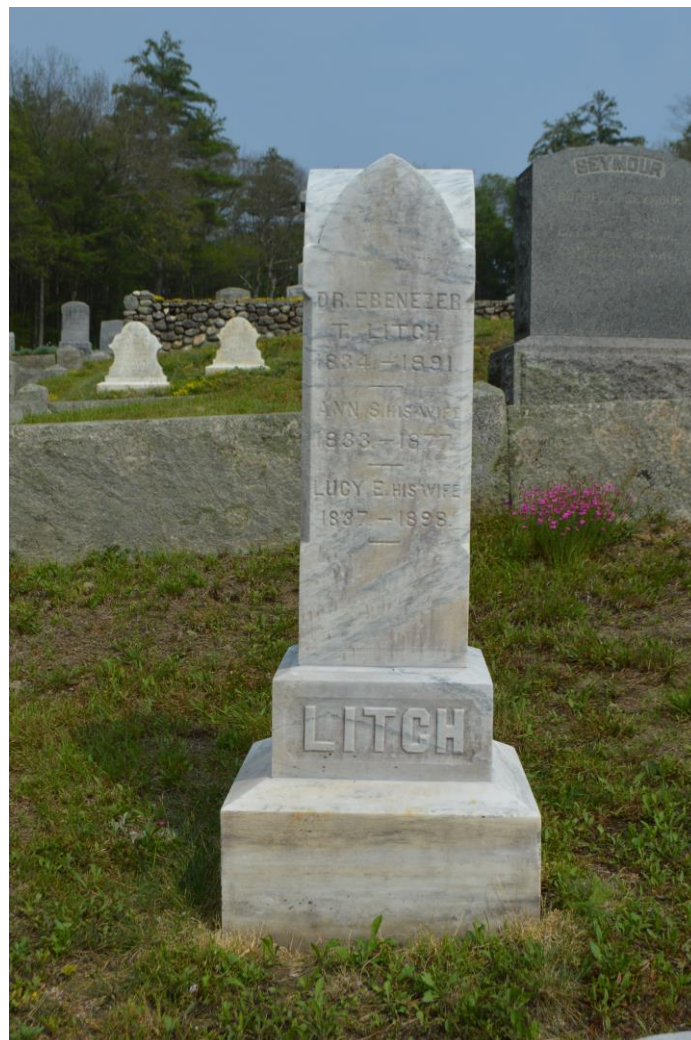
Cemetery Center Cemetery
Location Erving, MA
Record Date May 2023
Name Litch, Ebenezer, Ann S., Lucy E.
Date of Death 1891 1877 1898
Material Marble
Style pedestal

Stone Condition Ambient dirt and biological growth
Leaning
Missing mortar

Treatments Cleaned and treated with D2
Reset base stone plumb
Reassemble with lime mortar

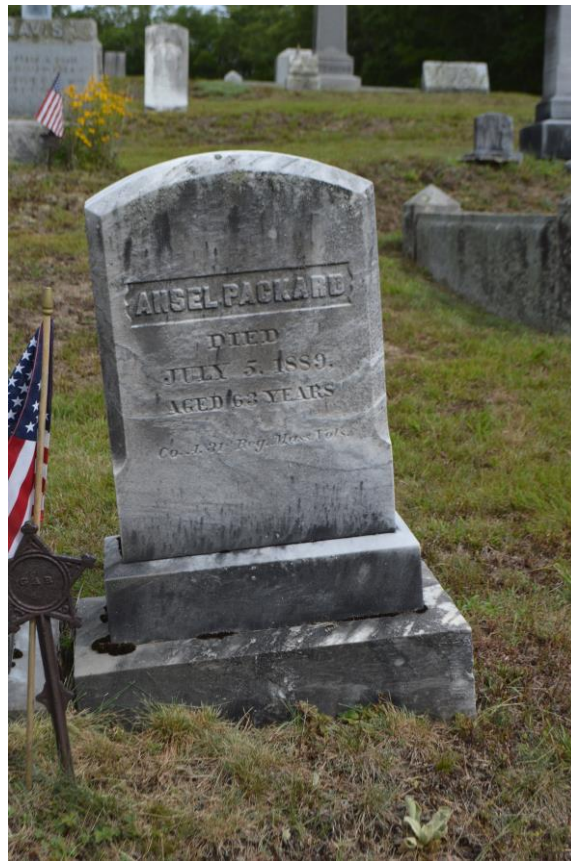
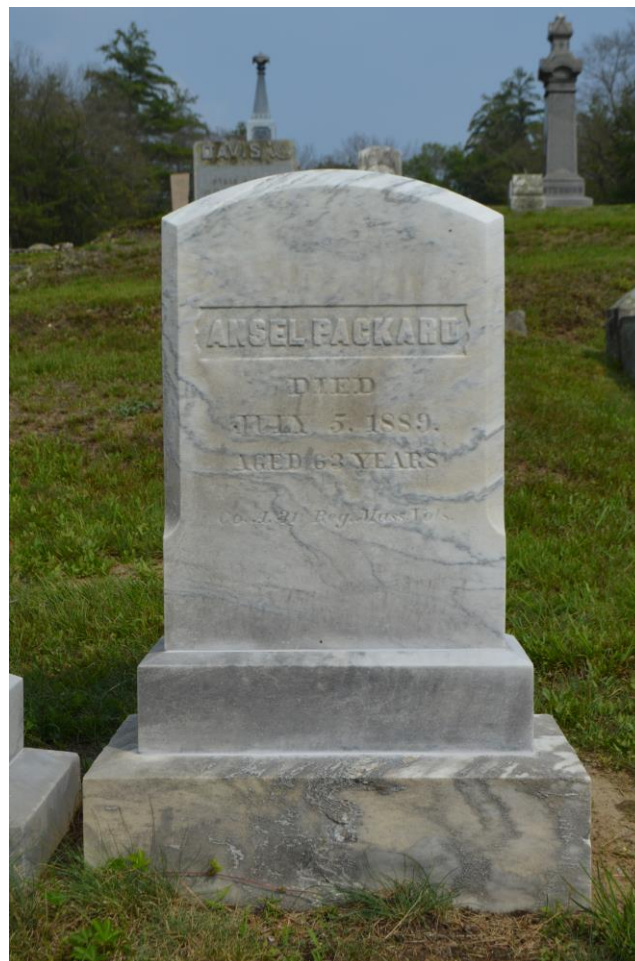
Cemetery Center Cemetery
Location Erving, MA
Record Date May 2023
Name Packard, Ansel
Date of Death July 5, 1889
Material Marble
Style Die with base

Stone Condition Ambient dirt and biological growth
Leaning
Sunken base
Erosion
Missing mortar

Treatments Cleaned and treated with D2
Reset foundation stone plumb
Fill erosion area
Reset die with lime mortar

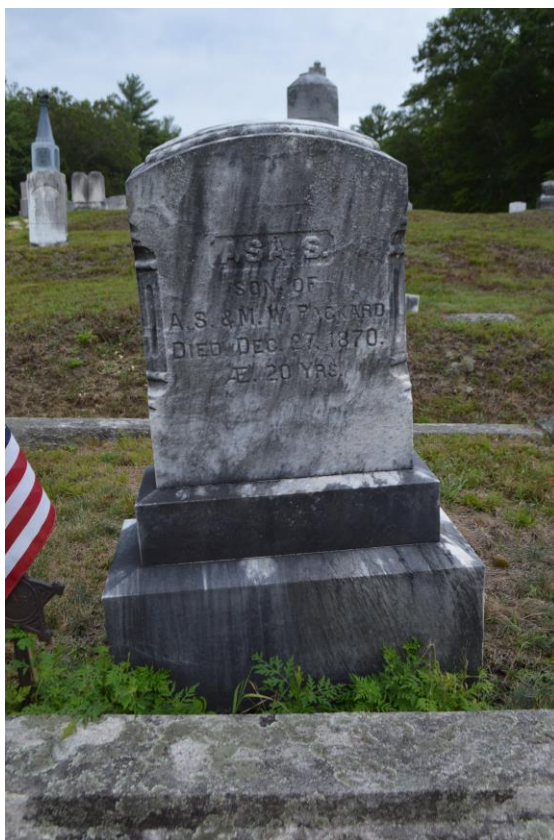
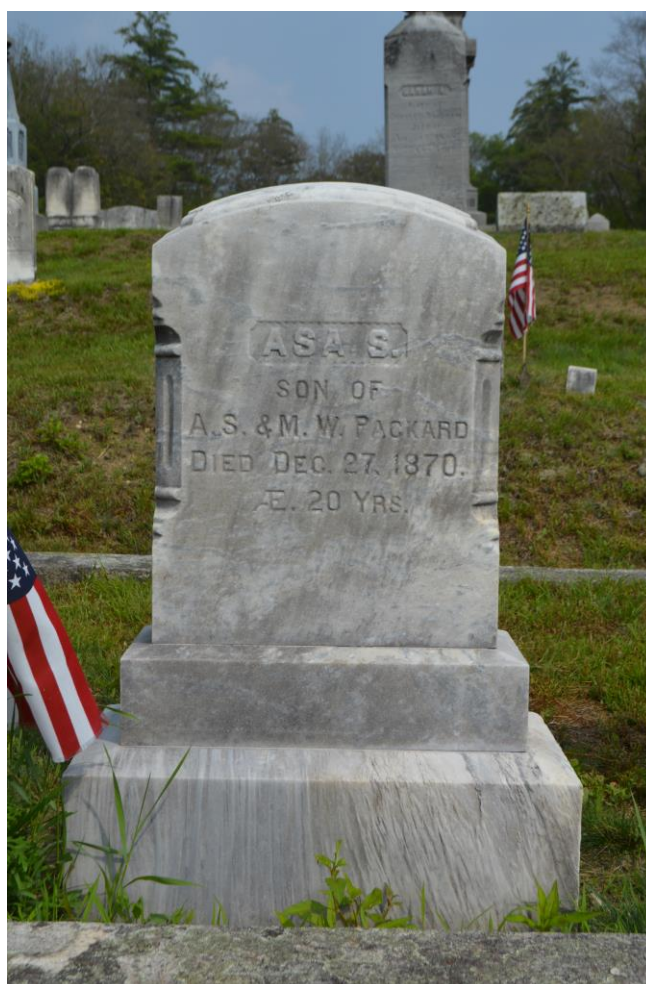
Cemetery Center Cemetery
Location Erving, MA
Record Date May 2023
Name Packard, Asa
Date of Death Dec. 27, 1870
Material Marble
Style Die with base

Stone Condition Ambient dirt and biological growth
Leaning
Sunken base
Erosion
Missing mortar

Treatments Cleaned and treated with D2
Reset foundation stone plumb
Fill erosion area

Reset die with lime mortar

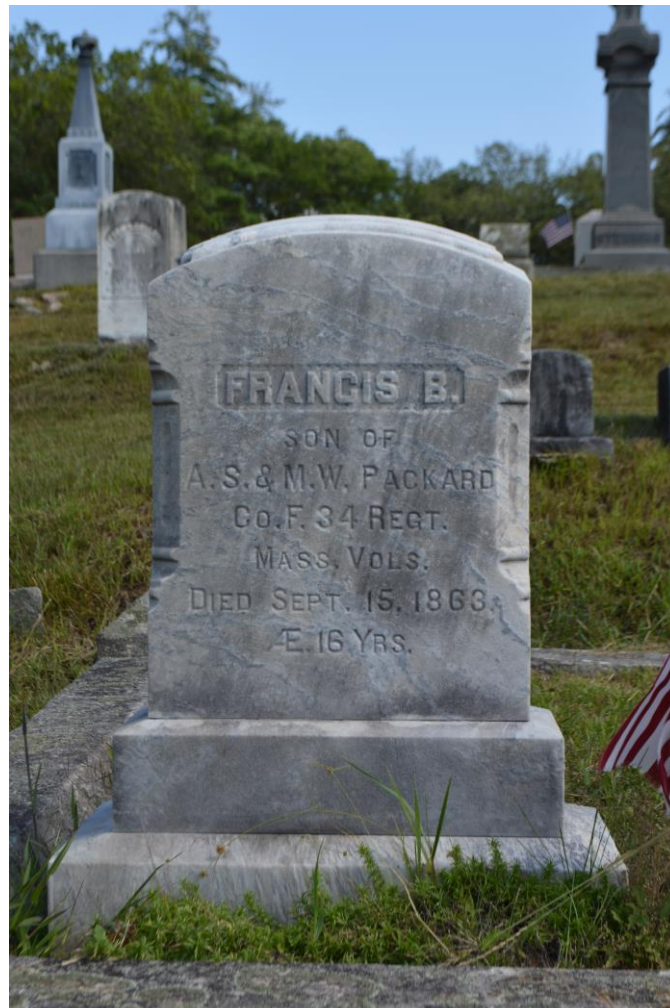
Cemetery Center Cemetery
Location Erving, MA
Record Date May 2023
Name Packard, Francis B.
Date of Death Sept. 15, 1863
Material Marble
Style Die with base

Stone Condition Ambient dirt and biological growth
Leaning
Sunken base
Erosion
Missing mortar

Treatments Cleaned and treated with D2
Reset foundation stone plumb
Fill erosion area
Reset die with lime mortar

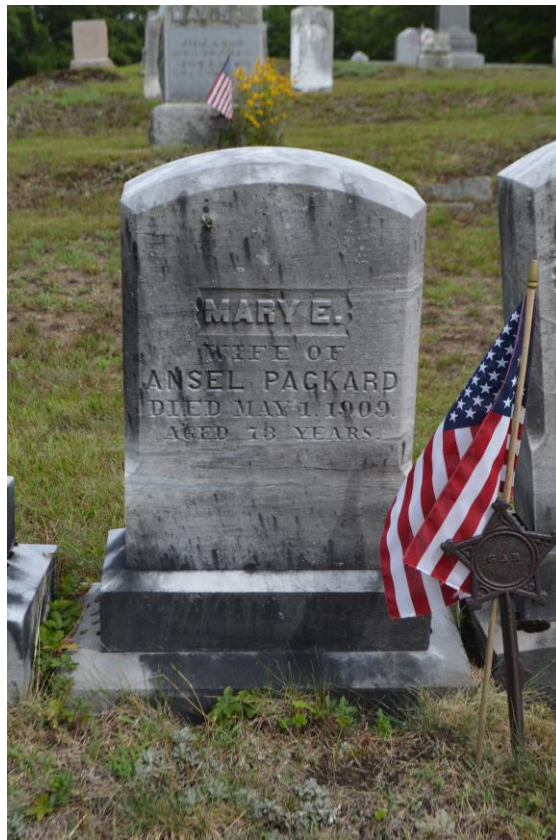
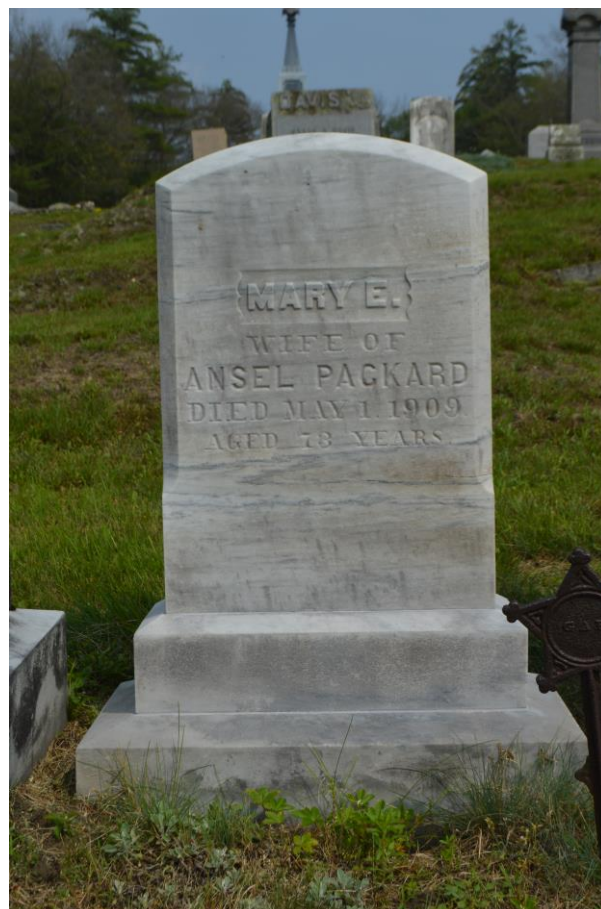
Cemetery Center Cemetery
Location Erving, MA
Record Date May 2023
Name Packard, Mary E.
Date of Death May 1, 1909
Material Marble
Style Die with base

Stone Condition Ambient dirt and biological growth
Leaning
Sunken base
Erosion
Missing mortar

Treatments Cleaned and treated with D2
Reset foundation stone plumb
Fill erosion area
Reset die with lime mortar
