Gravestone Preservation Project

Center Cemetery

Erving, Massachusetts

Conservation report for Center Cemetery 2023

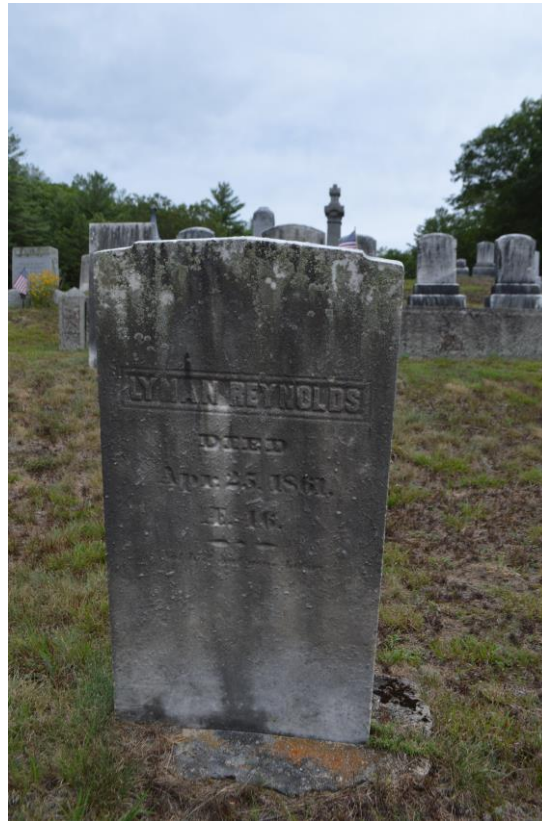
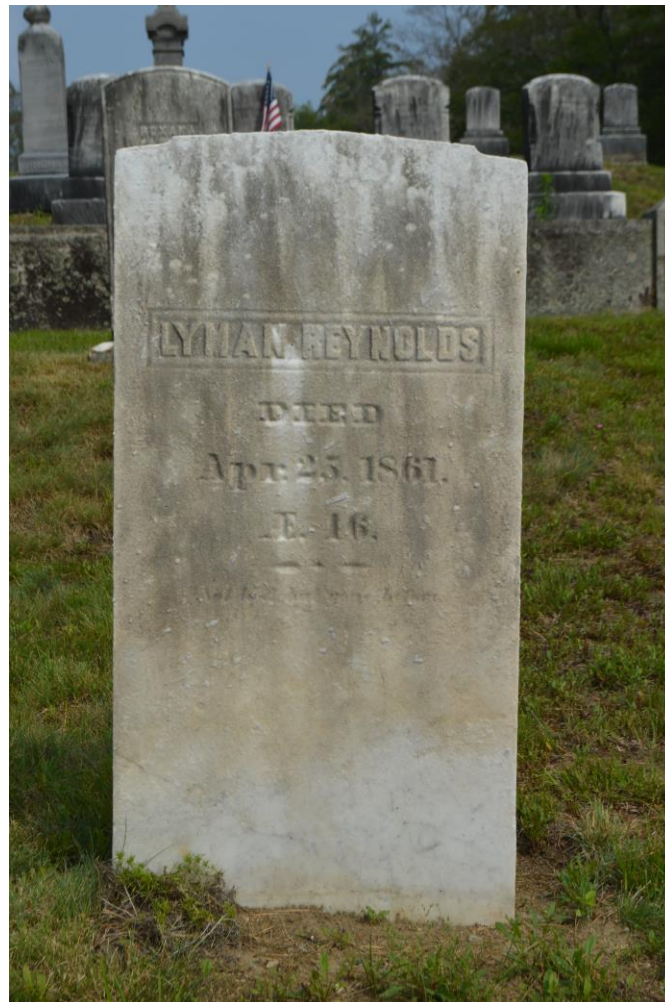
Cemetery Center Cemetery
Location Erving, MA
Record Date May 2023
Name Reynolds, Lyman
Date of Death April 25, 1861
Material Marble
Style Tablet with base

Stone Condition Ambient dirt and biological growth
Leaning
Concrete

Treatments Cleaned and treated with D2
Reset base and stone plumb

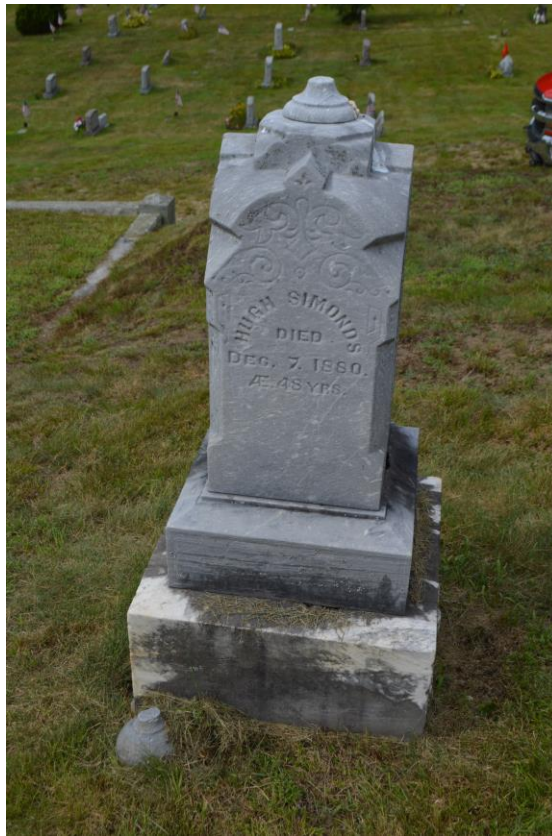
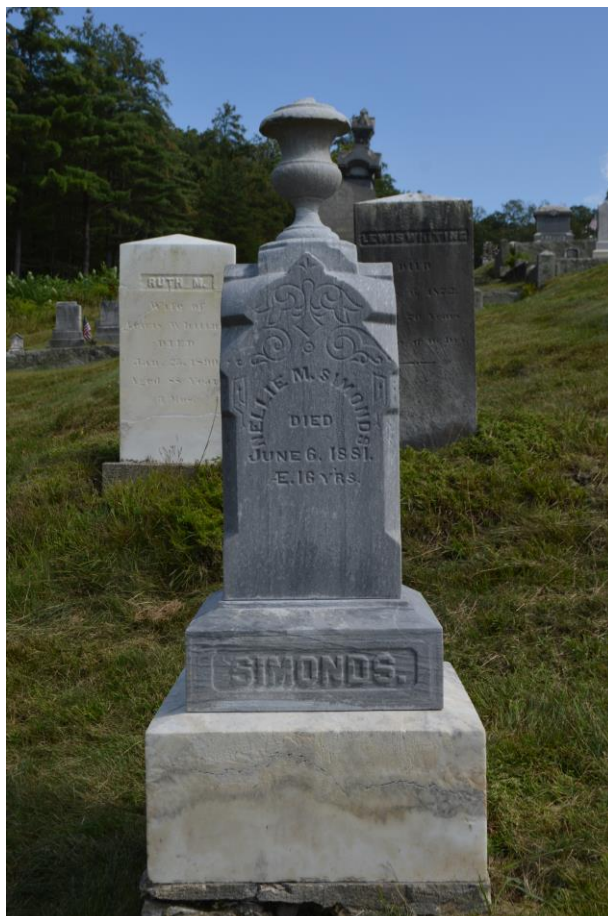
Cemetery Center Cemetery
Location Erving, MA
Record Date May 2023
Name Simonds, Hugh & Nellie
Date of Death Dec. 7, 1880 June 6, 1881
Material Marble
Style pedestal with urn

Stone Condition Ambient dirt and biological growth
Leaning
Missing mortar
Urn broken off

Treatments Cleaned and treated with D2
Reset base stone plumb
Reassemble with lime mortar
Reattach urn with Jahn M120

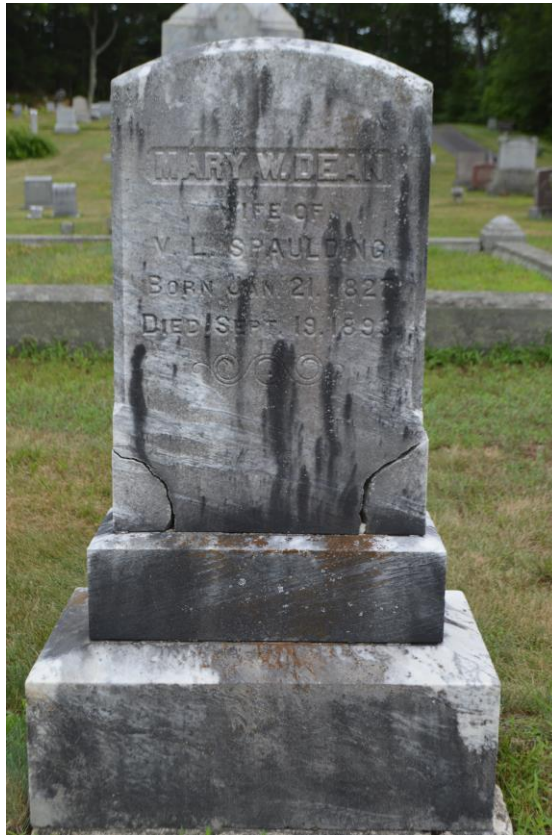
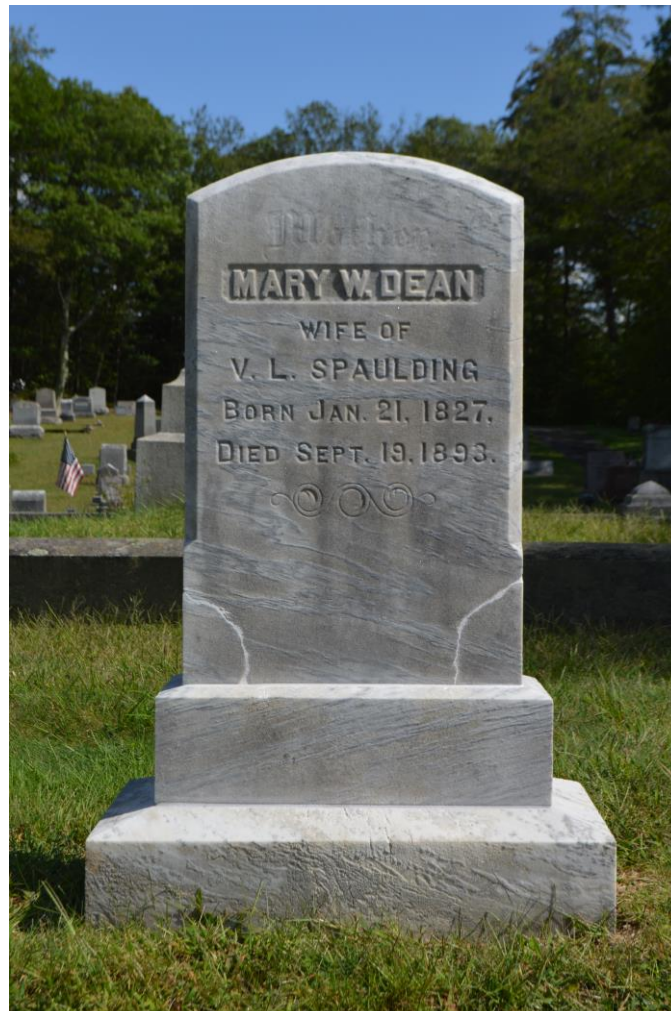
Cemetery	Center Cemetery
Location	Erving, MA
Record Date	May 2023
Name	Spauling, Mary
Date of Death	Sept. 19, 1893
Material	Marble
Style	Die with base

Stone Condition	Ambient dirt and biological growth Leaning Sunken base Broken corners, pins Missing mortar
------------------------	--

Treatments	Cleaned and treated with D2 Reset foundation stone plumb Remove pins Reattach fragments with Jahn M120 Reset die with lime mortar
-------------------	---

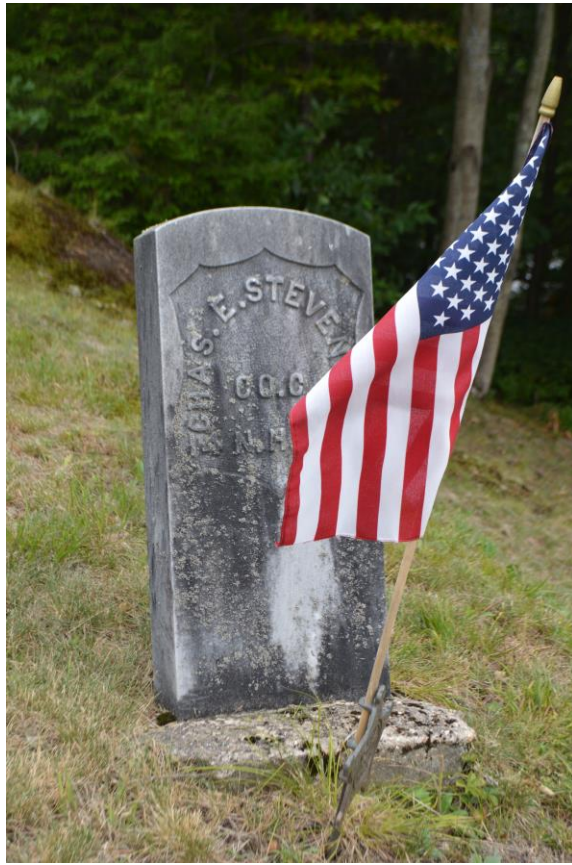
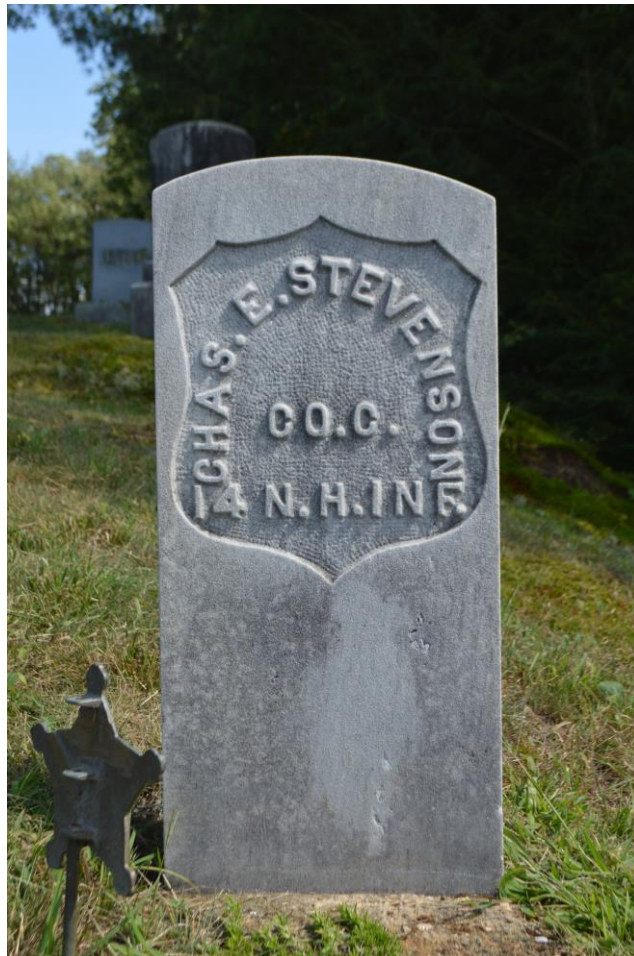
Cemetery Center Cemetery
Location Erving, MA
Record Date May 2023
Name Stevenson, Chas. E.
Date of Death
Material Marble
Style Tablet

Stone Condition Ambient dirt and biological growth
Leaning
Concrete

Treatments Cleaned and treated with D2
Reset base and stone plumb

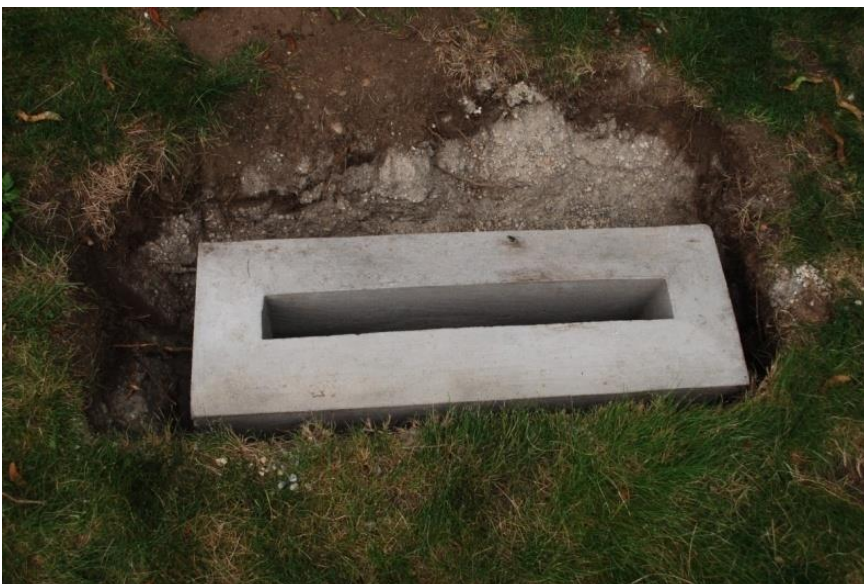
Cast concrete bases are typically made with a slot that is $\frac{1}{2}$ " wider and thicker than the stone and is recessed 3"-4". Depending on the size of the stone the base is usually 8"-12" deep, 8"-12" greater thickness and 6"-8" wider than the stone. This method is fine when resetting stones with a square bottom. If casting with a recessed slot, drainage holes must be provided.
