Former International Paper Mill Feasibility Study

**Town of Erving &
Franklin Regional Council of
Governments**

December 2015

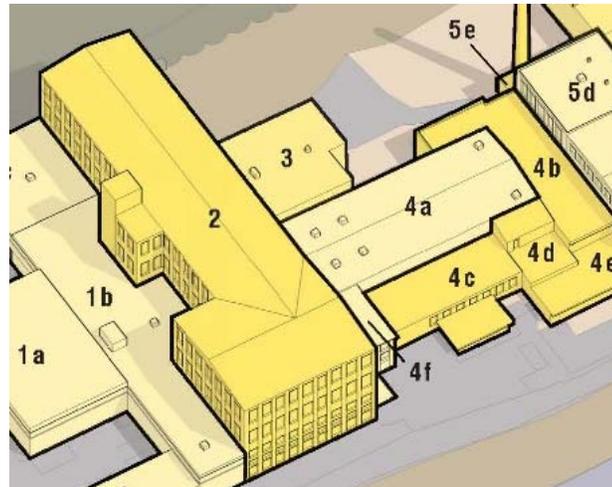
Building 3 is a small utilitarian structure that is not directly connected to the other portions of the mill complex. The project team did not visit the interior of this building on the site visit, it is labeled as “Fuel Storage” on a building plan. It is not a large structure at just over 3,000 square feet and is not likely to be reused for a significant purpose. It may be useful as a mechanical or utility structure, or it may be more appropriate to remove the structure to open access to the rear of the site and reduce crowding around Building 2.

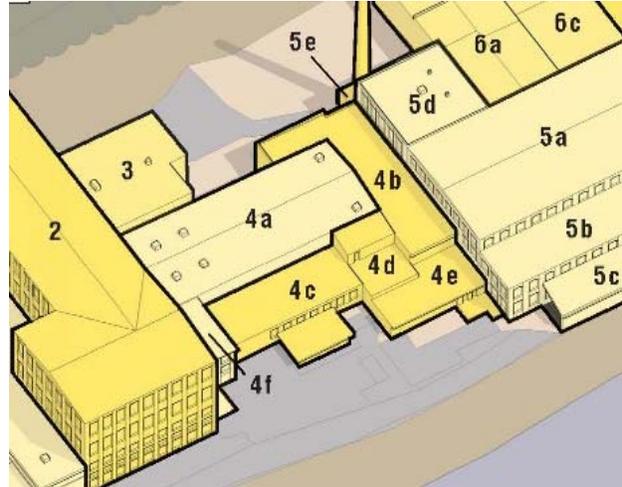
Building 4 (4a, 4b, 4c, 4d and 4e)

Building 4 was also a part of the most historic and original portion of the mill dating from 1902. However, Building 4 was functionally-oriented and is one of the most idiosyncratic and utilitarian portions of the entire mill complex. The upper floor housed the two paper machines that were at the core of the manufacturing operations. Underneath the paper machines were two floors that included the Sizing Rooms and the pumps. The buildings were designed and constructed around the dimensions and needs to support the function of this equipment. Accordingly, the spaces include substantial concrete structures, small alcoves, short ceiling heights and generally very interesting spaces that are difficult to reuse.

The main portion of Building 4 is labeled as Building 4a where the paper machines were located. The other buildings 4b, 4c, 4d, 4e and 4f offered small support spaces for equipment or other uses and add onto the primary building massing of 4a. The buildings vary in height between 1-story and 3-stories and total about 38,000 square feet. The buildings do not likely provide adequate windows or natural lighting for interior spaces and the flexibility for potential reuse is limited.

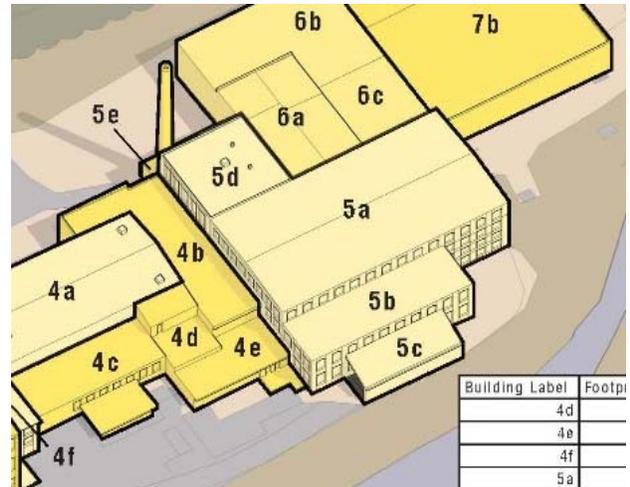
Building 5 (5a, 5b, 5c and 5d)

Building 5 included the Beater Room and the Rag Room that were part of the paper production processes. The lower levels included the boiler room and water tanks. The spaces left in the upper floors of the building are generally well-proportioned and have ample ceiling heights to support reuse. On the lower floors, the infrastructure that is left from pumps and water tanks remains and offers challenges for adaptation and reuse. The area around the chimney stack has a portion of roof that has collapsed.

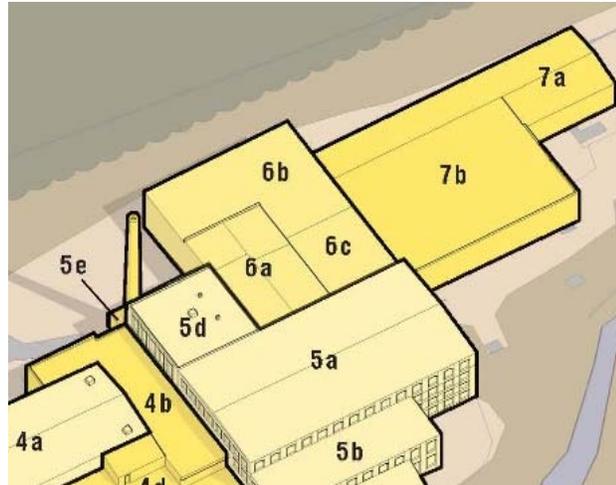
Building 6 (6a, 6b and 6c)

Building 6 includes rear support spaces. The building has a traditional mill character, but many of the windows have been removed with openings boarded or blocked up. The proportion of the building may present some difficulties for reuse and flexibility.

Building 6 includes building areas 6a, 6b and 6c. Each portion of the building is 3-stories in height and totals about 26,000 square feet. The buildings do not likely provide adequate windows or natural lighting for interior spaces and the flexibility for potential reuse may be limited.

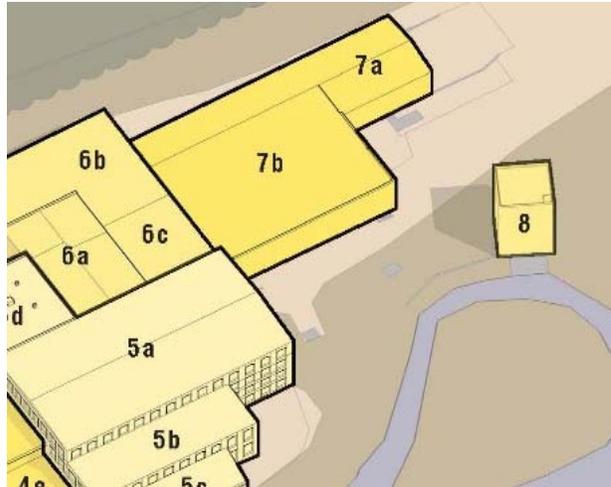
Building 7 (7a and 7b)

Building 7 is the most recent improvement to the mill complex. The stock house and shipping area with loading docks was built in the 1990s. It is a simple steel structured building with metal siding and roof. The structure and buildings are relatively new and reasonably maintained. However, the loading dock area is accessed by an unimproved site route which includes dirt and gravel paths and an open lawn that is accessed by the tunnel provided through and under Buildings 1 and 2. The building itself could be reused for some purpose as it is in good condition. However, the site provisions for truck circulation and access create very practical difficulties in making reuse feasible.

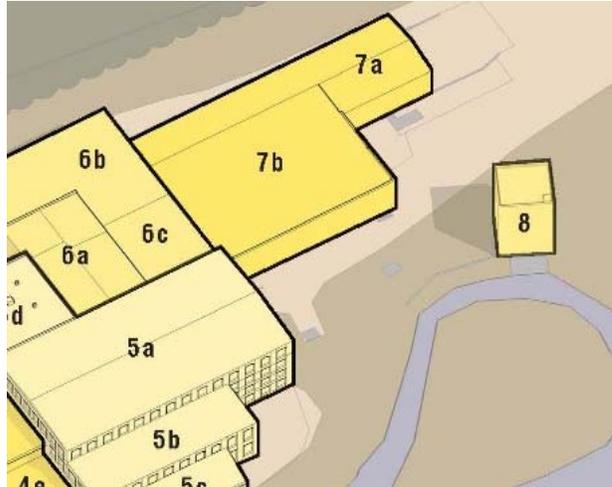
The pump house is a separate brick bearing wall building that is positioned on the downslope toward Millers River. It includes punched openings for windows on all sides. The project team did not visit the interior of this building on the site visit. It appears to be in reasonable condition and may provide a unique opportunity for reuse on the site. The building is completely separate from the other portions of the mill complex and can be considered somewhat more independently from the others. If a reuse could be identified to complement the overall repositioning approach to the property, Building 8 could contribute to an interesting site. If not, it would not be a major loss to the project.

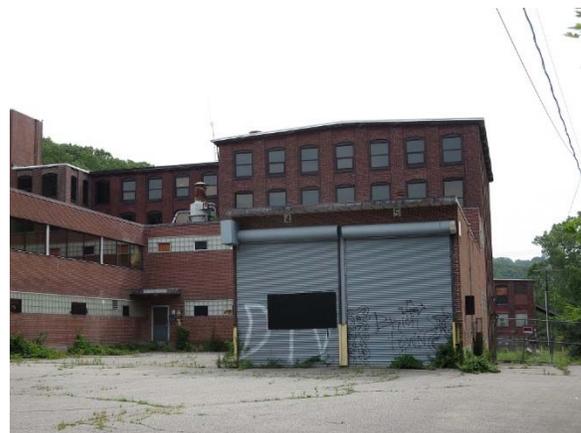
The condition of the exterior masonry walls of 1b appear to be similar to Building 1a, as no significant structural deficiencies were noted in the walls. The roof is also a stone ballasted system with concrete panels, however, there was not as much ponding water noted on the 1b roof. The roof of 1b is supported by structural steel beams that clear span the width of the building, supported by an exterior wall to the west and the wall of Building 2 to the east.

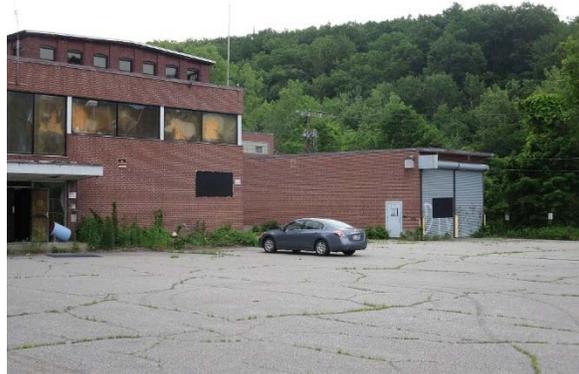
- e) **Building 1e** is a second enclosed loading dock which is connected to the first floor of Building 1b. It is configured in the same way as Building 1d, with two bays sunken relative to the floor of 1b. The roof of this building is a stone ballast system with precast panels and steel support beams, similar to the other adjacent buildings. No significant ponding water was noted, and no water infiltration was apparent from the inside of the building.

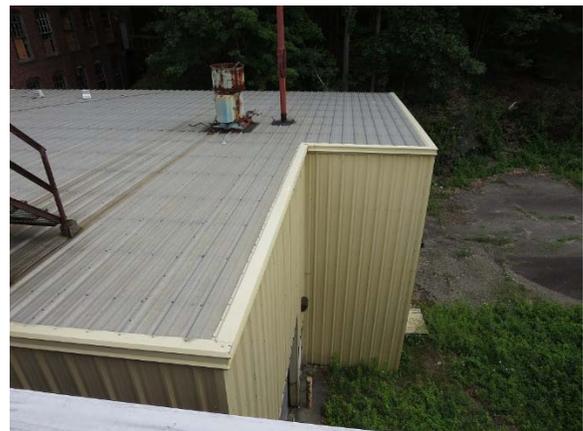
The structure is a single two story light-gauge sheet metal building with a sloped metal roof. This building is not connected to any surrounding buildings and we could not access the interior during our review. The exterior appears to be in good to fair condition with no critical deficiencies noted. The siding on the northeast corner of the building is damaged, likely impacted by a vehicle. There are two large overhead metal garage doors on the eastern side of the building.

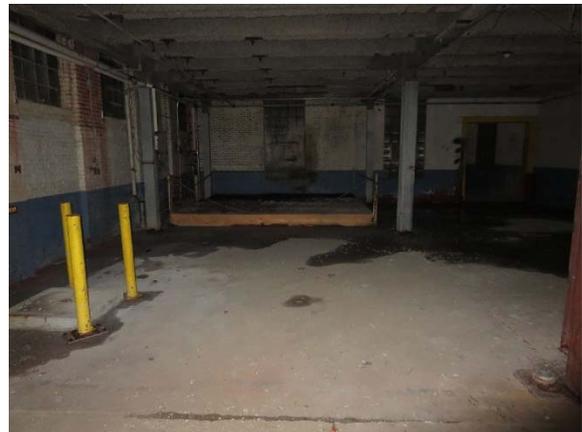
- c) Building 6c is a two story building which is connected to Buildings 6b, 6a, and 7b. Its ground floor is a cast-in-place concrete slab supported by stay-in-place corrugated steel formwork and steel wide flange sections. This slab is fireproofed and looks to be in good condition. There is a circular opening in the floor where a vat presumably passed through which has since been covered with a wood platform. Its second floor is a similar cast-in-place concrete slab, which appears to be in good condition as well. Some bricks are missing from the base of the wall on the third floor. The roof is in good condition.

- c) Building 6c is in good condition overall. The floor slabs are in good condition, as is the roof. There is some water present inside the building, which is possibly coming from the interfaces between this building and the ones it was constructed in between. Because this building appears to be supported mainly by the three buildings surrounding it, removing the other buildings without removing this one would be difficult. We only recommend a further investigation of this building if Buildings 5a, 6a, and 6b are also going to be kept.

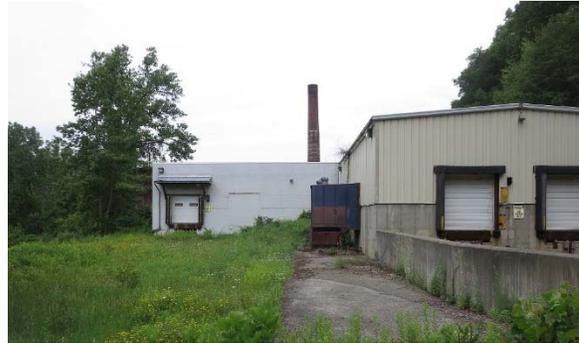
- a) Building 7b is a large storage area with single-wythe CMU walls. The CMUs on the southern wall near the connection with Building 5a area appear to be coving. The roof is sheet metal supported by light trusses. It frames into Building 7a indicating that Building 7b was constructed afterwards.

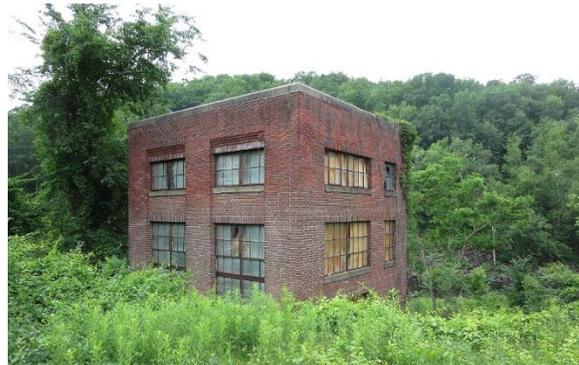
Building 8 is a freestanding pump station located slightly southeast of the main complex. Some of the exterior mortar appears to be lightly eroded around the upper third of the building. The concrete roof slab is in fair condition. Exposed rebar and flexural cracks are visible from inside the building. A roof hatch in the southeast corner of the roof has been left open, and water has entered the building through it. There is organic growth on the walls in that corner.

Building 8 is in fair condition overall. The masonry is in fair condition and would likely require repointing in some locations to account for lost mortar depth. Repointing may be required on the inside and outside of the walls due to the open roof hatch. The roof slab is also in fair condition, showing flexural cracks and small patches of exposed rebar. The slab will most likely have to be replaced or receive local repairs. A further investigation of this building will determine the slab's capacity and the extent of the mortar repairs potentially required.

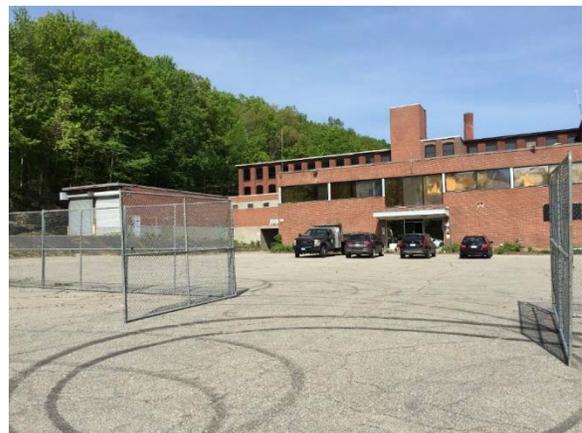
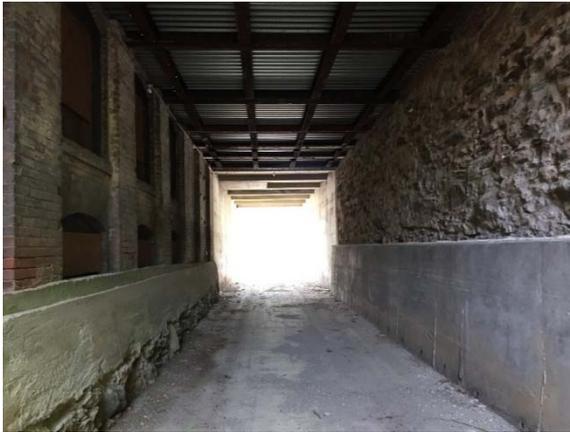
Vehicle access along the north end of the site is greatly restricted by both an existing tunnel through the building and narrow existing pathways between ledge at cropping shown in a photo above and the existing building. At these locations, two way vehicle access cannot be provided unless widening is completed which would require significant rock excavation. For the cost comparison of scenarios we did not include widening of this route. The existing tunnel is retained in all scenarios and may require improvements for future use that were not included in the conceptual cost estimates. Below are pictures of the tunnel and existing pathway along the north side of the site.

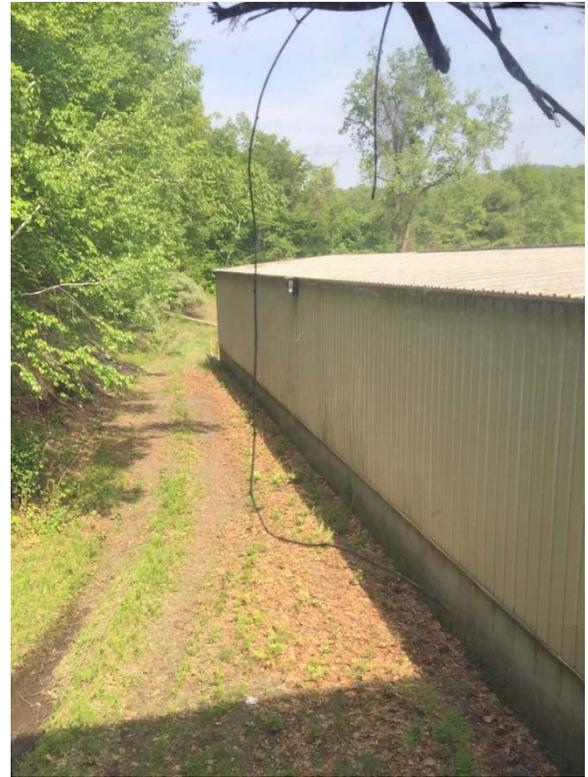
The east end of the site was identified on the survey as gravel access. For scenarios 1 and 2 this gravel access is reconstructed as a new hot mix asphalt parking lot to provide additional parking adjacent to the east side of the remaining buildings. Below is a photo showing the existing condition of the gravel area to be reclaimed as parking.

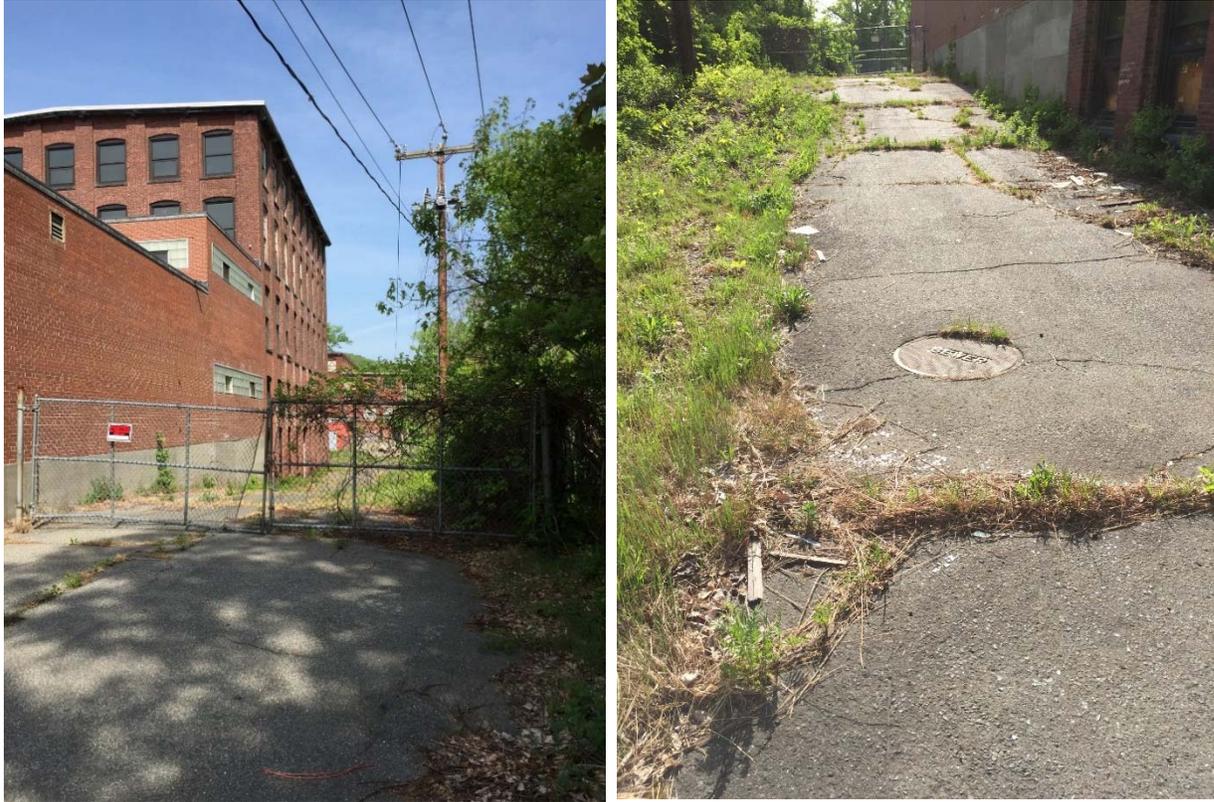
Existing access along the south end of the building is also limited but appears that there may be adequate space to widen the existing access to provide 2 way vehicle access. Widening of this access is recommended for scenarios 1 and 2 but is not required for scenarios 3 and 4 as this route could be restricted to one way vehicle access in conjunction with the one way access through the tunnel. The photos below show the existing access along the south side of the building.
