ROAD SAFETY AUDIT

Route 2 from MM 60 to MM 62.9

Town of Erving

02/17/2023

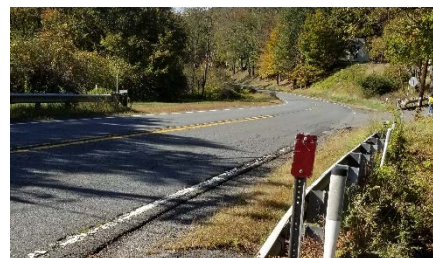
Image 1: Route 2 Approaching Holmes Avenue from Wheelock Street

Holmes Avenue is a residential roadway owned by the Town of Erving and provides access to other residential roadways leading up to the Farley Ledges Trailhead. Holmes Avenue intersects Route 2 at both ends to form stop-controlled approaches at skewed angles. On the east end, Holmes Avenue is oriented at a relatively steep downgrade coming down towards Route 2, which curves to the left when looking both east and west from the approach. The west end of Holmes Avenue also comes at a similarly steep downgrade towards the approach to Route 2, which curves to the right when looking east and has a crest curve when looking west. Stop bars and stop signs are present on both approaches for traffic control. The roadway width is 15-foot wide but still accommodates 2-way traffic. There is no posted speed limit along Holmes Avenue.

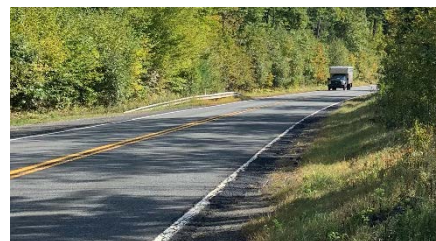
Image 2: Route 2 Near Mile Marker 62, Facing East

This Route 2 section is located near Mile Marker 62 towards the middle of the project area. Cluster 2 is approximately half a mile long and runs parallel to the Millers River adjacent to the south. This section is relatively straight but is located in between two sharp curves located to the east and west. There are no side roads intersecting Route 2 along this segment. Striping comprises of the typical double-yellow centerline, with narrower shoulders that are one to two feet wide. No roadway lighting is present along this section of corridor. There are no curbs at the edge of Route 2, but

there are guardrails that are mainly present on the south side of the roadway. At the western end of this roadway section, there are two pullout areas located on either side of the roadway that are typically used for rest areas and recreational use at the river. The posted speed limit is 45 MPH in both directions within this section, and eventually transitions down to 40 MPH to the west where the sharp curve begins. Without the presence of side streets, the land use along this section is primarily forest land.

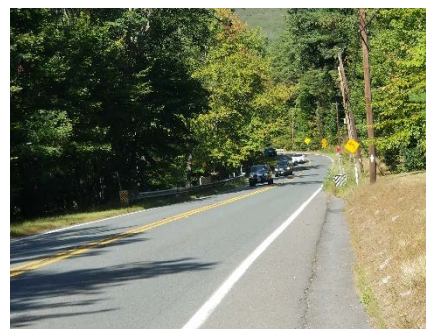
Image 3: Route 2 facing West from Mountain Road

This final segment is located towards the eastern limits of this project near Mile Marker 62.9 and Mountain Road. Along this section, Route 2 operates with one lane in each direction separated by a double-yellow centerline, where it transitions to a passing zone for westbound traffic located west of Mountain Road.

Shoulders also narrow down to a width of one foot. Guardrails are mainly present on the south side of the roadway, with a small section installed on the north side just west of Mountain Road.
