F01372-06
August 24, 2015
Revised October 12, 2015

Re: **Pre-Demolition Hazardous Building Materials Assessment
Former International Paper Mill
Erving, MA**

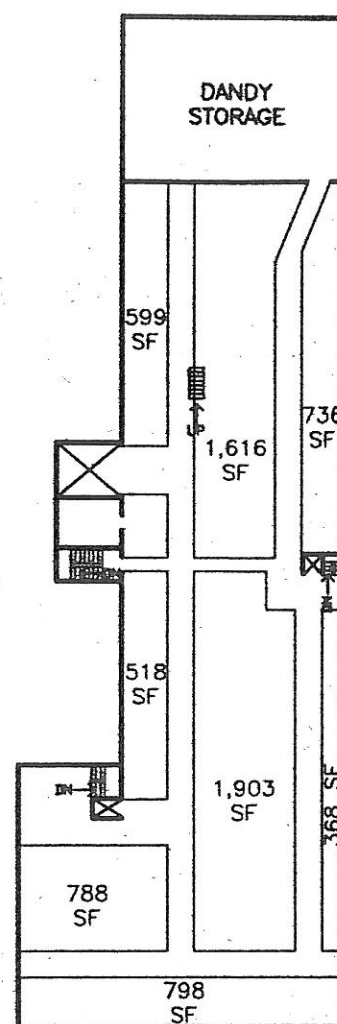
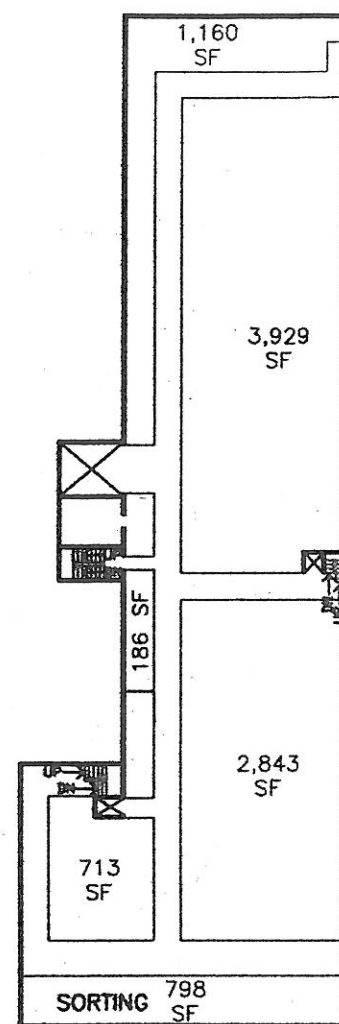
4th FLOOR

3rd FLOOR

PAPER STORAGE TALLY
3RD FLOOR 19,521 SF
4TH FLOOR 7,326 SF

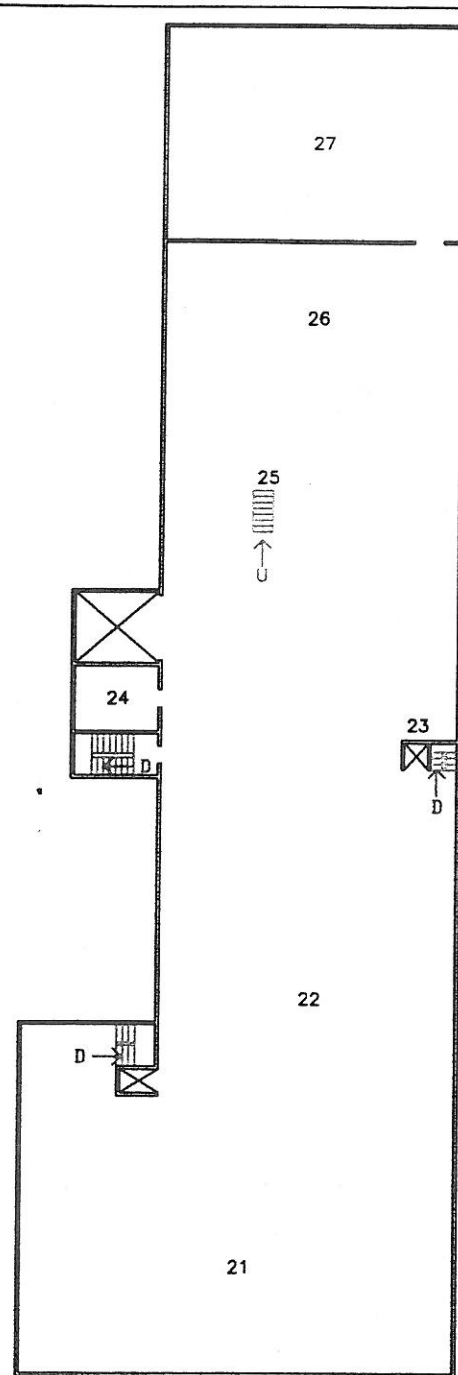
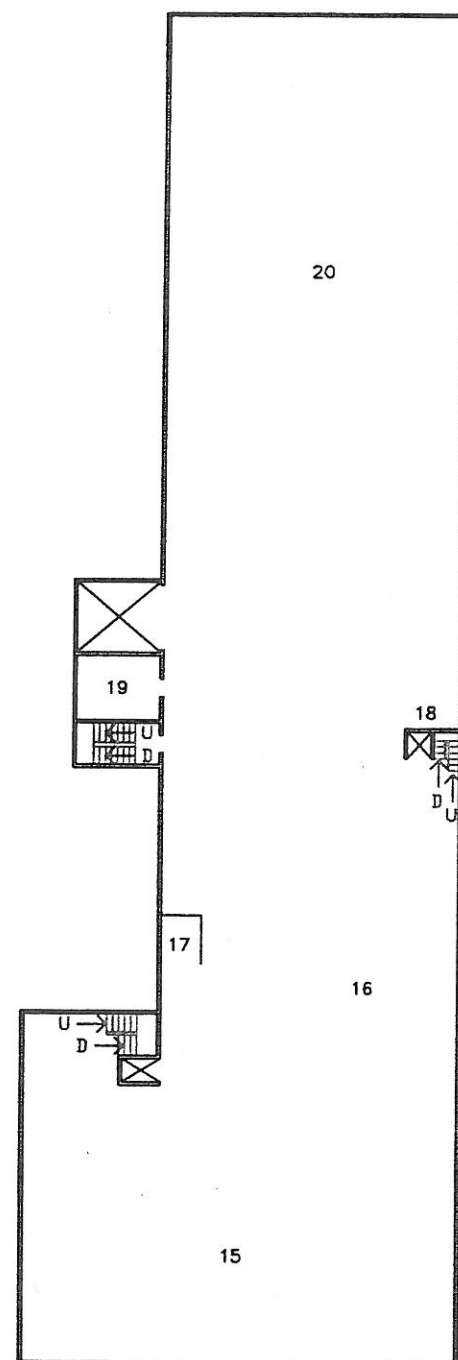
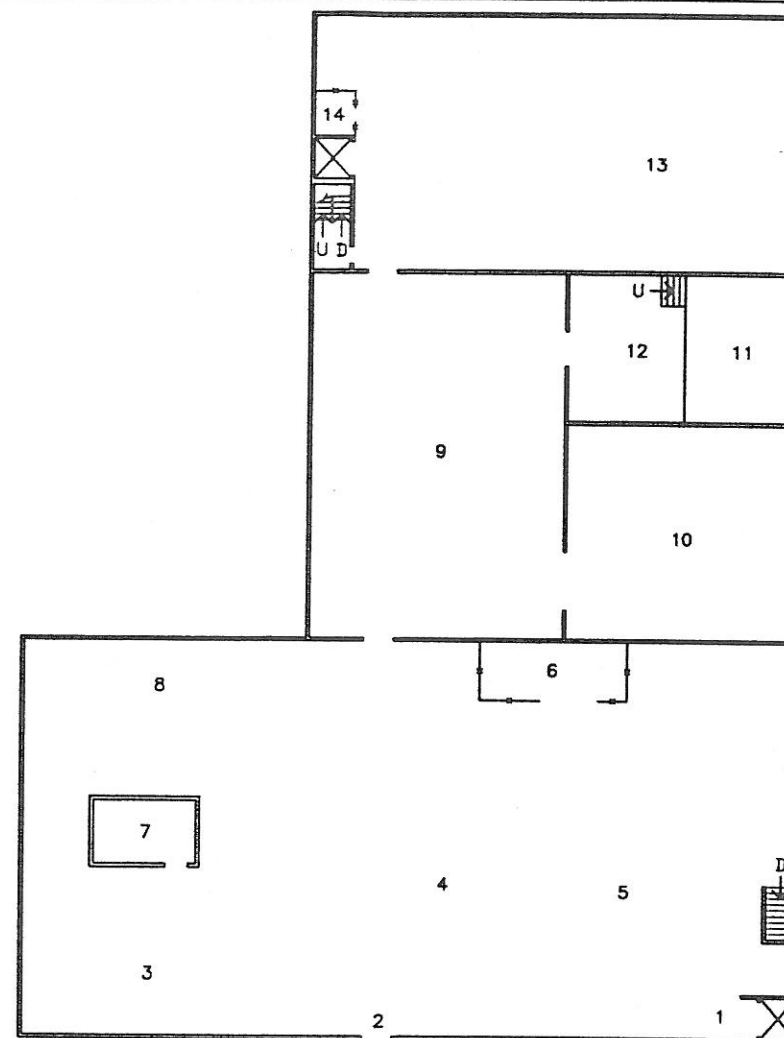
4th FLOOR

3rd FLOOR

- 1-ELEVATOR OUT OF SERVICE
- 2-ROOF ACCESS
- 3-WIPITS AREA
- 4-MISC STORAGE
- 5-WIPITS AREA
- 6-BREAKERS
- 7-UNION OFFICE
- 8-CHEMICAL AREA-BERMED
- 9-CARDBOARD RECYCLING STORAGE
- 10-MOTORS STORAGE
- 11-MEZZANINE STORAGE-JANITORIAL SUPPLIES
- 12-JANITOR OFFICE
- 13-BROKE STORAGE
- 14-ELEVATOR CABLE MOTOR
- 15-SORT DEPARTMENT
- 16-VIPITS AREA
- 17-OPEN OFFICE AREA
- 18-ELEVATOR OUT OF SERVICE.
- 19-LADIES ROOM
- 20-WIPITS AREA
- 21-CORE STORAGE
- 22-PALLETS, SKIDS & TOPS STORAGE
- 23-ELEVATOR OUT OF SERVICE
- 24-FORMS & OFFICE PAPER STORAGE
- 25-STAIRWAY SUSPENDED FROM CEILING.
- 26-MISC STORAGE
- 27-DANDY ROLL & FELTS STORAGE

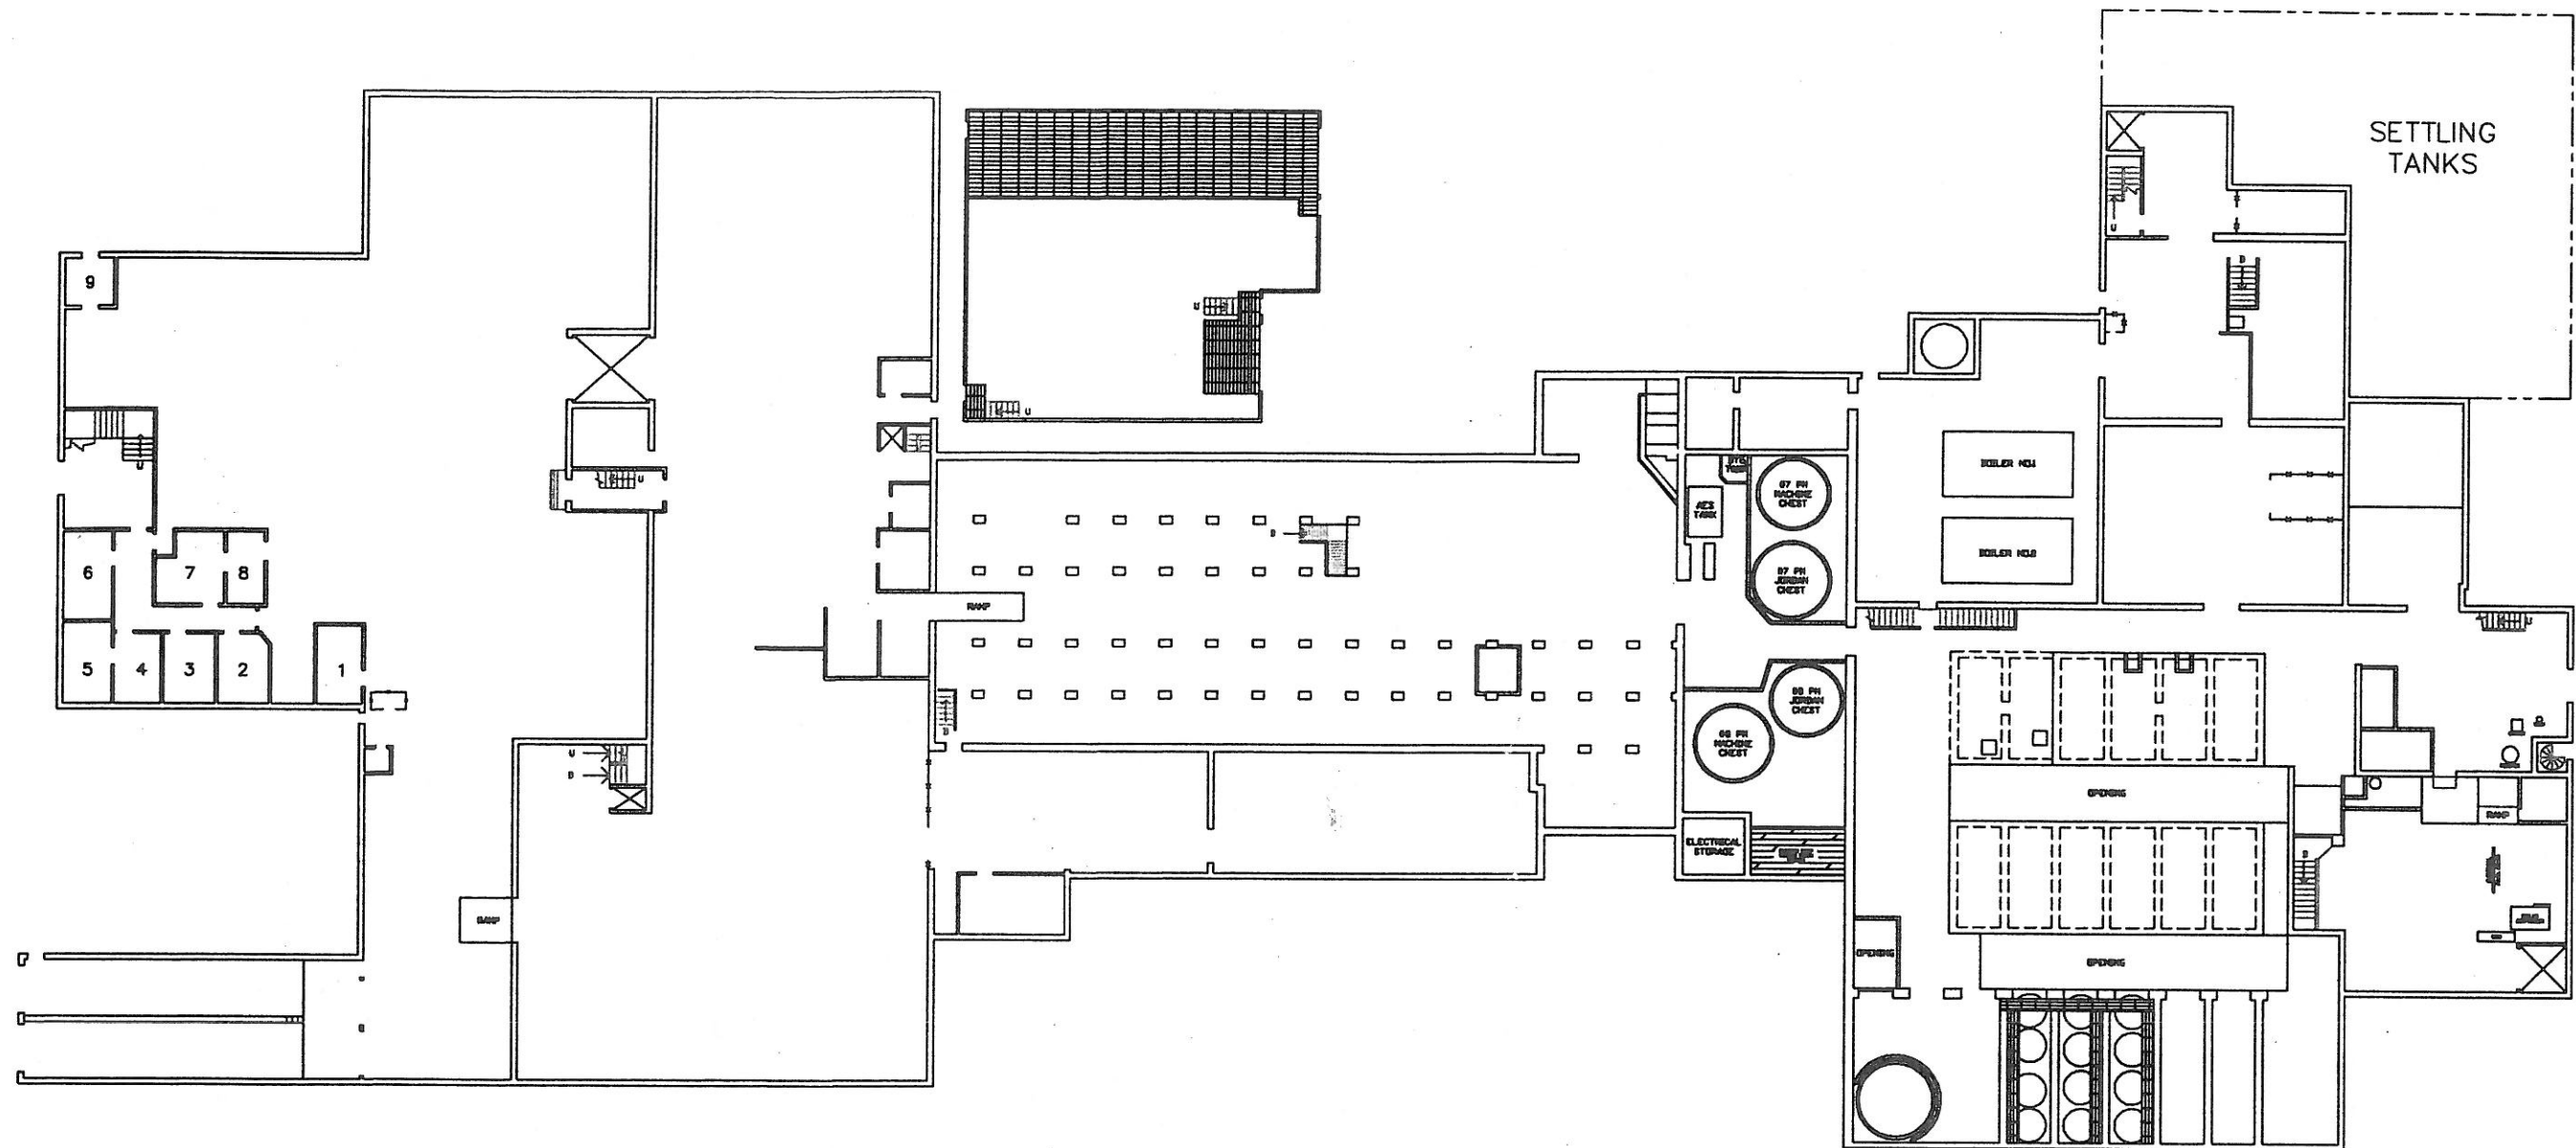
- 1-HEALTH SERVICES
- 2-PRODUCTION ACCOUNTING-JACKIE TREAT
COST ACCOUNTING CLERK-JOHN PELOSO
- 3-CONTROLLER-STEVE TREAT
- 4-BUSINESS ANALYST-PAT O' SHEA
BUSINESS ANALYST-DAVID WELLS
- 5-STORAGE CLOSET
- 6-DON PERKINS
HEATHER ROMAN
- 7-PURCHASING CLERK-NANCY ORTH
- 8-PURCHASING MANAGER-DEBORAH LEARY
- 9-AT&T SWITCH ROOM
