WATERSHED-BASED PLAN

Keyup Brook Within the Towns of Erving and Northfield, MA

November 2023

Franklin Regional Council of Governments 12 Olive Street Greenfield, MA

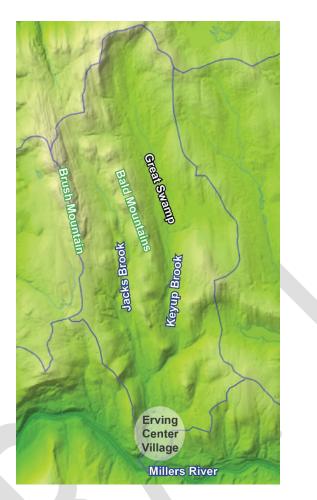
Figure 2: Major topographical features in the Keyup Brook Watershed

Figure 2 shows how Keyup and Jacks Brooks flow through relatively narrow valleys surrounded by high-elevation hills. Jacks Brook flows south between the Bald Hills and Brush Mountain, where there is a nearly 600-foot elevation difference between the brook and the Brush Mountain ridge. The wider valley that characterizes the upper watershed of Keyup Brook in the Northfield State Forest narrows between the Bald Hills and other hills in the northeast corner of Erving, flowing through a highly constricted valley along Swamp Road before it meets Jacks Brook.
