# **Center Cemetery Gravestone Preservation Project**

**Erving, Massachusetts  
September, 2018**

**Report prepared by  
Ta Mara Conde  
Historic Gravestone Services  
New Salem, MA**

## **Conservation report for Center Cemetery 2018**

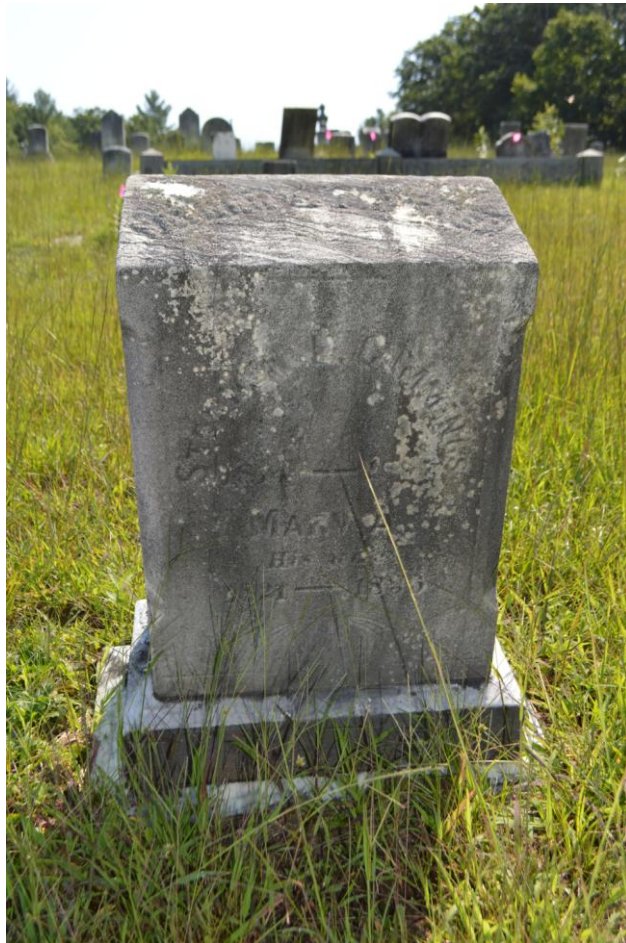
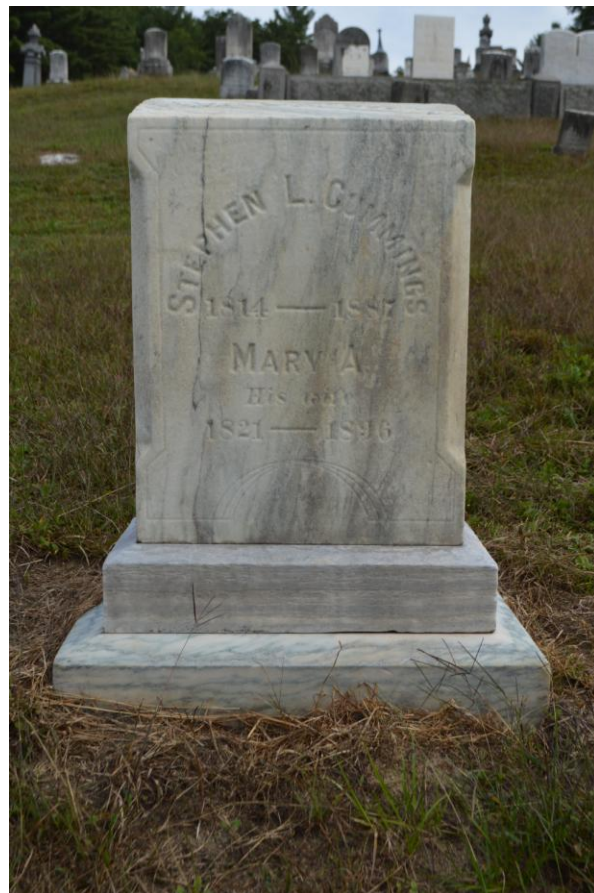
<b>Cemetery</b>	Center Cemetery
<b>Location</b>	Erving, MA
<b>Record Date</b>	August 2018
<b>Name</b>	Cummings, Stephen & Mary
<b>Date of Death</b>	1887                      1896

<b>Stone Condition</b>	Ambient dirt and biological growth Leaning Plinth & base sunken Pins
------------------------	---

<b>Treatments</b>	Cleaned and treated with D2 Remove pins Reset base stone plumb Reattach plinth & die with lime mortar
-------------------	--

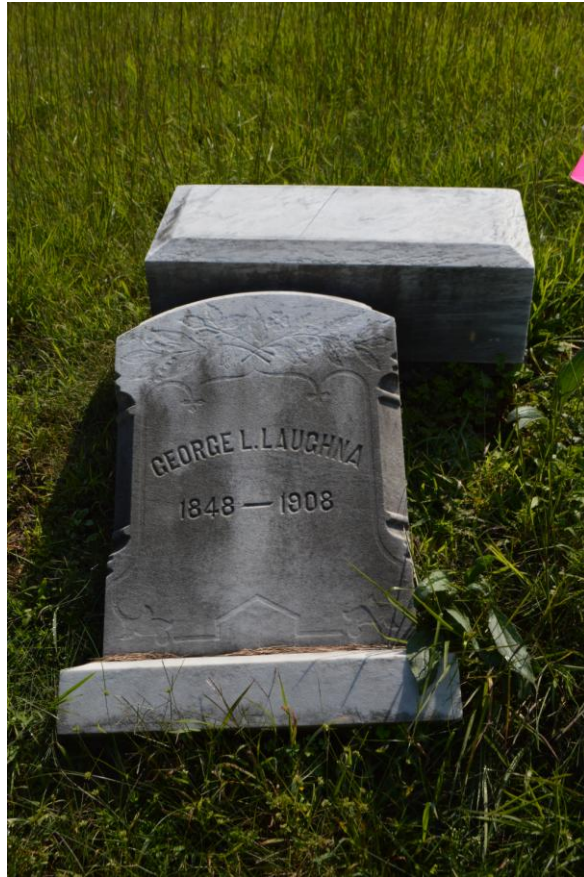
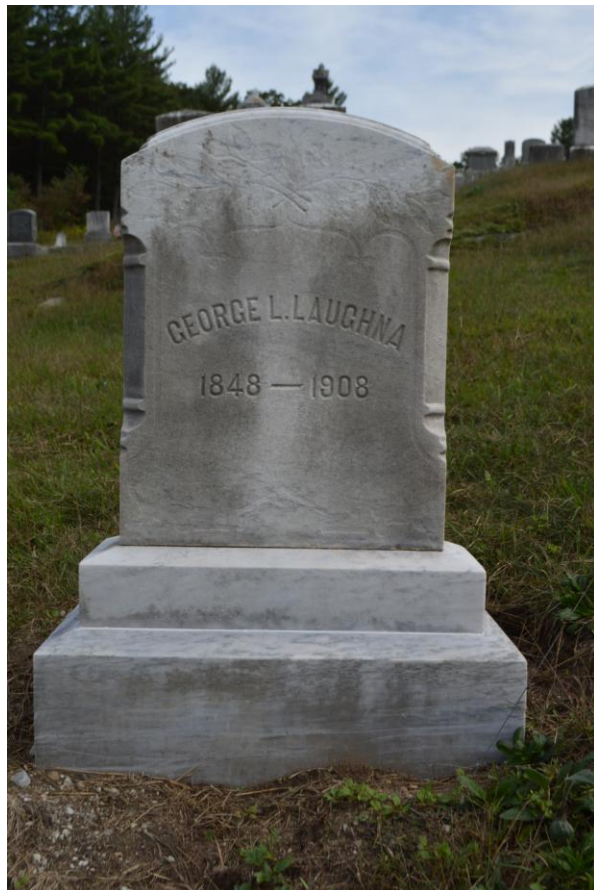
**Cemetery** Center Cemetery  
**Location** Erving, MA  
**Record Date** August 2018  
**Name** Laughna, George L.  
**Date of Death** 1908

**Stone Condition** Ambient dirt and biological growth  
Fallen off base  
Base set on rubble  
Leaning

**Treatments** Cleaned and treated with D2  
Reset base stone plumb  
Reattach die with lime mortar

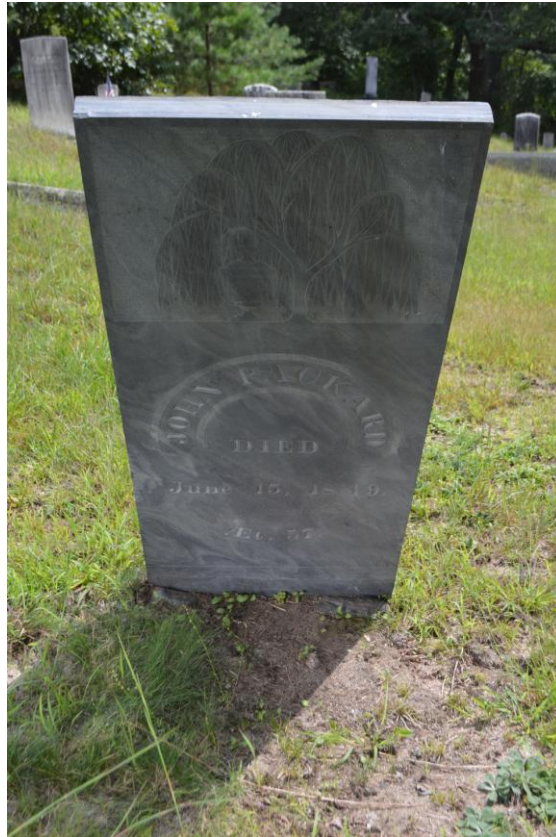
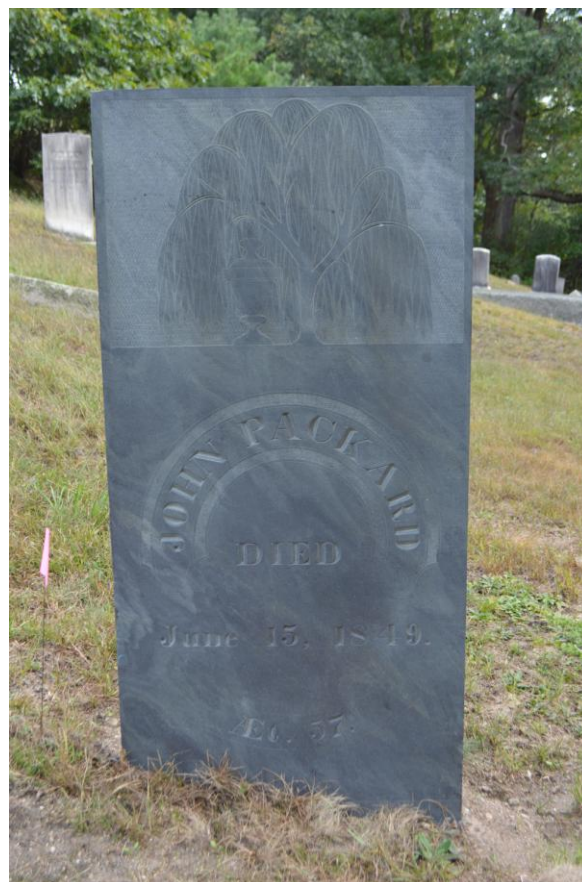
**Cemetery** Center Cemetery  
**Location** Erving, MA  
**Record Date** August 2018  
**Name** Parkard, John  
**Date of Death** June 15, 1849

**Stone Condition** Ambient dirt and biological growth  
Leaning  
Plinth & base sunken  
Pins

**Treatments** Cleaned and treated with D2  
Remove pins  
Reset base stone plumb  
Reattach plinth & die with lime mortar

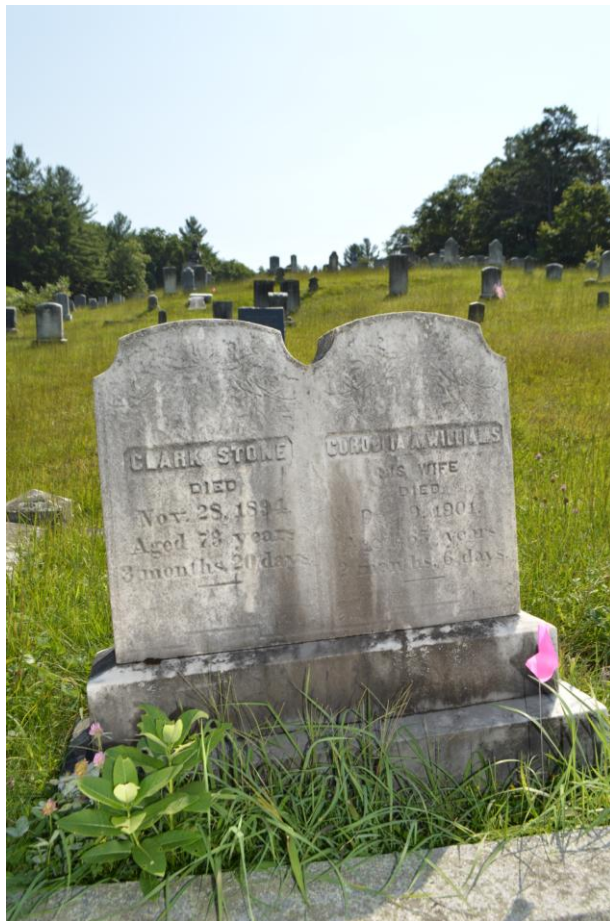
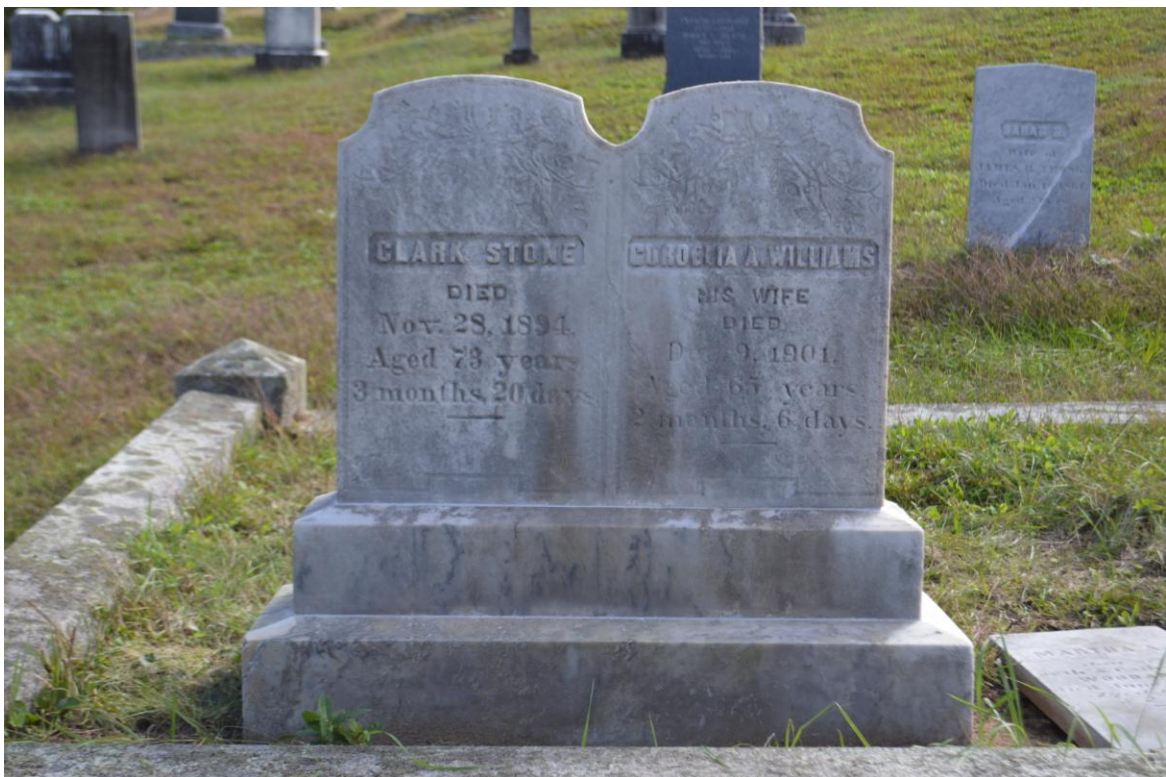
**Cemetery** Center Cemetery  
**Location** Erving, MA  
**Record Date** August 2018  
**Name** Stone, Clark and Cordelia  
**Date of Death** Nov. 28, 1894      Dec. 9, 1901

**Stone Condition** Ambient dirt and biological growth  
Leaning  
Plinth & base sunken  
Pins

**Treatments** Cleaned and treated with D2  
Remove pins  
Reset base stone plumb  
Reattach plinth & die with lime mortar

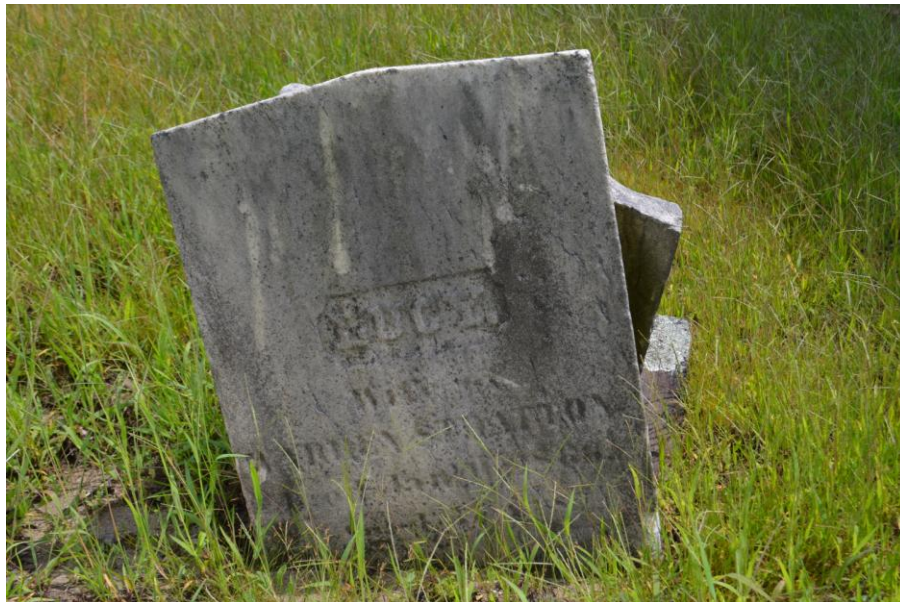
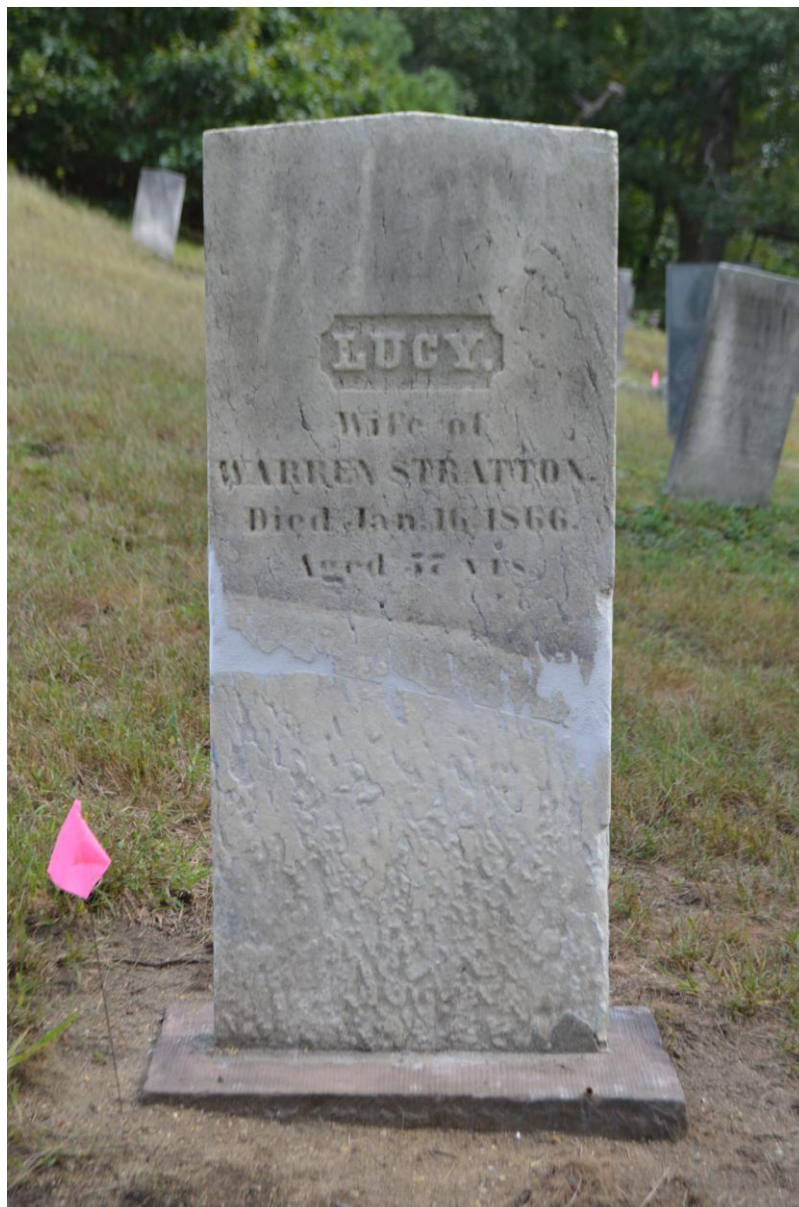
**Cemetery** Center Cemetery  
**Location** Erving, MA  
**Record Date** August 2018  
**Name** Stratton, Lucy  
**Date of Death** Jan. 16, 1866

**Stone Condition** Ambient dirt and biological growth  
Leaning  
Broken, 2 fragments

**Treatments** Cleaned and treated with D2  
Reset base & fragment plumb  
Reattach fragment with Jahn M120

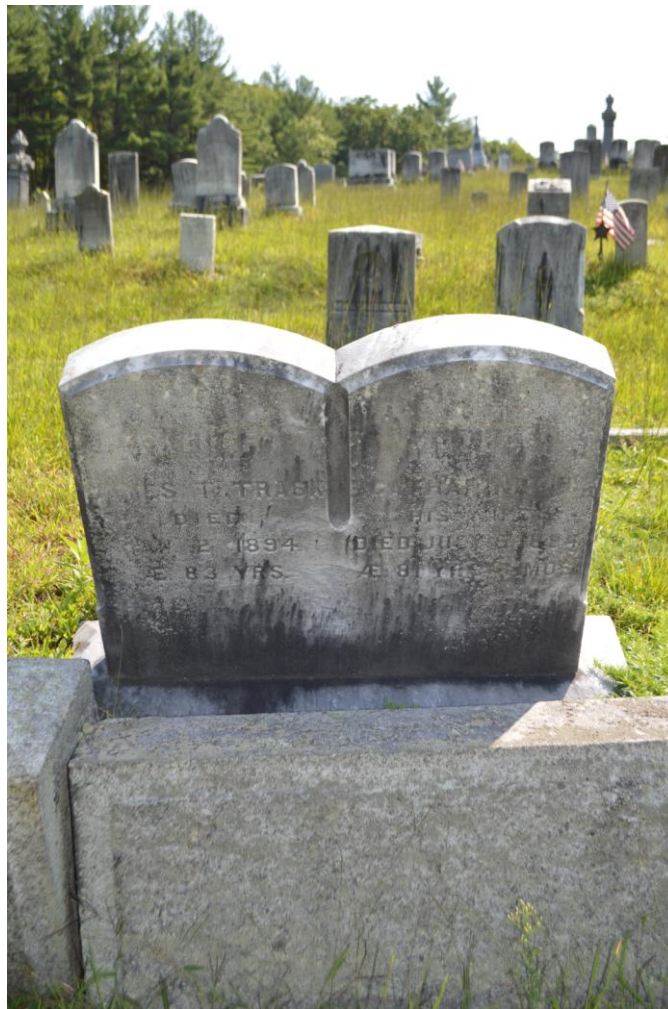
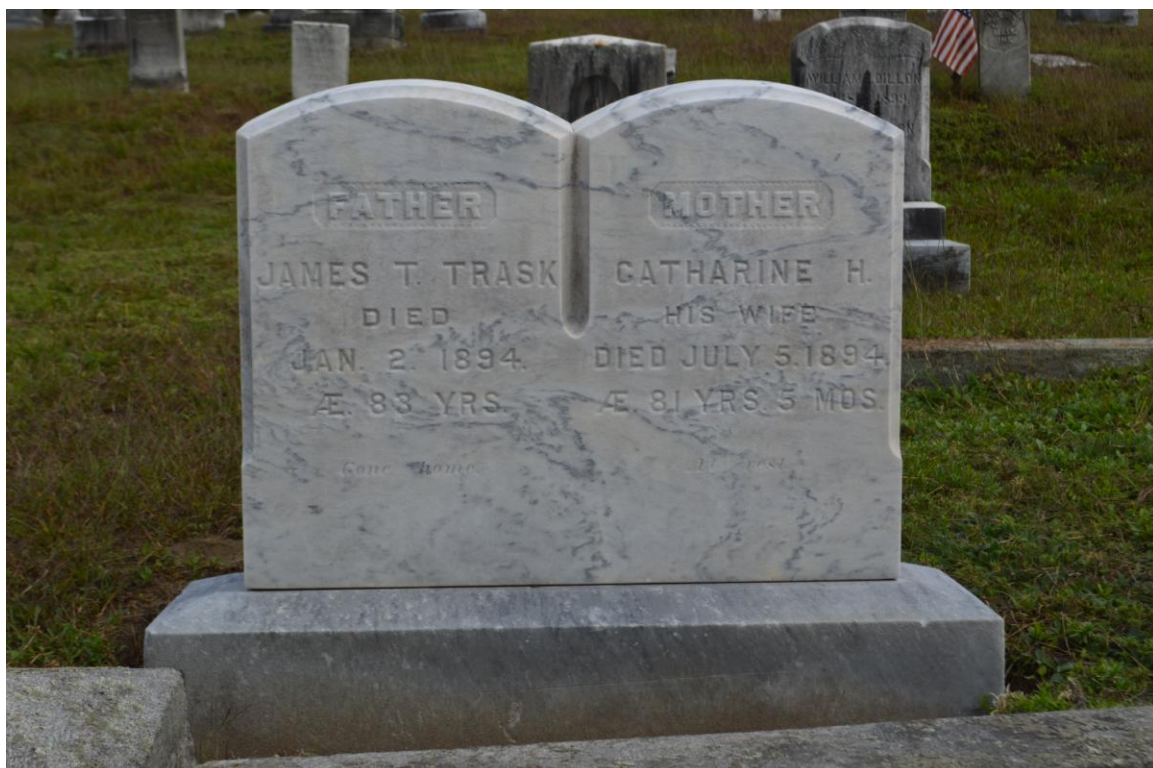
**Cemetery** Center Cemetery  
**Location** Erving, MA  
**Record Date** August 2018  
**Name** Trask, James and Catharine  
**Date of Death** Jan. 2, 1894      July 5, 1894

**Stone Condition**      Ambient dirt and biological growth  
Leaning  
Plinth & base sunken  
Pins

**Treatments**      Cleaned and treated with D2  
Remove pins  
Reset base stone plumb  
Reattach plinth & die with lime mortar

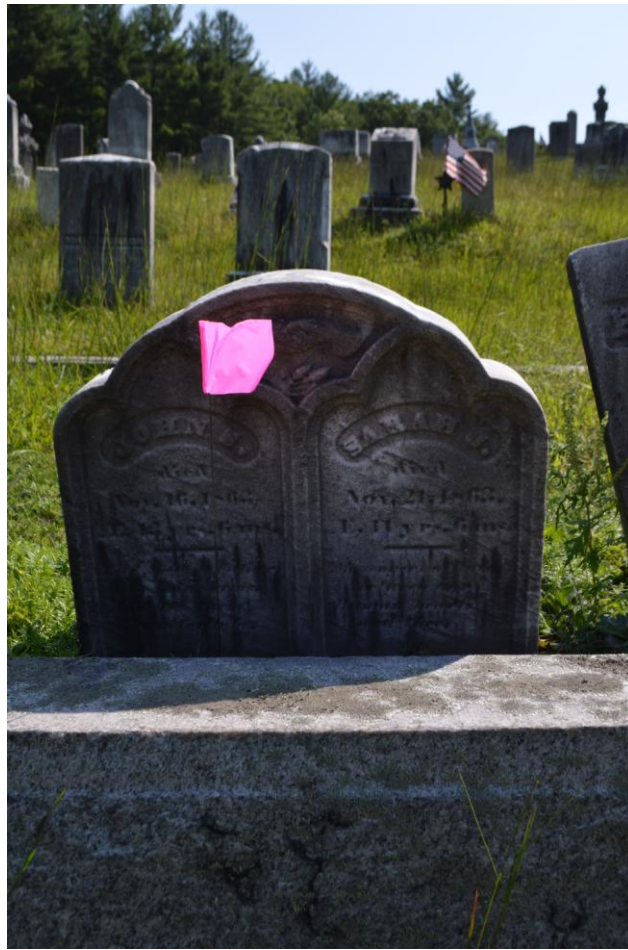
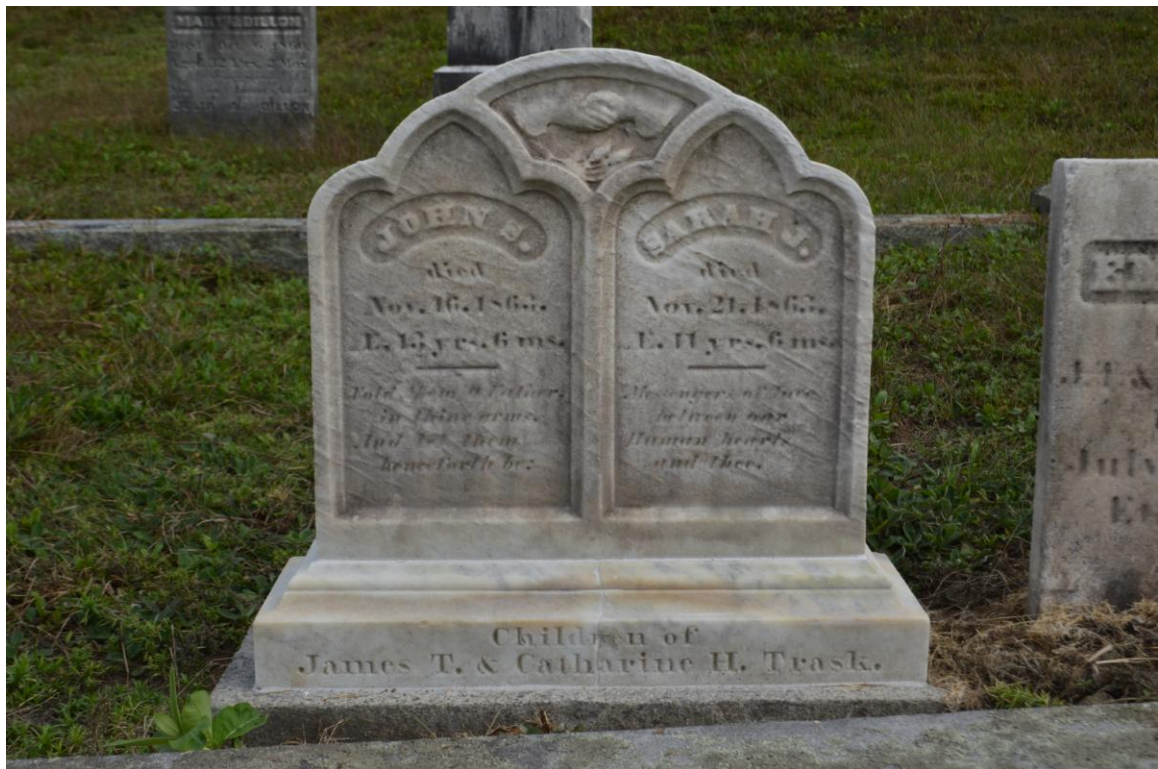
<b>Cemetery</b>	Center Cemetery
<b>Location</b>	Erving, MA
<b>Record Date</b>	August 2018
<b>Name</b>	Trask, John and Sarah
<b>Date of Death</b>	Nov. 16 & Nov. 21, 1863

<b>Stone Condition</b>	Ambient dirt and biological growth Leaning Plinth & base sunken Pins
<b>Treatments</b>	Cleaned and treated with D2 Remove pins Reset base stone plumb Reattach plinth & die with lime mortar

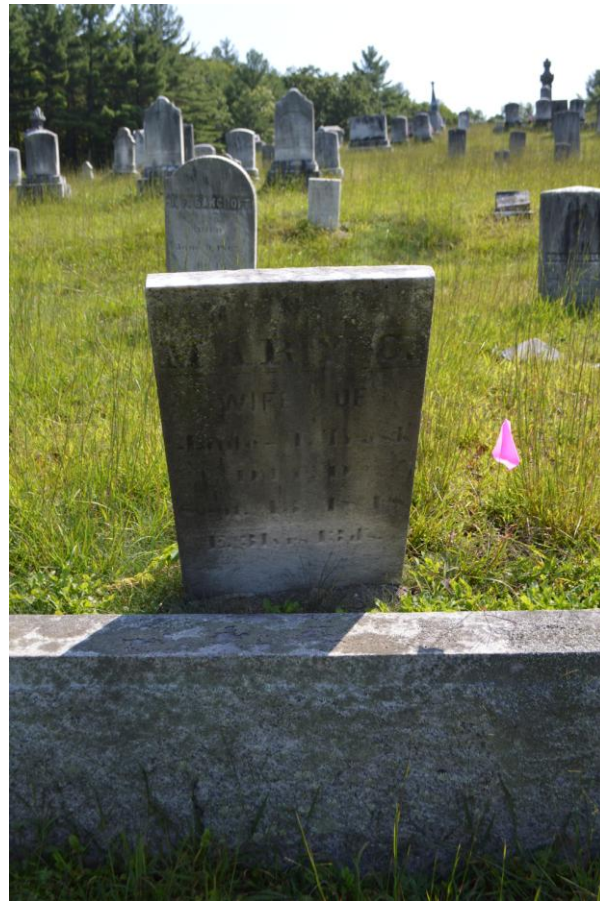
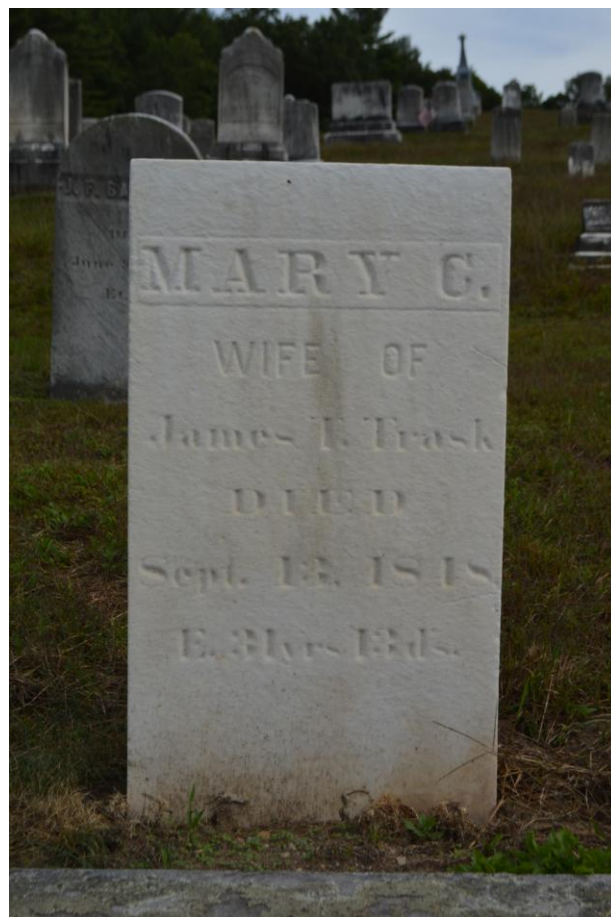
**Cemetery** Center Cemetery  
**Location** Erving, MA  
**Record Date** August 2018  
**Name** Trask, Mary C.  
**Date of Death** Sept. 13, 1848

**Stone Condition** Ambient dirt and biological growth  
Leaning  
Concrete around base

**Treatments** Cleaned and treated with D2  
Remove concrete  
Reset stone plumb

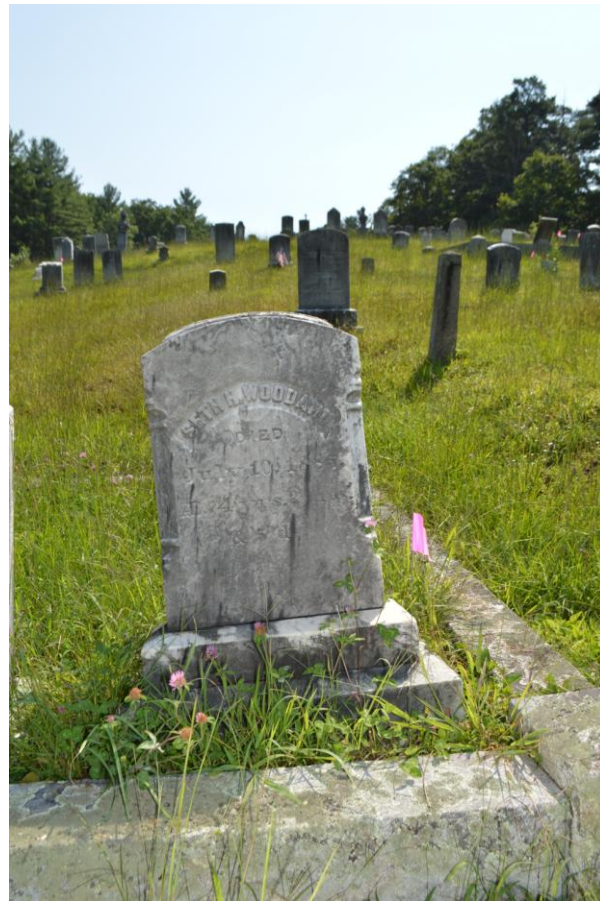
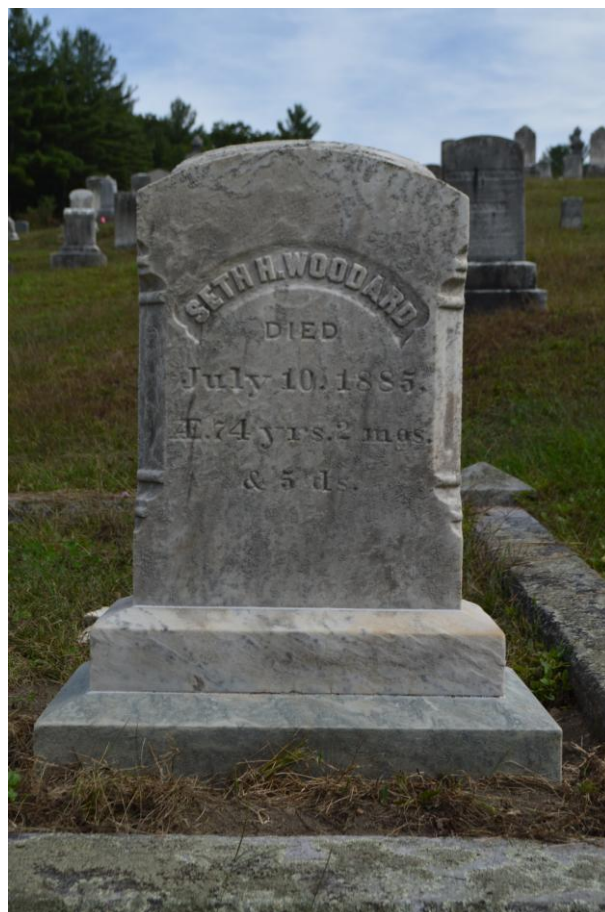
**Cemetery** Center Cemetery  
**Location** Erving, MA  
**Record Date** August 2018  
**Name** Woodard, Seth H.  
**Date of Death** July 10, 1885

**Stone Condition** Ambient dirt and biological growth  
Leaning  
Plinth & base sunken  
Pins

**Treatments** Cleaned and treated with D2  
Remove pins  
Reset base stone plumb  
Reattach plinth & die with lime mortar
